Data Structure Report No. 039

Investigations at Queen's University Belfast, Co. Antrim
New Library Project: PO1 811
AE/05/76

Queen's University Belfast
New Library Project: PO1 811

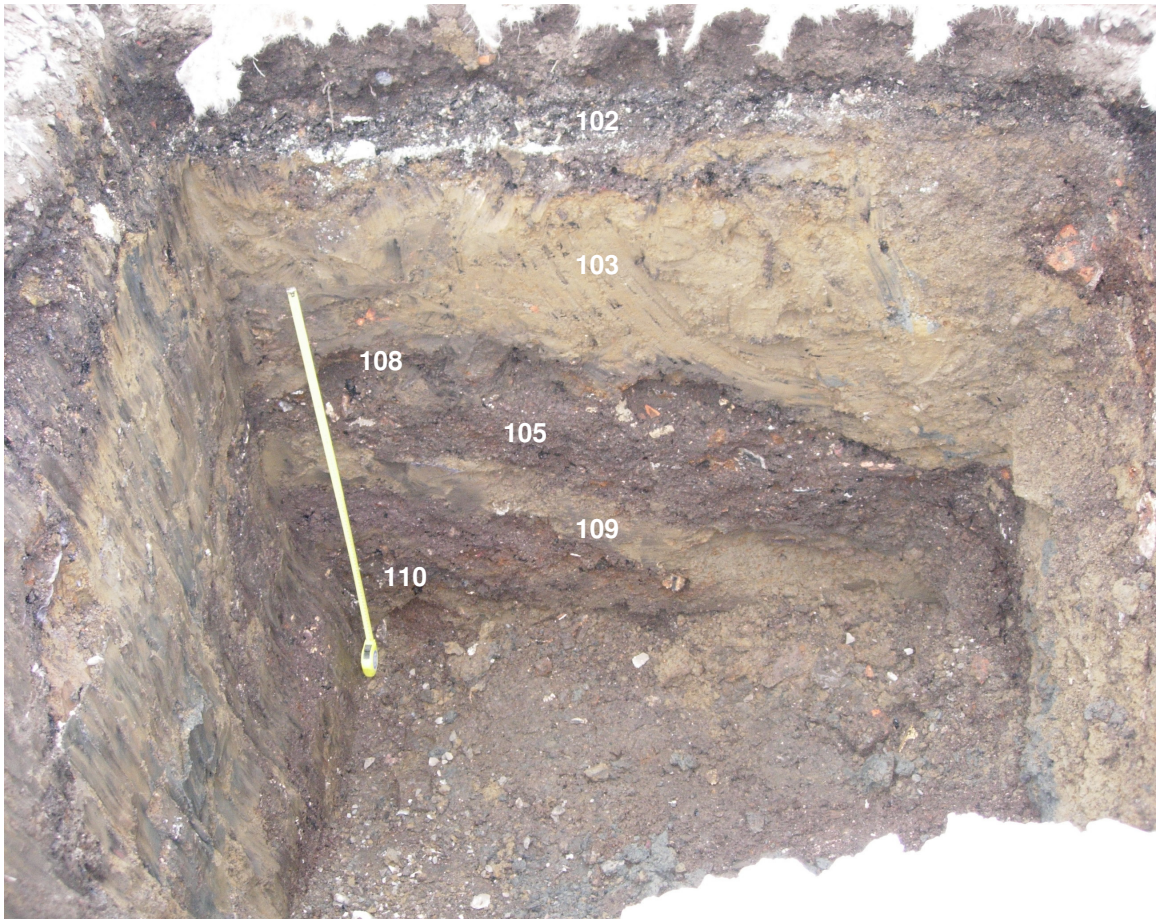
Plate 1 – Trench A South facing section showing levelling deposits (Context Nos. 102 and 103) and 'dump' deposits (Context Nos. 108, 105 and 110).

6.1.1 The dump deposits, (in particular Context Nos. 110 and 112), produced artefactual material dated to the mid nineteenth century or later. A limited finds retrieval exercise may recover artefactual material reflecting the early history of Queen's College. This may be undertaken as part of a monitoring exercise during the initial construction works at this location.

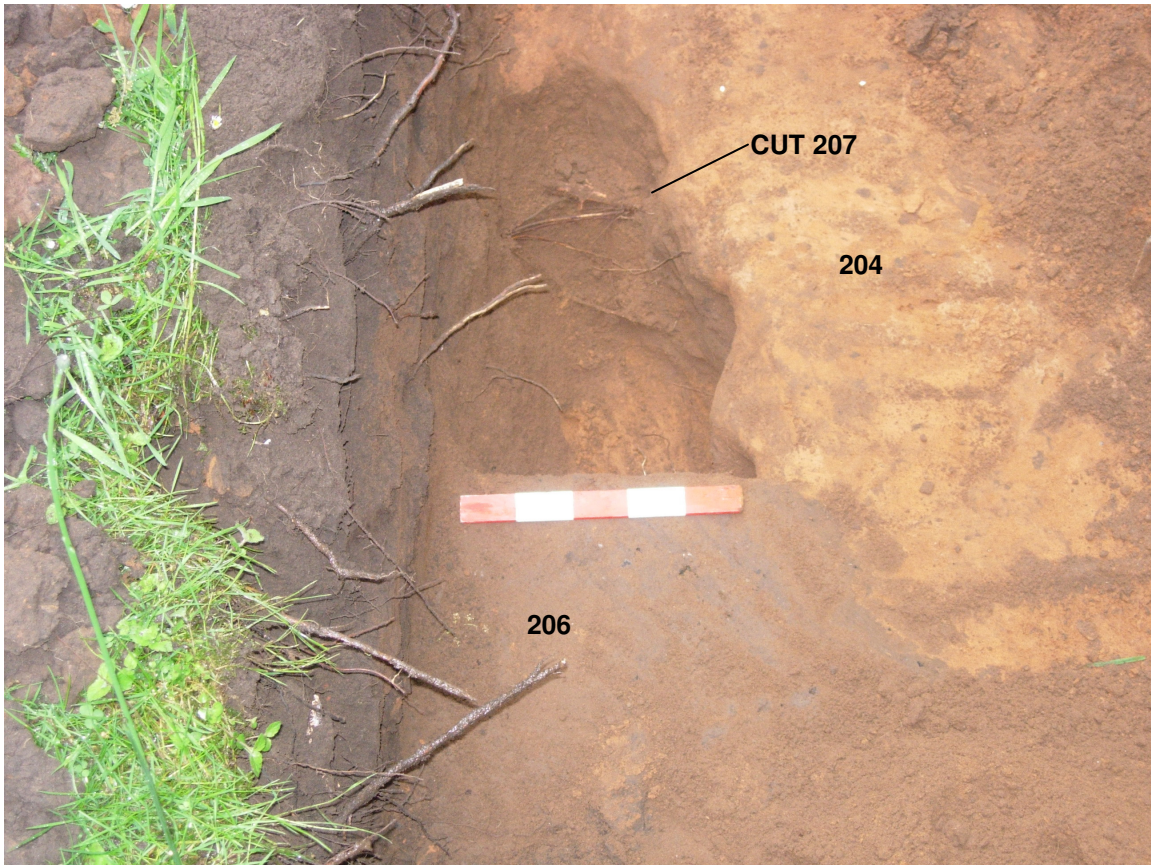
4.3.4 A negative feature was observed at this level in the north-west corner of the trench. The cut of the feature was assigned Context No. 207. The fill (Context No. 206) consisted of loose, medium-brown sandy silt with both light glassy slag (Small Find No. 69) and possible struck (Small Find No. 72) and reworked flints (Small Find No. 71) contained within it. However, upon excavation of half of the feature, numerous rodent burrows were noted undercutting the subsoil (Context 204) and it was concluded that the feature (Context No. 207) represented modern animal disturbance.

Plate 2 - Trench B showing Context No. 207 following excavation of half of the feature. From the west. (0.50 metres scale)

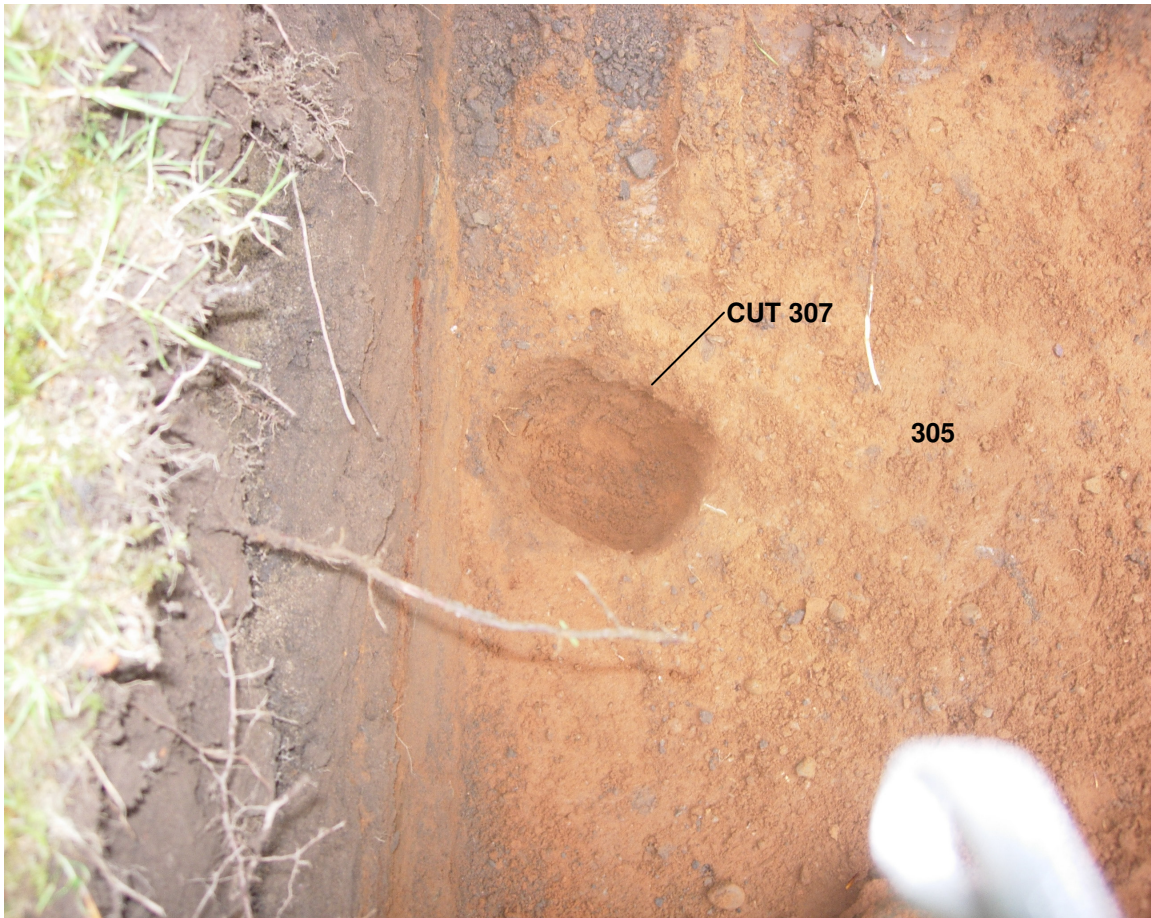
4.4.4 A possible small post-hole (Context No. 307) was observed cutting the subsoil (Context No. 305) in the south-western corner of the trench. This measured approximately 0.2m (east - west) by 0.18m (north - south) and was 0.14m deep. The fill (Context No. 306) consisted of mid to dark brown silty loam. No other features were noted at this level.

Plate 3 – Trench C showing Context No. 307. From the north.

7.1.1 It is recommended that further monitoring takes place upon initial construction phases of the New Library. This would be especially important in the areas of Trenches B and C where possible prehistoric features survive.
