**Evaluation/Monitoring Report No. 125**

**SITE TO THE REAR OF 5 SAVALMORE COTTAGES  
COALPIT ROAD  
NEWRY  
CO. DOWN**

**LICENCE NO.: AE/07/86**

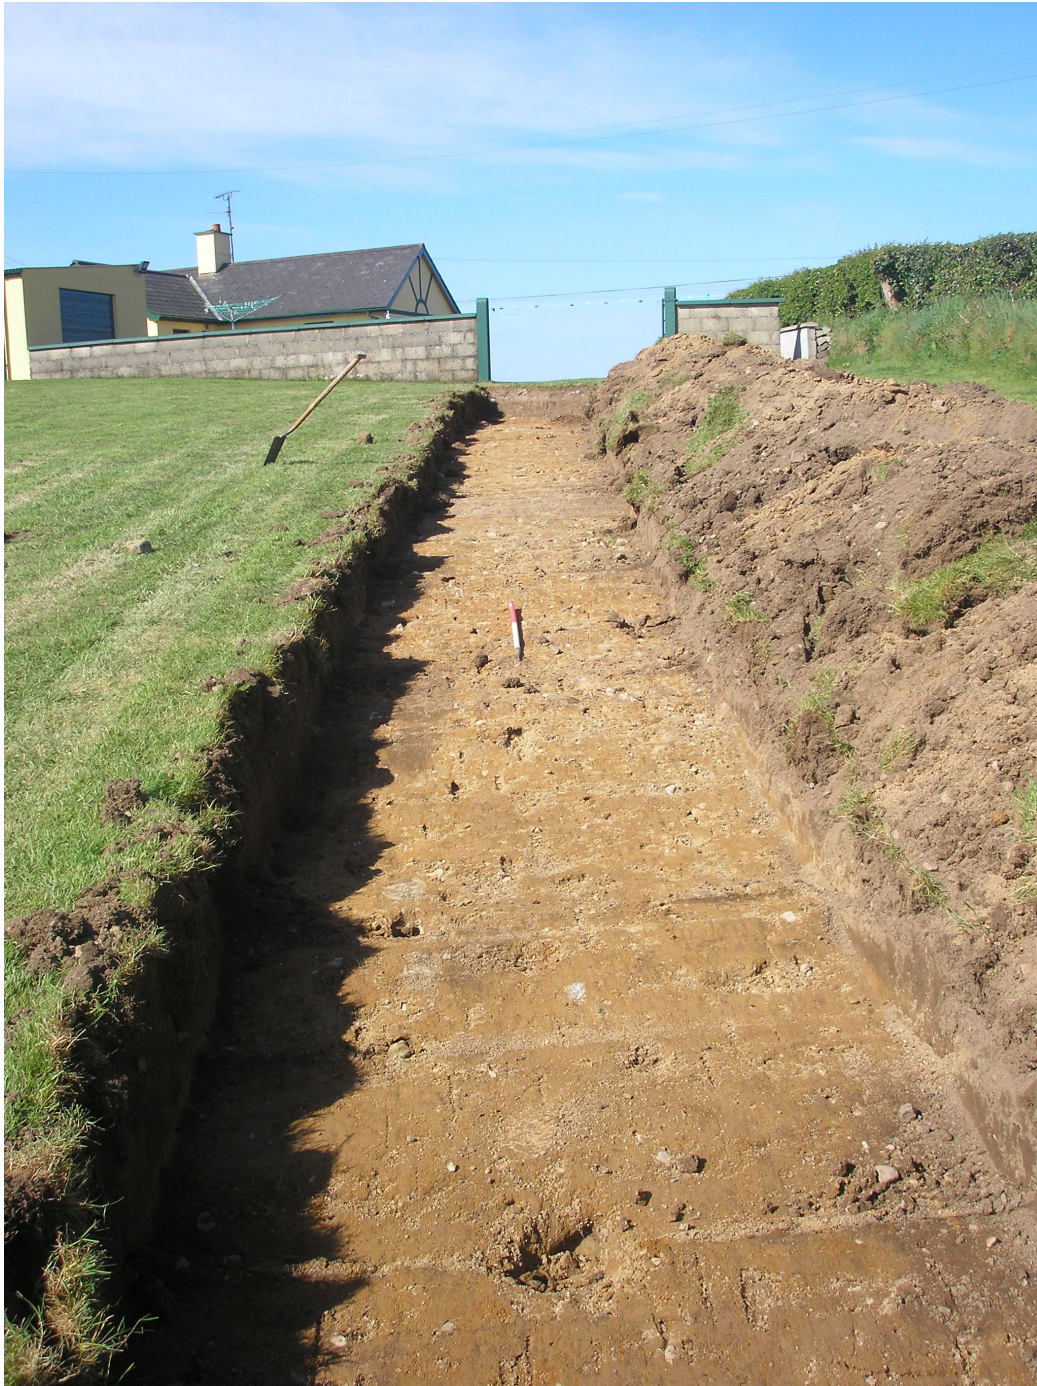
Trench One was located parallel to the northern boundary of the application site. Trench One was approximately 2m wide and 40m long and was aligned approximately south-west/north-east (Plate One). The trench was positioned along the proposed access route for the application site and was excavated to the surface of the natural subsoil.

The subsoil in Trench One (Context No. 103) was an orange compact boulder clay with occasional inclusions of medium to large angular stone, and was encountered at a depth of around 0.3m.

*Plate One: Trench One following excavation to the surface of the subsoil  
(Context No. 103, looking south-west.*

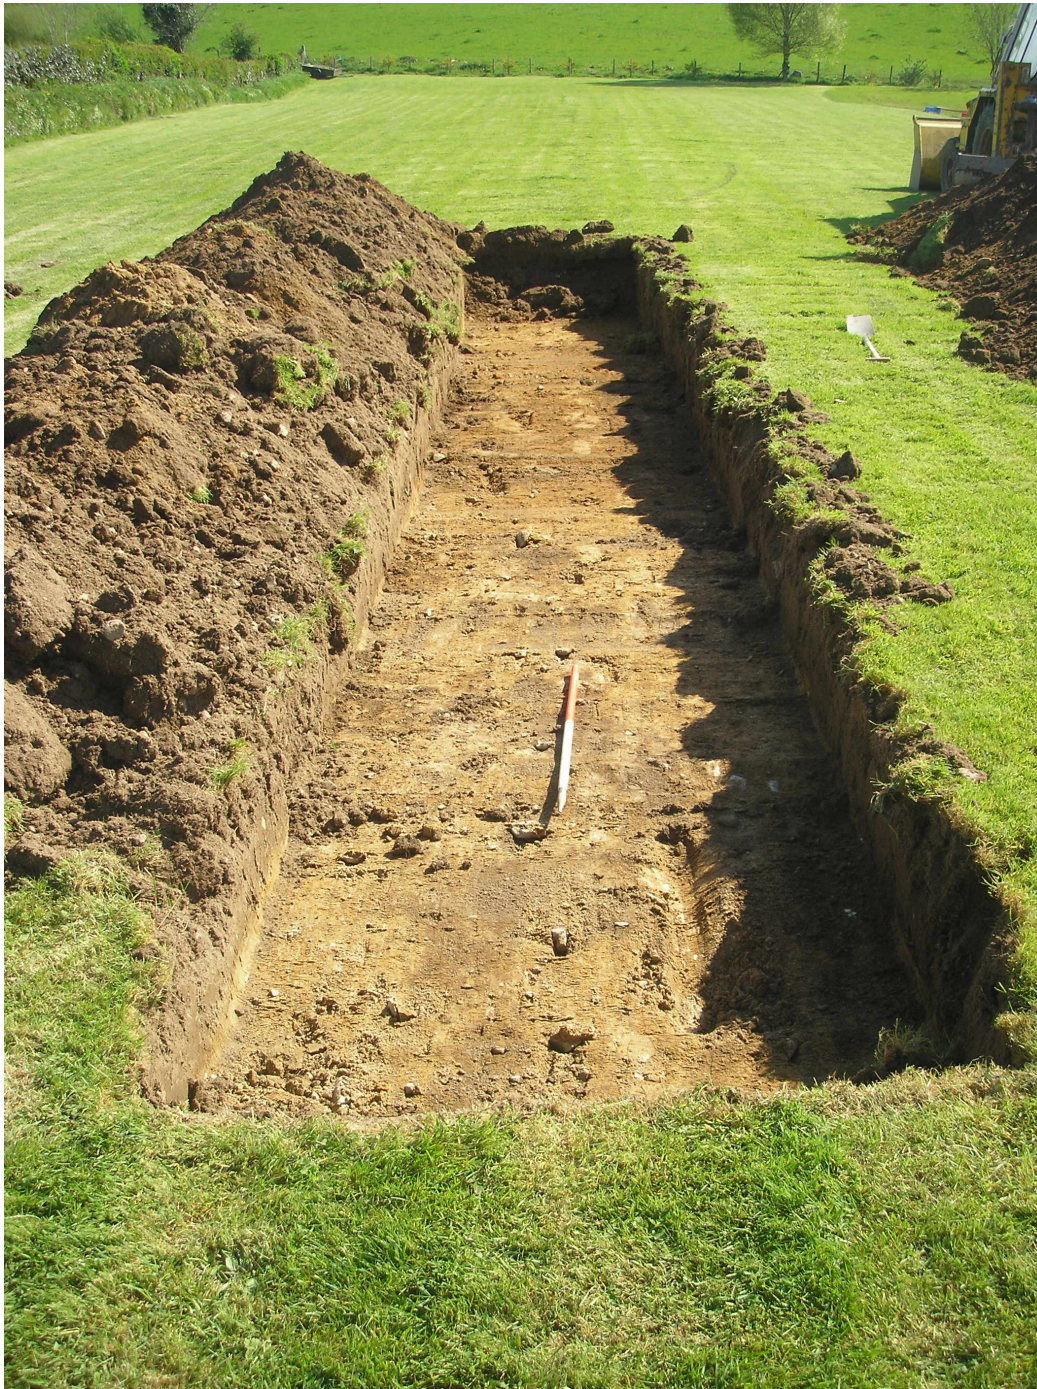
Trench Two was positioned parallel to and approximately 3m to the south of Trench One. The trench was 2m wide and 20m long and was excavated to the surface of the subsoil (Plate Three).

The subsoil in Trench Two (Context No. 203) was an orange compact boulder clay with occasional inclusions of medium to large angular stone, and was encountered at a depth of around 0.33m.

*Plate Three: Trench Two following excavation to the surface of the subsoil (Context No. 203) looking north-east.*

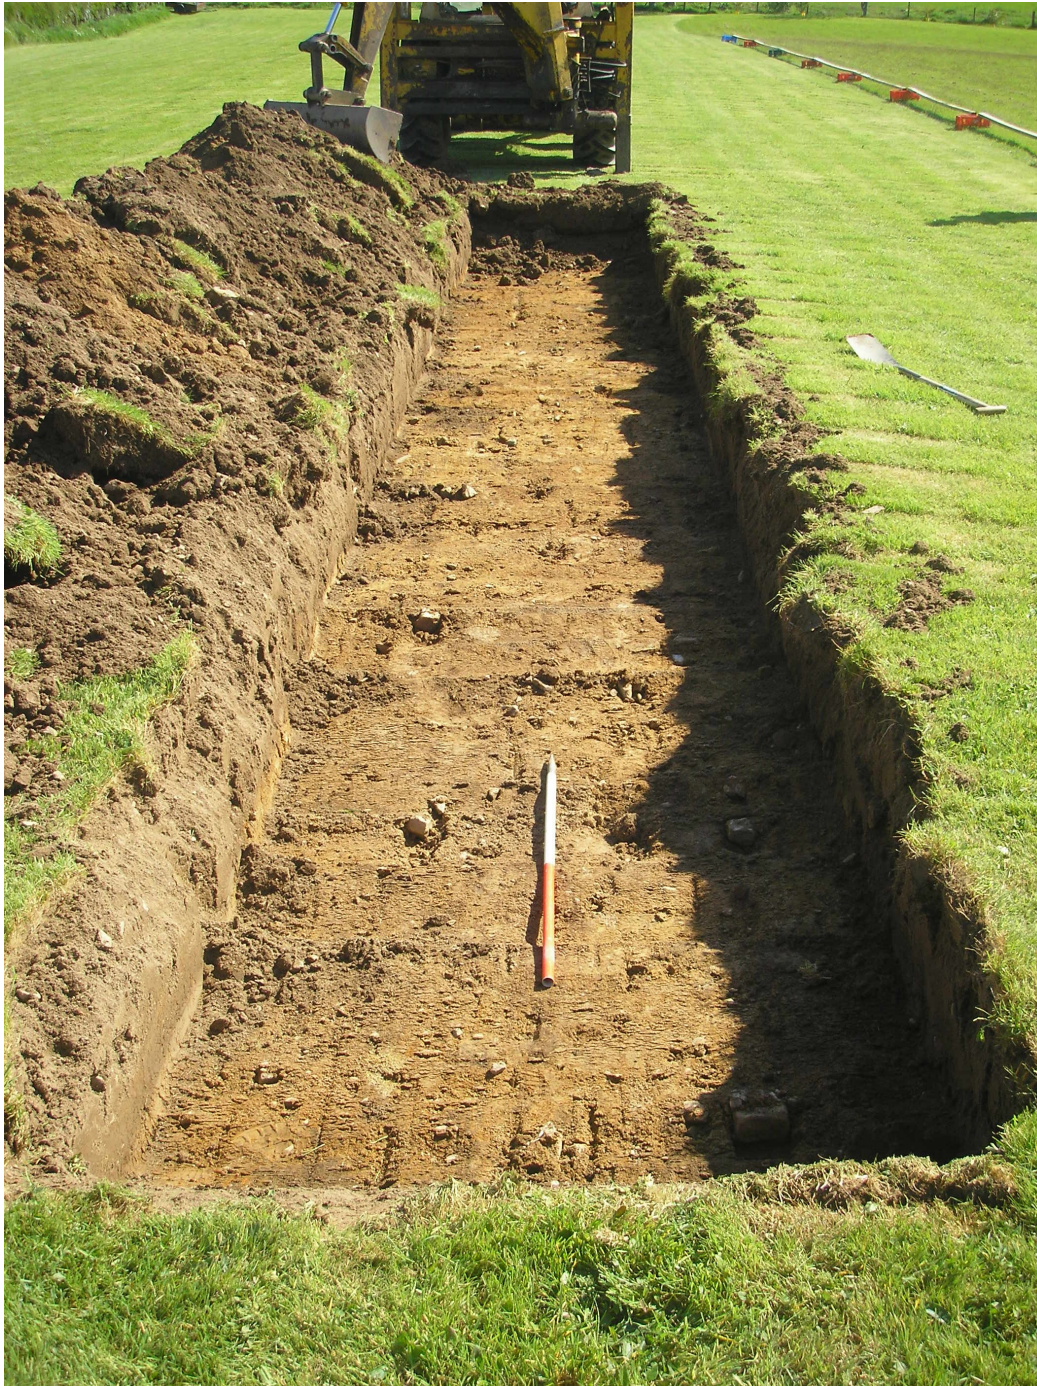
Trench Three was positioned parallel to and approximately 4m to the south of Trench Two. The trench was 2m wide and 20m long and was excavated to the surface of the natural subsoil (Plate Five).

The subsoil in Trench Three (Context No. 303) was an orange compact boulder clay with occasional inclusions of medium to large angular stone, and was encountered at a depth of around 0.35m.

*Plate Five: Trench Three following excavation to the surface of the subsoil (Context No. 303), looking north-east.*

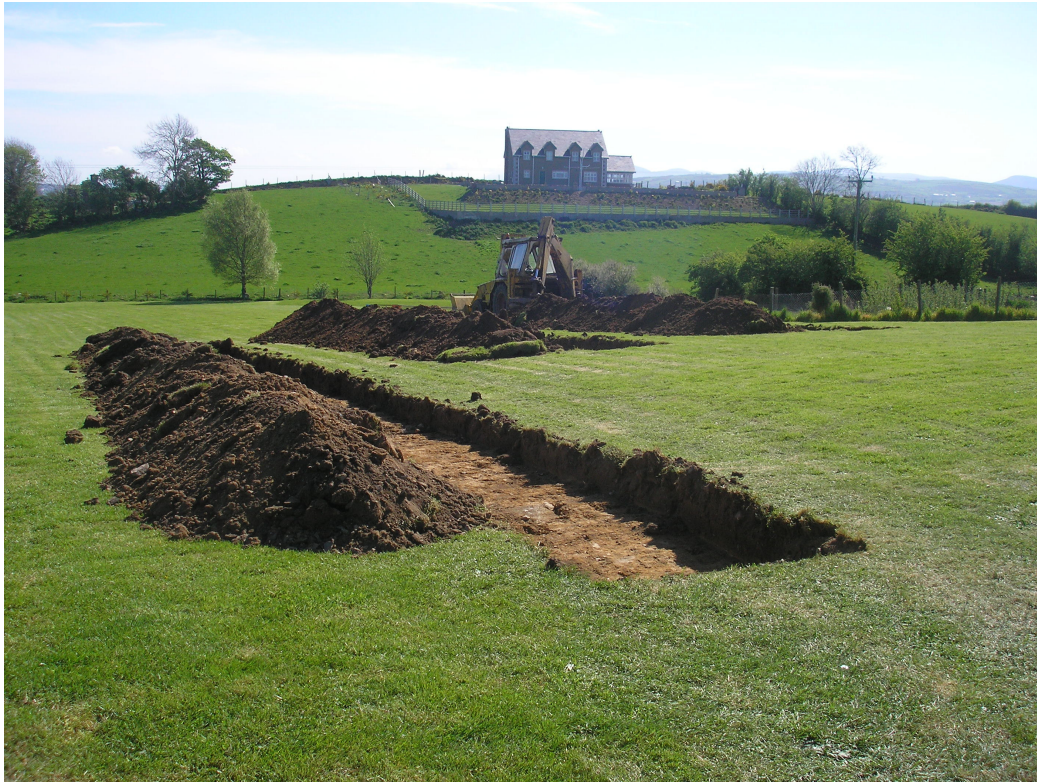
The three test trenches excavated at the application site contained nothing of archaeological significance. It is not thought that the development will impact upon previously unrecorded archaeological remains. It is therefore recommended that no further archaeological fieldwork is carried out. No publication is required save for a short summary in the annual *'Excavations'* bulletin.

*Plate Seven: General view of the application site following the excavation of the test trenches, looking south-east.*
