CAF Data Structure Report No. 74 (preliminary report)
Excavations at Castle Caulfield
Lisnamonaghan
Co. Tyrone
AE/11/75

**Investigations at Castle Caulfield
Lisnamonaghan
Co. Tyrone**

Preliminary report submitted to NIEA

Licence Number: AE/11/75

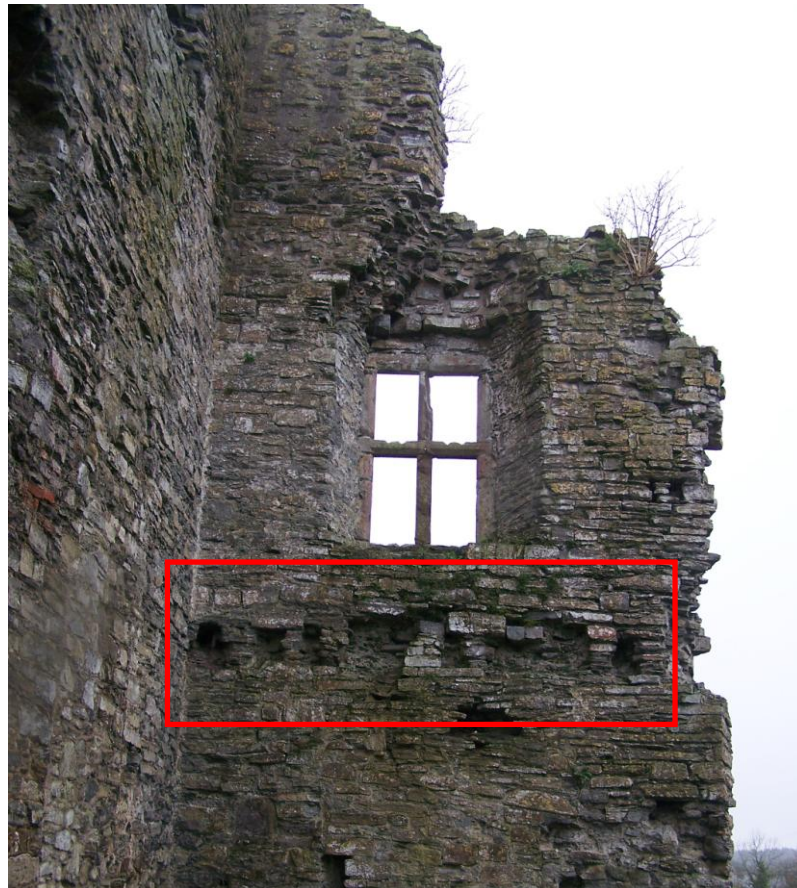
Plate 3: floor joist sockets below first floor window on south-western wall of main block (outlined in red), looking south-west

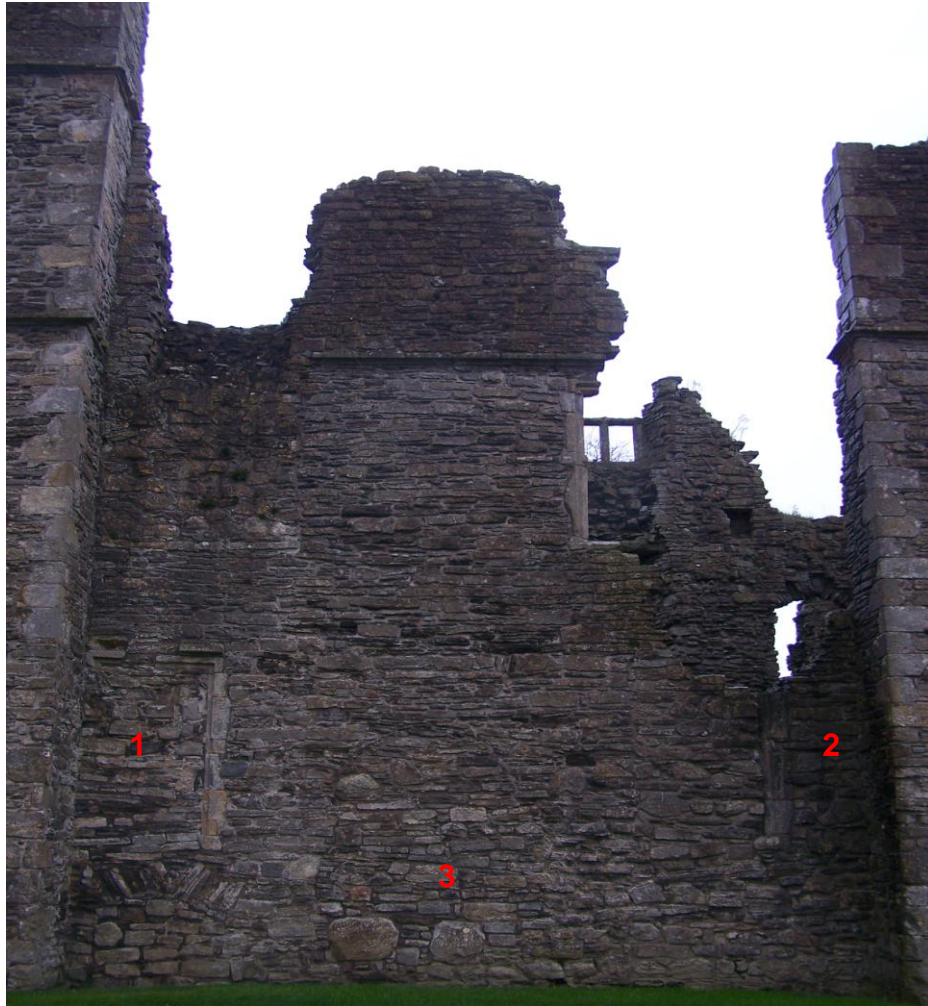
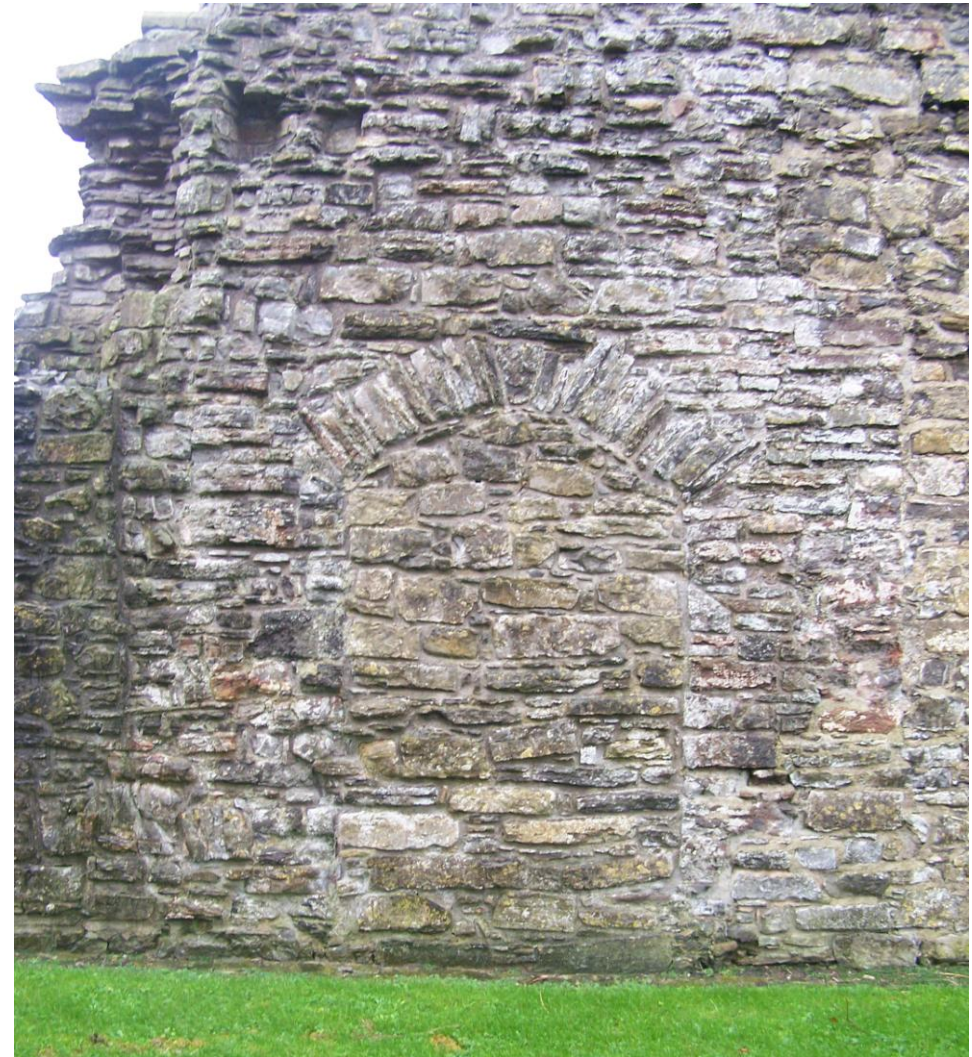
Plate 4 (left): Centre of south-eastern façade showing blocked-up windows (1 & 2) and possible central doorway (3), looking north-west, and
Plate 5: Blocked-up doorway on interior side of south-eastern wall of main block, looking south-east

exterior of the south-east facing façade appears to have a blocked-up central doorway flanked on either side by blocked-up windows, both with traces of their original dressed-stone surrounds (Plate 4). The doorway, which may have been the original entrance, can be seen more clearly on the interior of the south-eastern wall (Plate 5). However, it is equally possible that the original entrance was via a courtyard between the two wings on the north-western side of the house (Plate 6). Traces of a cross-wall between the north-eastern and south-western wings, which may have enclosed the courtyard, are visible on the south-western wall of the north-eastern wing (Plate 7). This cross-wall was described by Pynnar: 'Between the two cross ends there goeth a wall, which is 18 feet high, and maketh a small court within the building...' (Hill 1877, 553). It was still common for manor-houses of the time to have a more private entrance rather than a grand approach and guests may have had to wait in the courtyard before being admitted to see Sir Toby Caulfield.

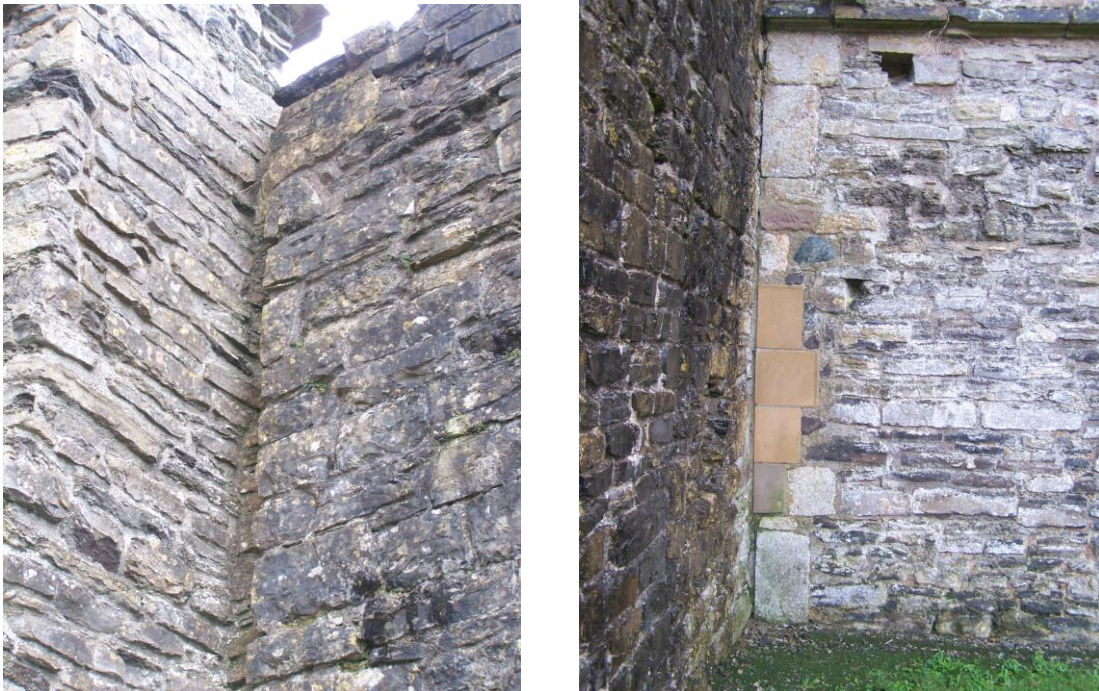
Plate 19 (left): The north-eastern junction between the castle and gatehouse walls, looking north-west, and Plate 20: The south-western junction between the castle and gatehouse walls, looking north-east

- 2.6.7 The gatehouse is to the north-west of the main building, adjacent to the north-eastern wing. There has been some debate as to which building was built first, as the gatehouse is of a different appearance and construction than the main building. It was built using different materials than the rest of the castle, and consists of large blocks of basalt which are more heavily weathered than the stones of the castle. The phasing is almost impossible to interpret by looking at the junctions between the two buildings but it was hoped that the relationship would be one of the research questions the 2011 excavation would address. The south-eastern corner of the gatehouse is bonded to the north-western corner of the north-eastern wing (Plates 19 and 20). Jope believed that the gatehouse was earlier than the main house noting that ‘...the separate gatehouse had survived from an earlier age mainly as an ornamental feature...’ (1958, 105). However, an article about the castle in the Irish Penny Journal of 1841 states that the gatehouse was built by the second Lord Charlemont: ‘[it] received....the addition of a large gatehouse with towers, and also of a strong keep or donjon’ (Anon. 1841, 217).

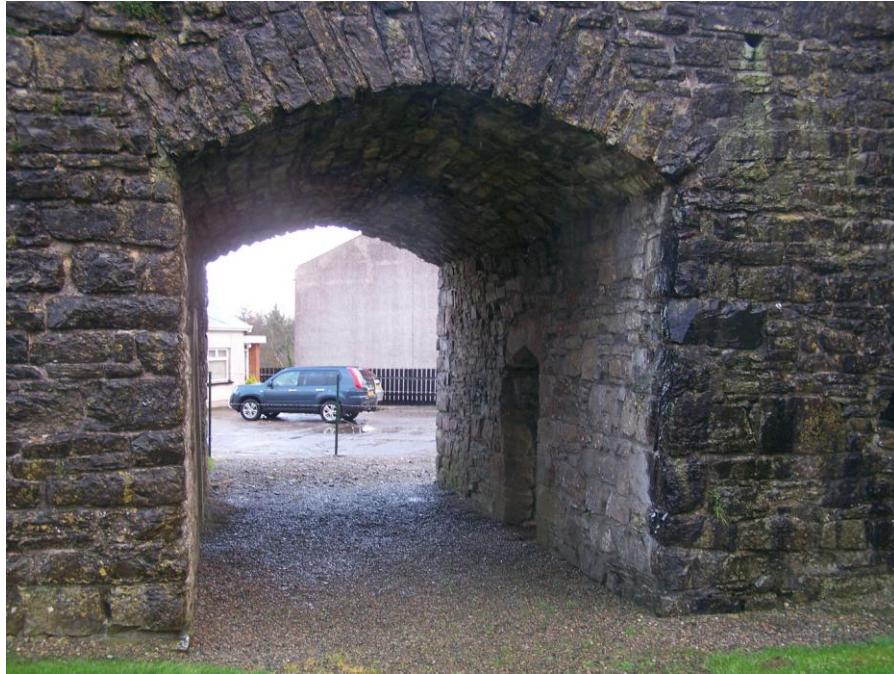
Plate 21: The vaulted passageway through the gatehouse, looking north-east

2.6.8 The gatehouse survives as a one-storey block consisting of two ground floor rooms on either side of a vaulted passage-way (Plate 21). The right-hand or north-western room has a circular tower or possible flanker attached to its northern corner (Plate 22). Both rooms have rectangular openings, thought to be musket loops (Plates 23 and 24), although some of the higher ones may be scaffolding holes or floor joist sockets. The left-hand or south-eastern room has a brick-lined fireplace at first-floor level (Plate 25) while the right-hand or north-western room has the remains of a fireplace and flue on the ground floor (Plate 26). Both rooms were accessed by low doorways in the centre of the walls on either side of the passage-way. The doorway to the north-western room has been reconstructed, but the doorway to the south-eastern room apparently bears its original sandstone lintel and jambs and is of Tudor-style (Plate 27). One curious feature of the building is the three 'murder holes' in the roof of the passage way, towards the north-eastern end, which may not be functional. The Caulfield coat of arms sits above the north-eastern entrance to the passageway (Plate 28) but this may have been taken from an earlier building.

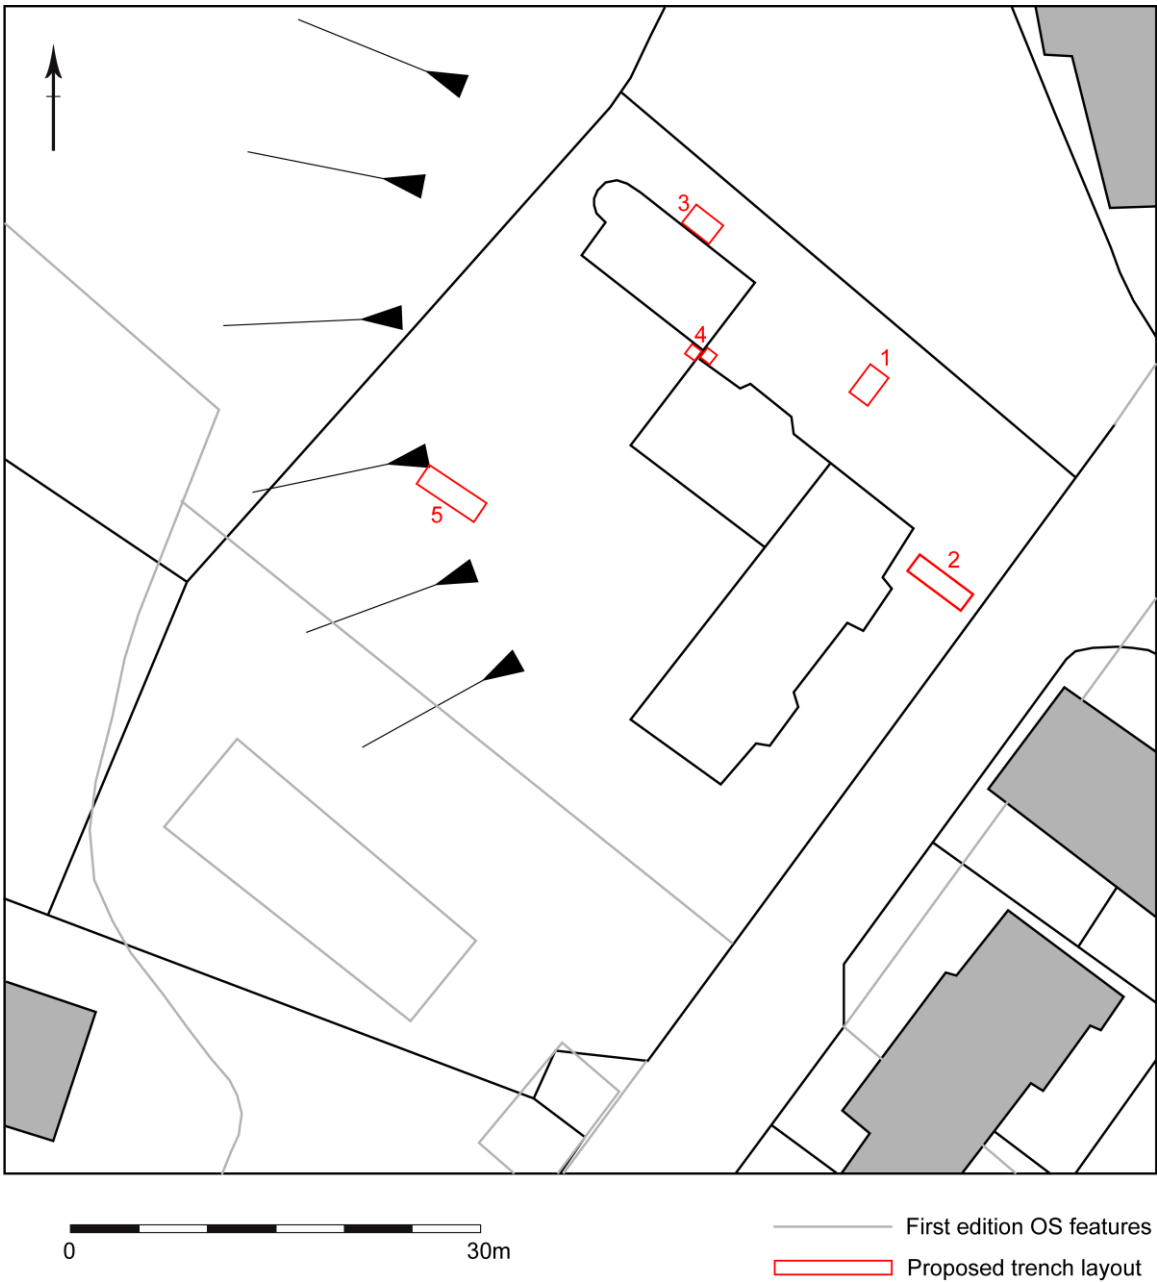
Figure 17: Site plan showing location of excavation trenches

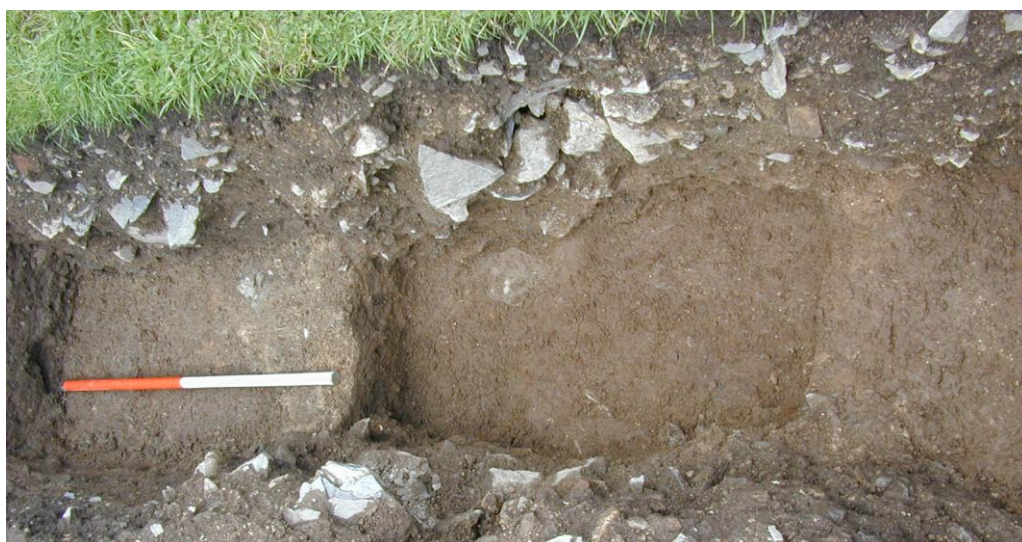
Plate 31: cut of the robber trench (C125) in Trench 1, looking south-west

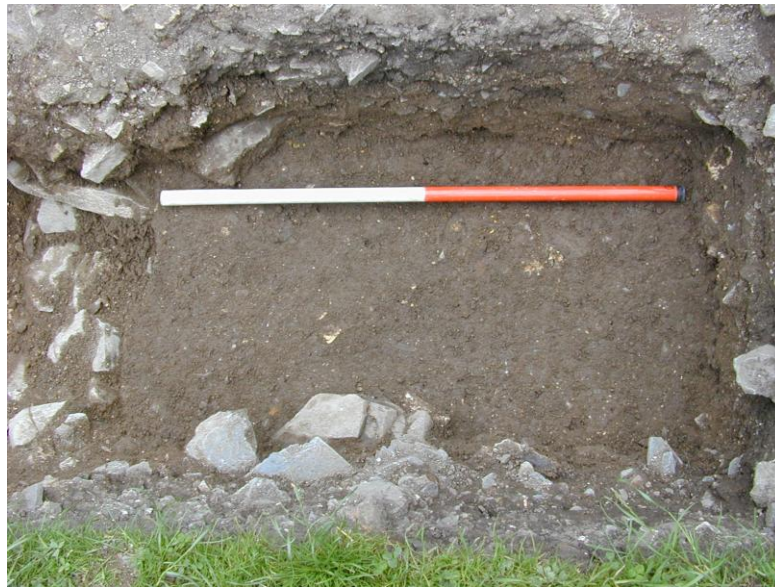
Plate 33: surface (C114) in Trench 1, looking east

33). It may have been a surface contemporary with the occupation of the castle or perhaps a period of repair or renovation. Below the sandy clay surface (C114), and in the western corner of the trench, was a layer of silty clay (C120) which was at least 1.10m long, 0.60m wide and 0.50m thick. It was dark greyish brown and quite compact with a slightly gritty texture. The silty clay contained small lumps of mortar plus a fragment of brick. Following the removal of the silty clay (C120) a layer of compact sandy silt (C121) was exposed. This layer was 0.10 thick and dark greyish brown with a gritty texture. It contained bone, brick and some possible fragments of dressed sandstone.

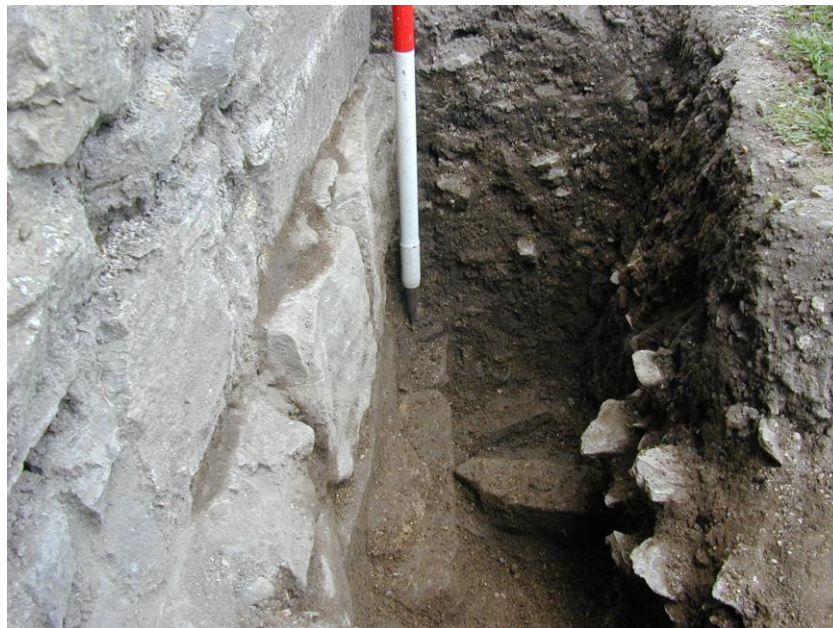
Plate 36: extension 1 in Trench 2 showing castle foundations (C204)

4.4.11 Physically underlying the sandy loam (C205) were the footing stones of the castle (C204) upon which the walls of the castle (C226) were built. The footing stones were found to be six courses deep and built onto the natural subsoil (C225). There was no evidence of a foundation cut but it is likely that terracing took place prior to the construction of the castle.

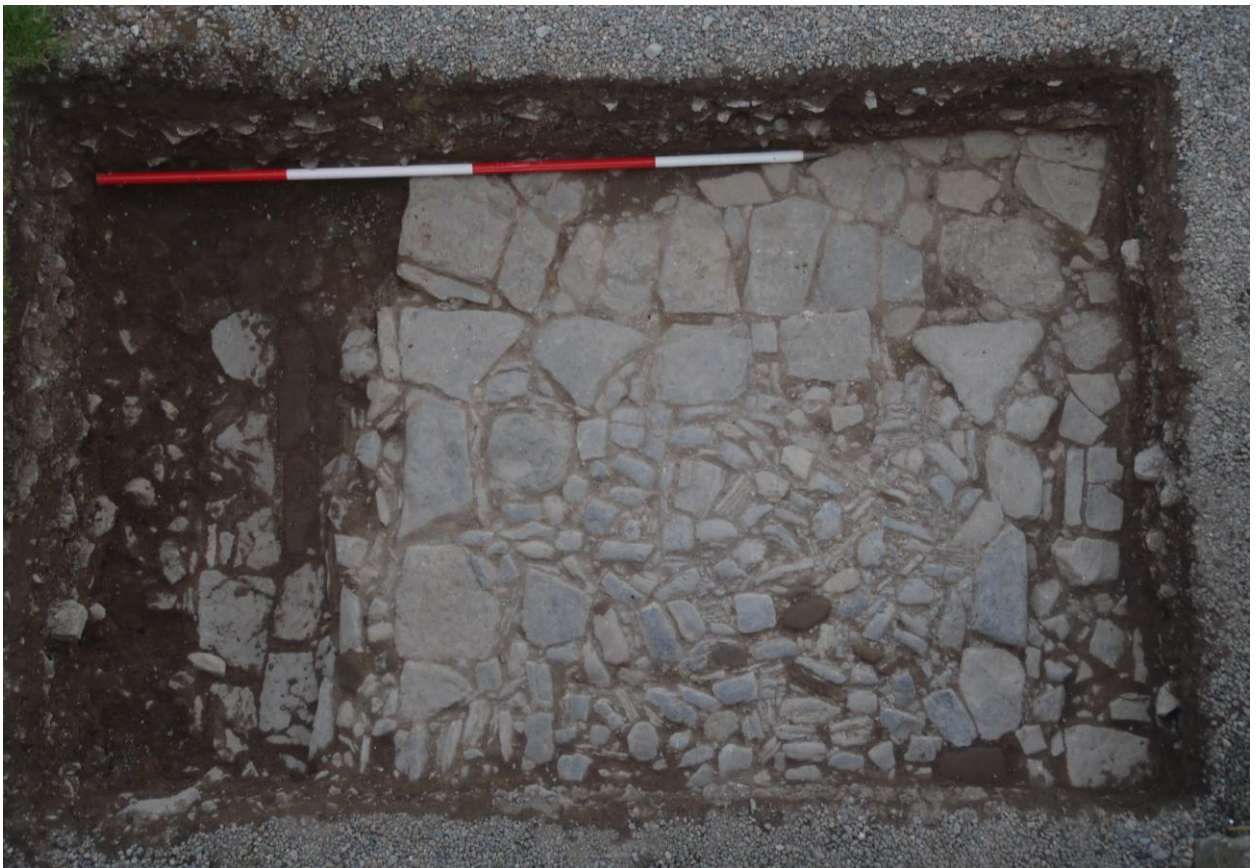
Plate 37: the cobbled surface (C315) from above

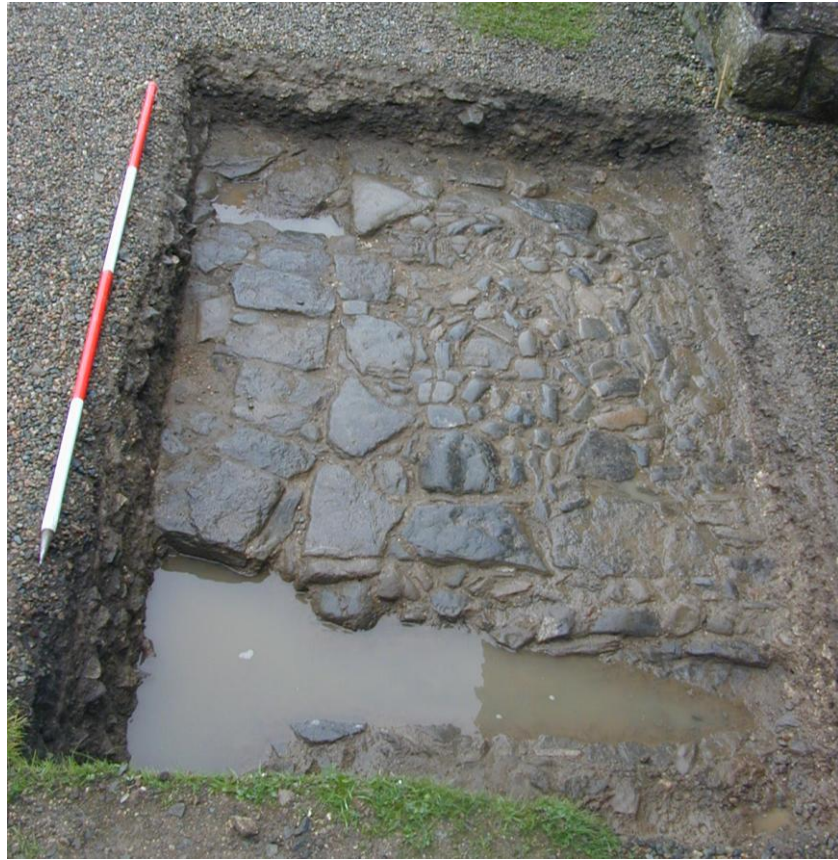
Plate 38: cobbled surface (C315) and drain (C316) with water, looking west

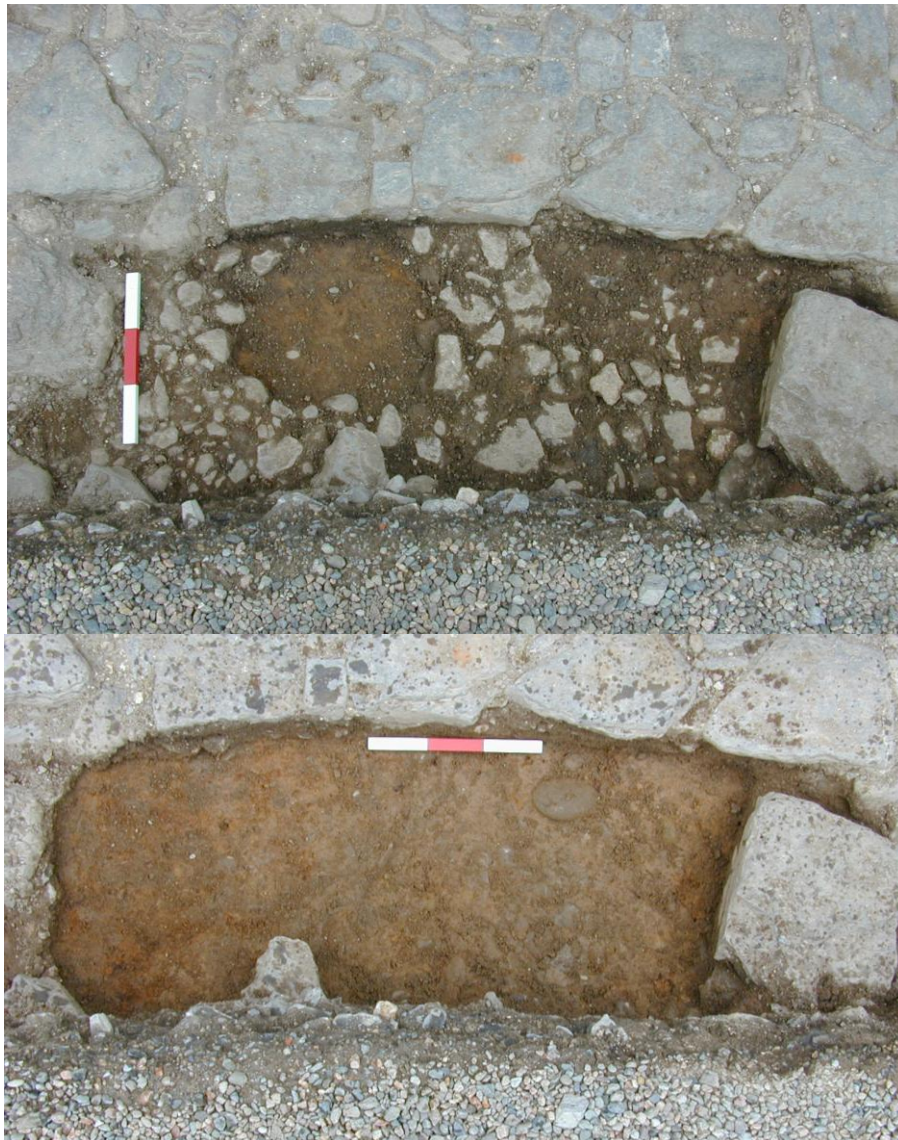
Plate 40 (above): levelling deposit (C317) below cobbles, from above and Plate 41: natural subsoil (C318) below cobbles, from above

4.5.9 Below the cobbled surface (C315), the drain (C316) and the rough cobbles (C322) was a deposit of small sub-rounded stones and clay (C317: Plate 40). This layer was compact and the stones were less than 80mm long. It was probably intended to level up the ground and provide a base for the larger cobbles above. The stony levelling deposit (C317) stratigraphically overlay two contemporary sequences of deposits at the south-eastern and north-western sides of the trench. At the south-eastern side were the foundation stones

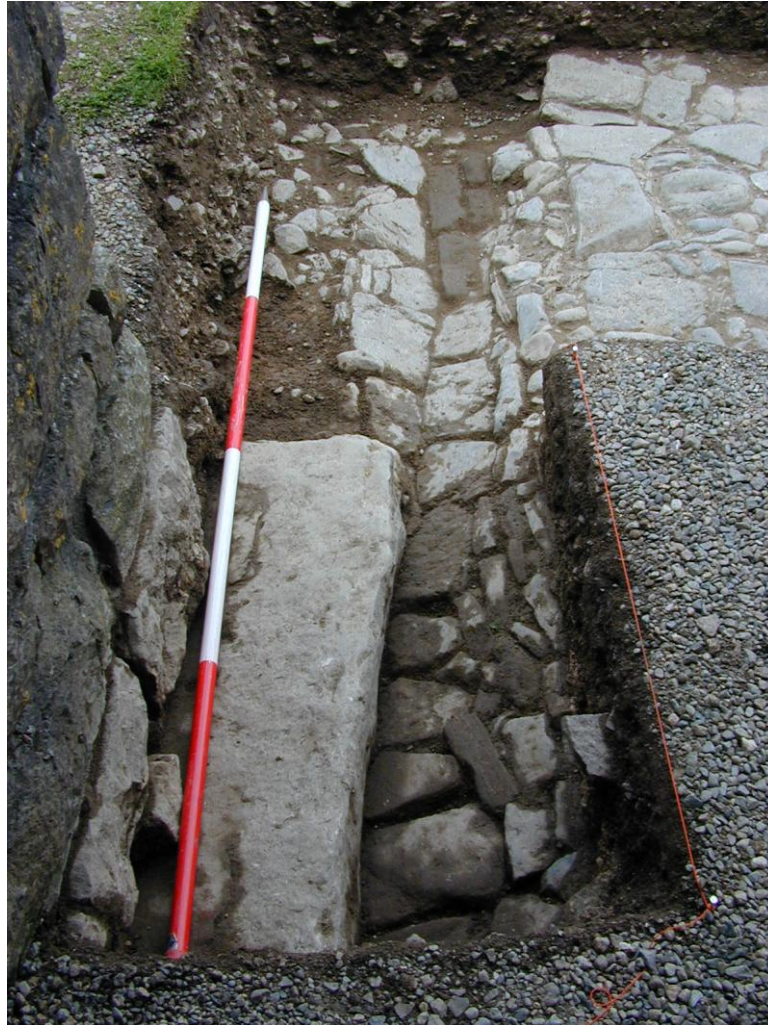
Plate 42: the large foundation stone (C324b) and drain (C316) in Extension 3, Trench 3, looking north-east

(C324a) for the original 17th century gatehouse. The main foundation stone was 1.25m long by 0.50m wide and at least 0.05m thick or high. It was aligned roughly east/west and was within a foundation cut backfilled with sandy clay (C323). The sandy clay backfill was orangeish brown in colour with a slightly gritty texture and had the appearance of re-deposited boulder clay, suggesting that the subsoil had been cut into for the construction of the gatehouse. At the opposite (north-western) side of the trench another large foundation stone (C324b) was exposed (Plate 42). This stone was at least 1.0m long by 0.4m wide and 0.06m thick. It would originally have been within a foundation cut and overlain by backfill but this was not visible in the excavated sequence at this side of the trench. Both the south-eastern (C324a) and north-western (C324b) foundation stones overlay a horizontal discontinuity (C327) representing the truncation of the natural subsoil (C318) and removal of the original topsoil to build the gatehouse. Below this was the natural boulder clay subsoil (C318: Plate 41) which consisted of brownish orange sandy clay, the surface of which was encountered at a depth of 0.40m.

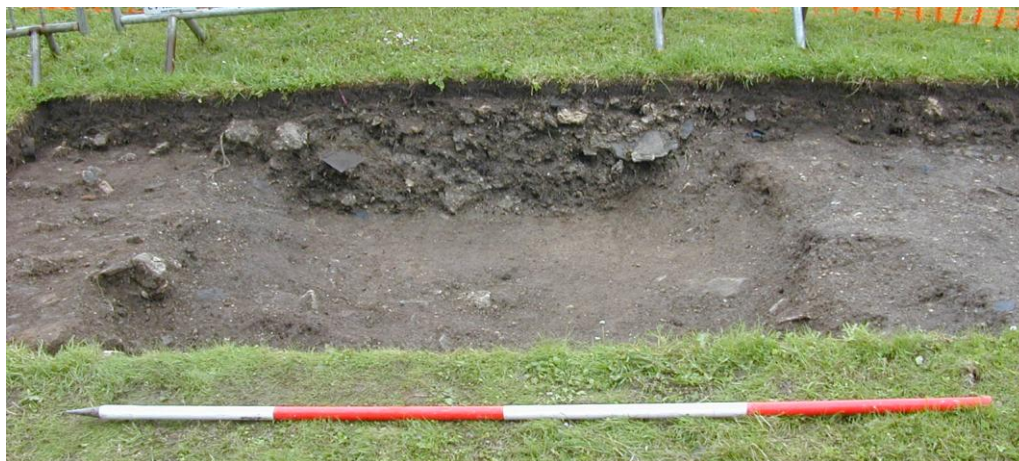
Plate 43: the cut feature (C505) in Trench 5, looking north-east

4.7.3 Below the humic topsoil (C502) was a cut feature (C505: Plate 43 and Figures 33 and 34) filled with a voided, rubbly deposit (C504). The cut feature was roughly linear in plan with irregular edges and may have been machine-cut. It continued beyond the limits of excavation, on a slightly curvilinear path, possibly continuing north towards the concrete foundations of a former site hut. The cut feature was 2.00m long, 1.55m - 2.70m wide and up to 0.47m deep. Local residents suggested that the feature was cut to lay a water pipe during re-pointing works at the castle in the late 1960s and early 1970s. Although no pipe was found in the base of the feature, it is possible that the pipe was removed prior to the feature being backfilled. The finds within the fill (C504) would therefore date to the end of the works at the Castle and not to the initial laying of the water pipe.
