Evaluation/monitoring Report No. 241

KING'S CASTLE NURSING HOME
ARDGLASS
CO. DOWN

AE/12/19

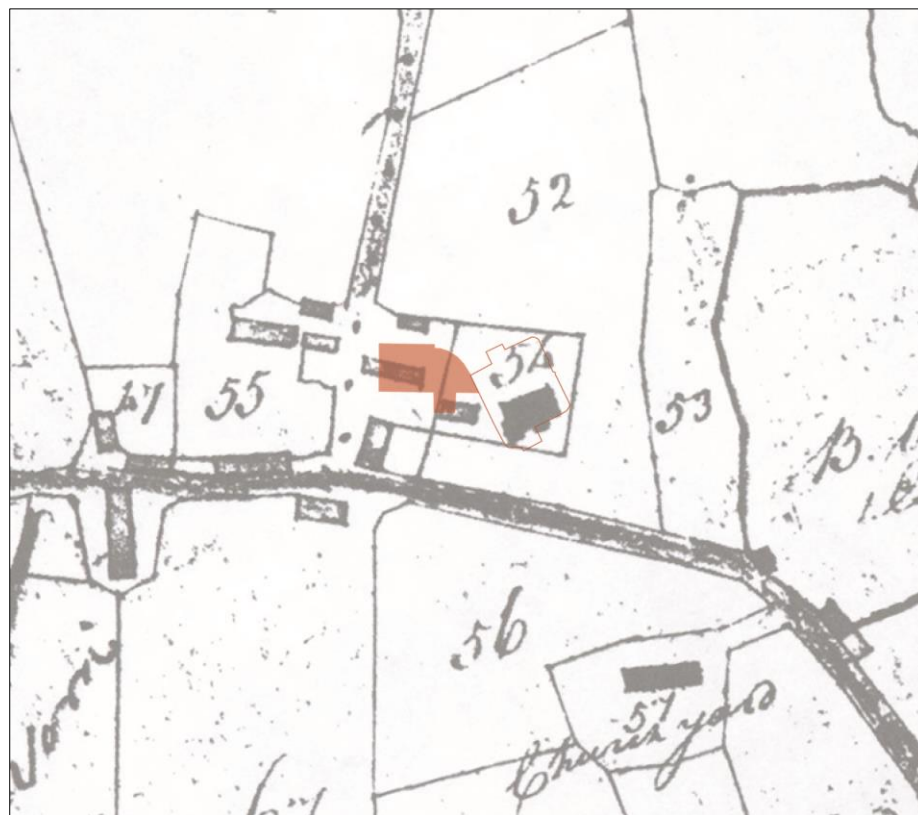
Figure 3: Detail from a survey of the Manor of Ardglass in the Barony Le Cale, Co. Down, estate of James, Duke of Leinster by Bernd., dated 1768 (PRONI D2223/M/1). The present footprint of King's Castle Nursing Home is outlined in red, while the proposed extension is given in solid red.

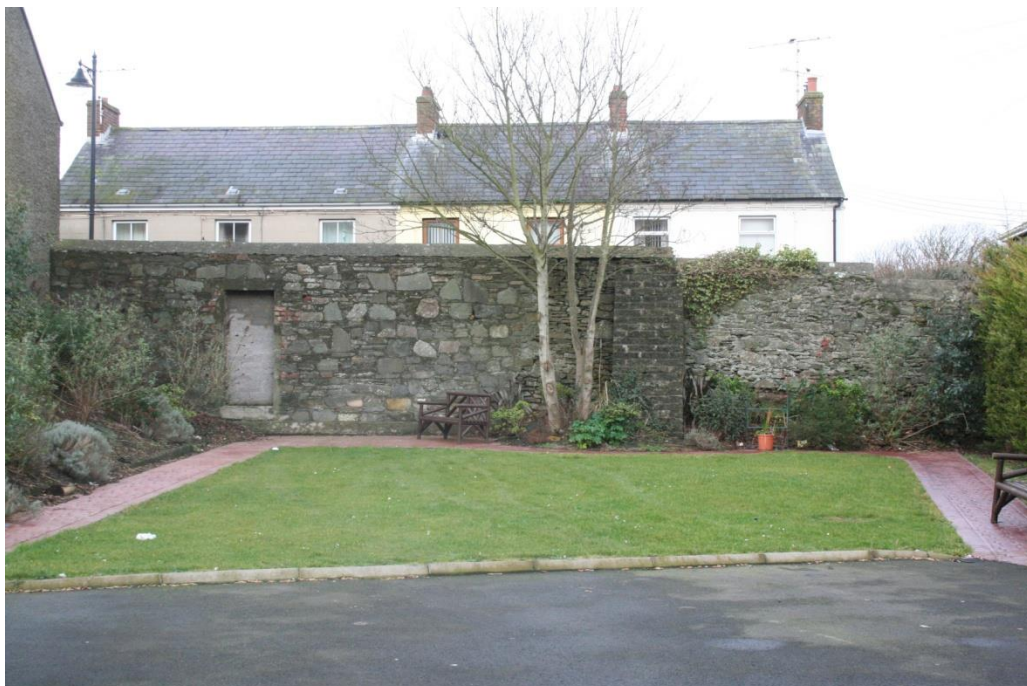
Plate 1: Garden area and tarmac driveway in the foreground which is to incorporate the new extension, looking west.

Initially the grassed garden area was topsoil stripped (Fig. 2, Area A and Plate 1 & 2) by a machine fitted with a straight edged 'sheugh' bucket. In this area approximately 10m x 15m was stripped to natural sand, with nothing of archaeological significance uncovered. Below the sod (C101; up to 13cm thick) was a layer of grey blue stoney hard core and mixed sand (C102; up to 12cm thick) which lay above a dark brown loamy soil (C103; up to 5cm thick) which overlay the natural sand (Plate 3). These layers covered the entire area. In the south west corner, above the natural was a spread of loose stones, brick and concrete within a matrix of red-brown gritty soil (C104; up to 15cm thick; Plate 4). Although not bonded, many of the large angular stones (up to 30cm in size) and brick had mortar adhering. The thin spread of stone covered an area 4m by 3m (Plate 5) and may represent a leveled garden wall. In association were two cement bases, possibly of gateposts (Plate 5). The components of this stone layer (brick, cement, flag stones, glass) indicate that it is of recent origin and the recovery of a beer tin from beneath the layer suggests that the spread was deposited very recently, perhaps part of leveling work undertaken to create the garden area.

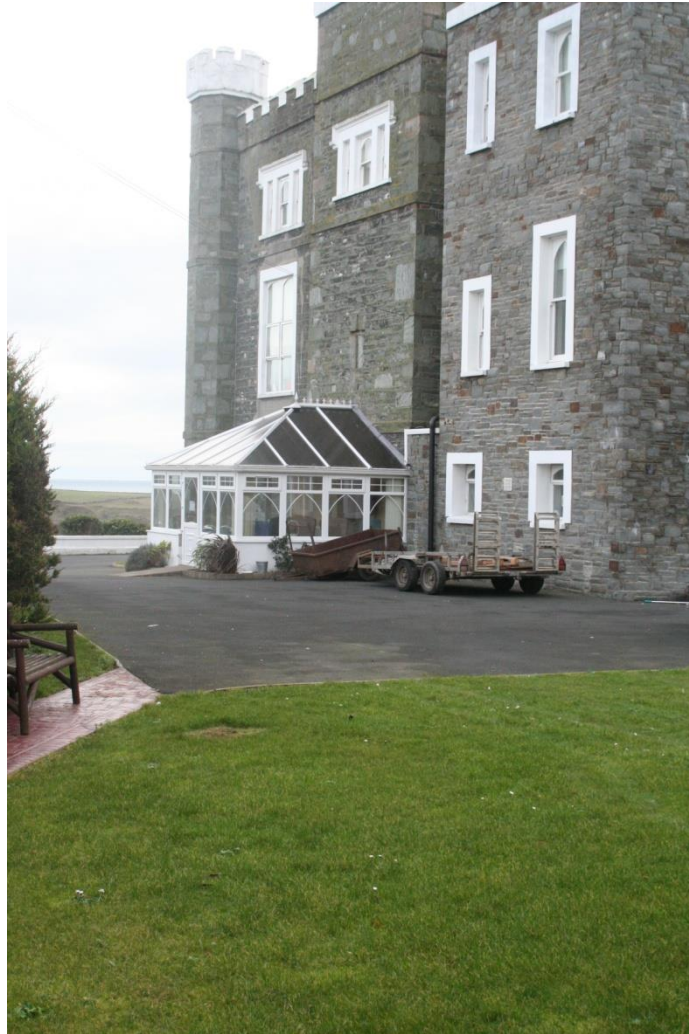
Plate 2: King's Castle Nursing Home from the garden looking north east across the tarmac area.

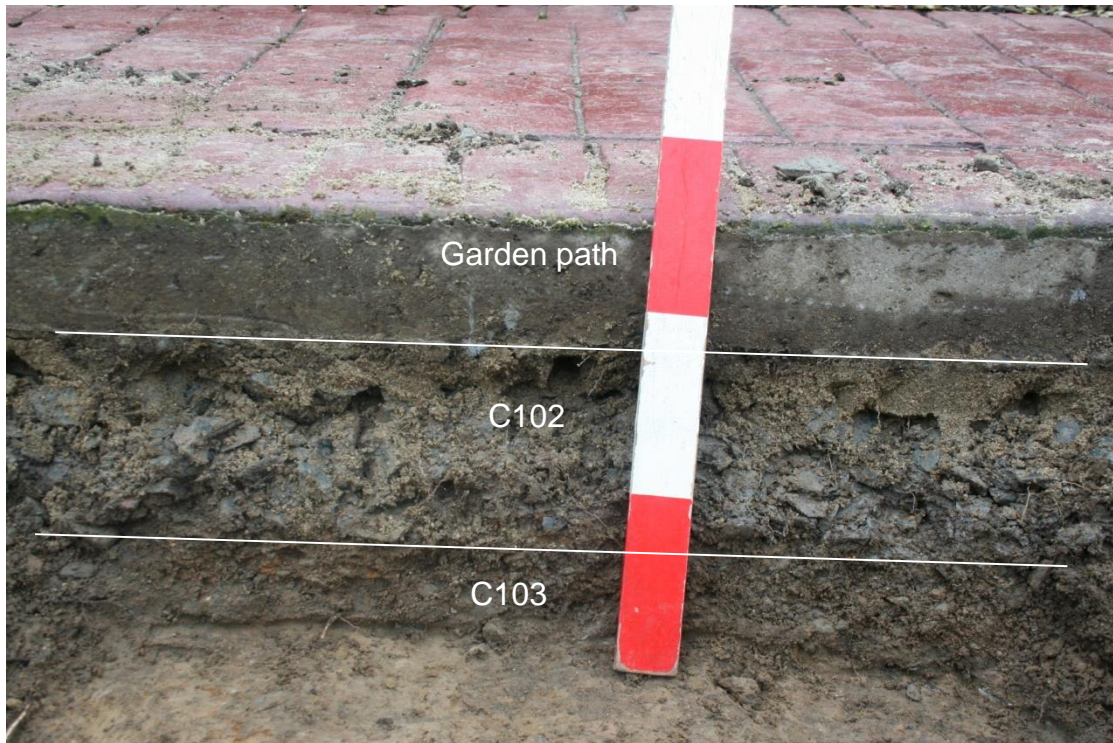
Plate 3: North facing section, looking south.

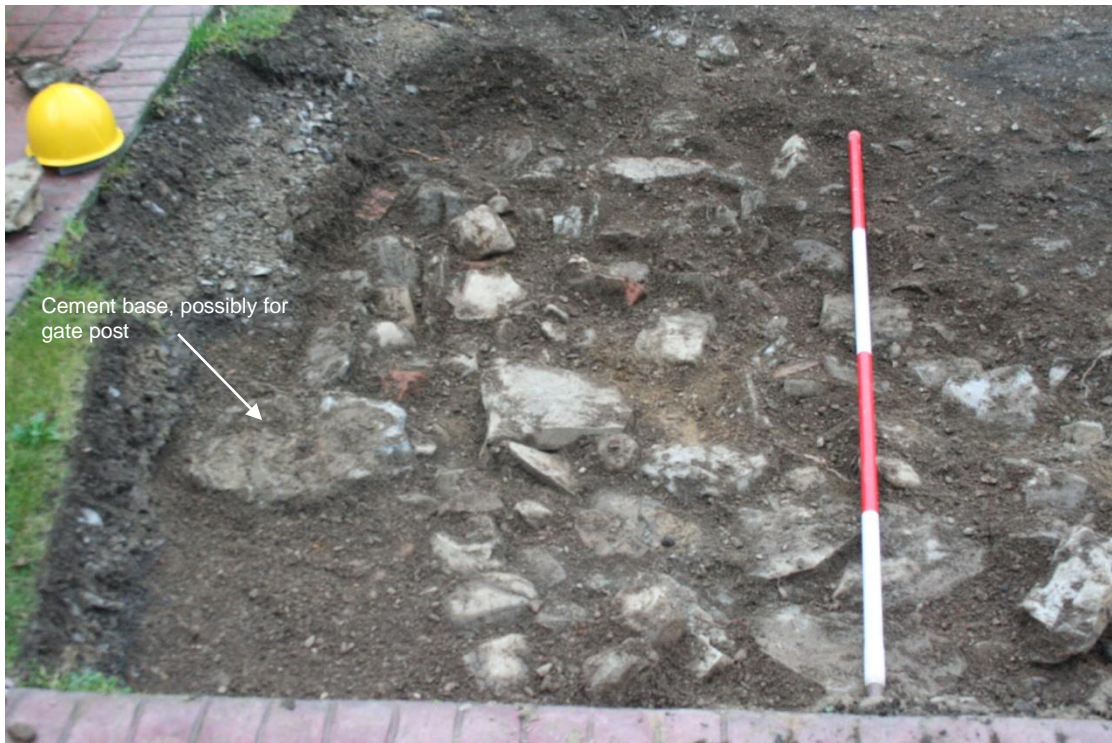
Plate 5: Stone layer (C104), looking north.

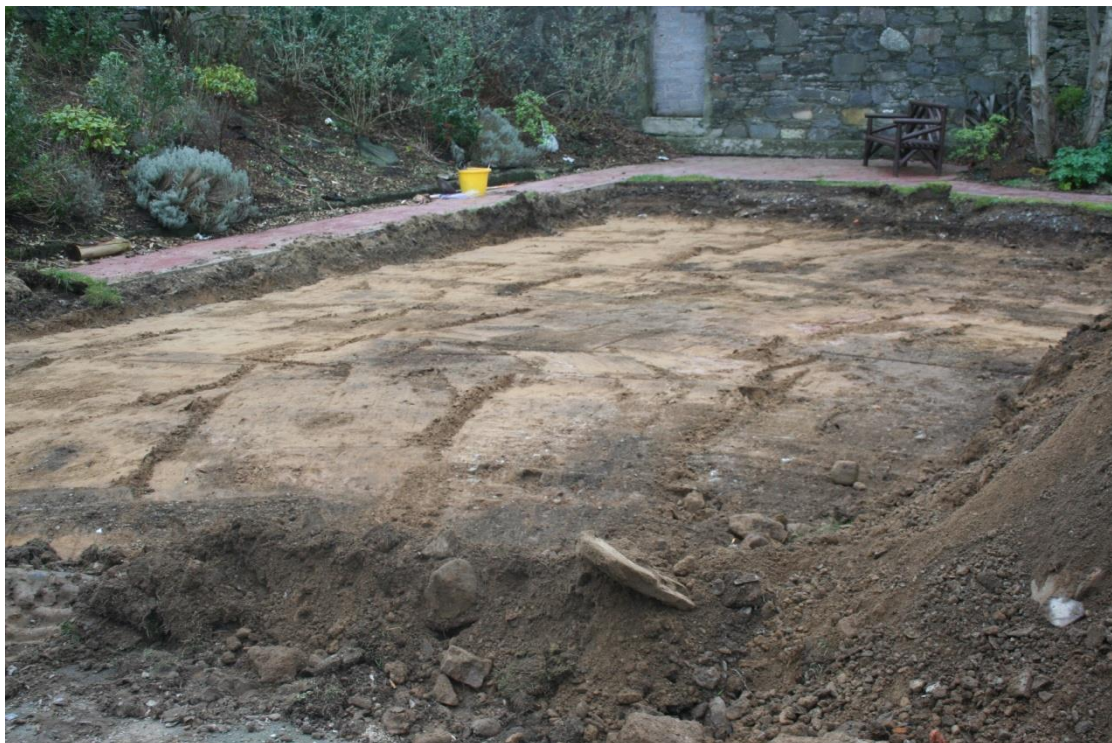
These layers (C101-104) were removed to reveal the natural subsoil (Plate 6) which had two recent features cut into it; a linear cut for a plastic pipe (Plate 7) and an 'L' shaped cement feature, a base or plinth for a brick garden wall (Plate 8).

Plate 6: Garden area on the removal of contexts 101-104, showing natural sand subsoil, looking south east.

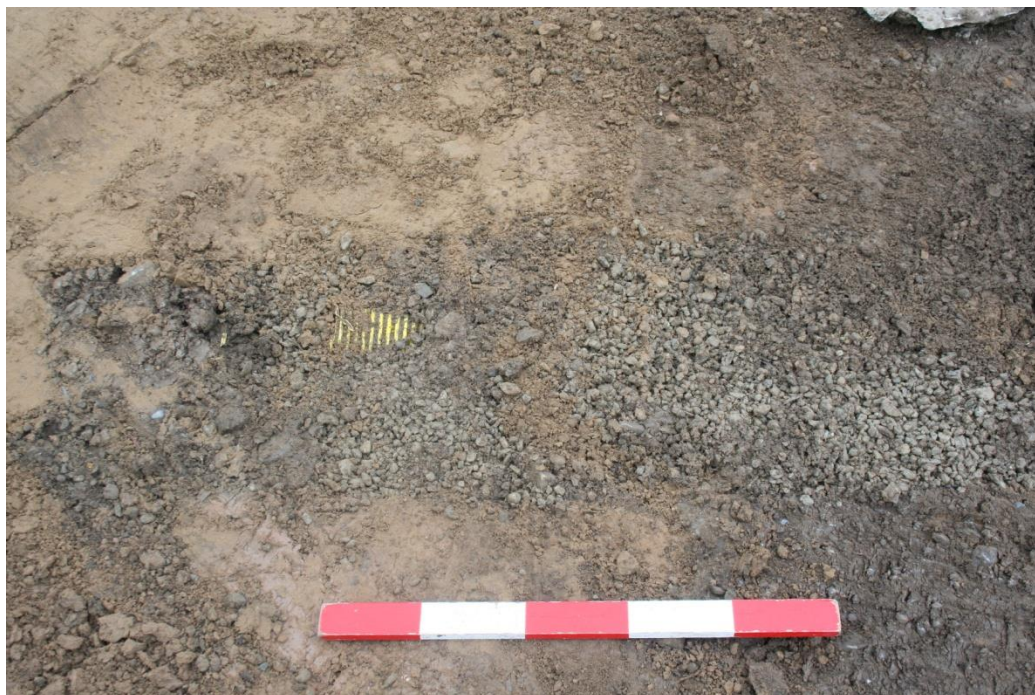
Plate 7: Modern pipe cut into natural subsoil.

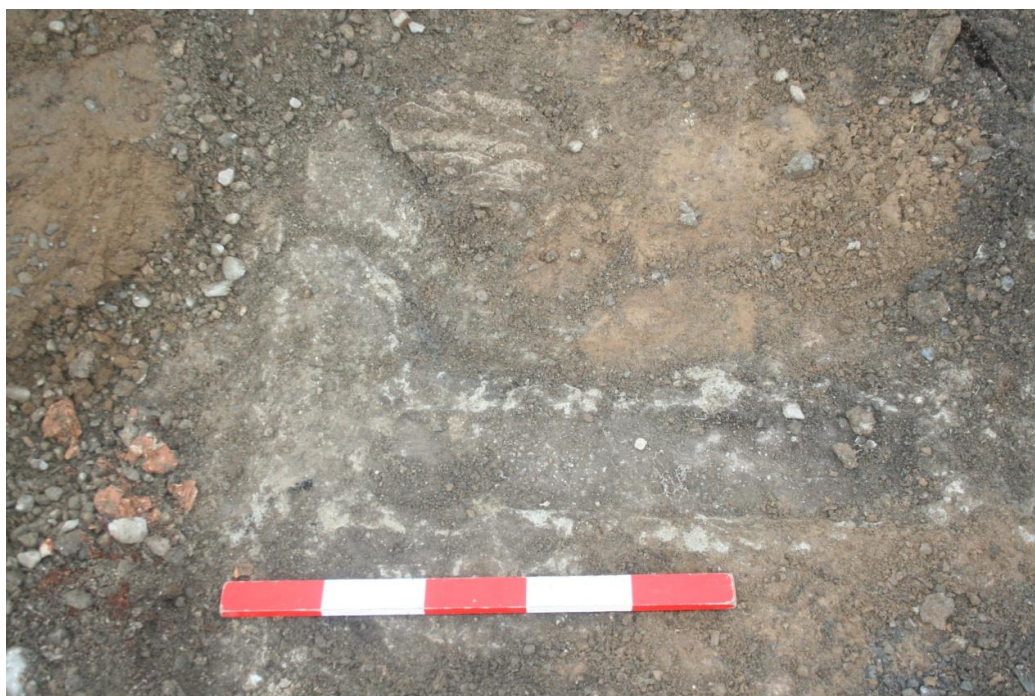
Plate 8: Concrete plinth, cut into natural subsoil

This layer (C102) was removed using a smoothed edged 'sheugh' bucket. The natural sand subsoil was revealed on removal of this hardcore layer (C102; Plate 10 and 11). A continuation of the 'L' shaped cement feature (see Plate 8) was also uncovered in this area, cut into the natural subsoil and it is clear that this is the remains of a garden wall feature.

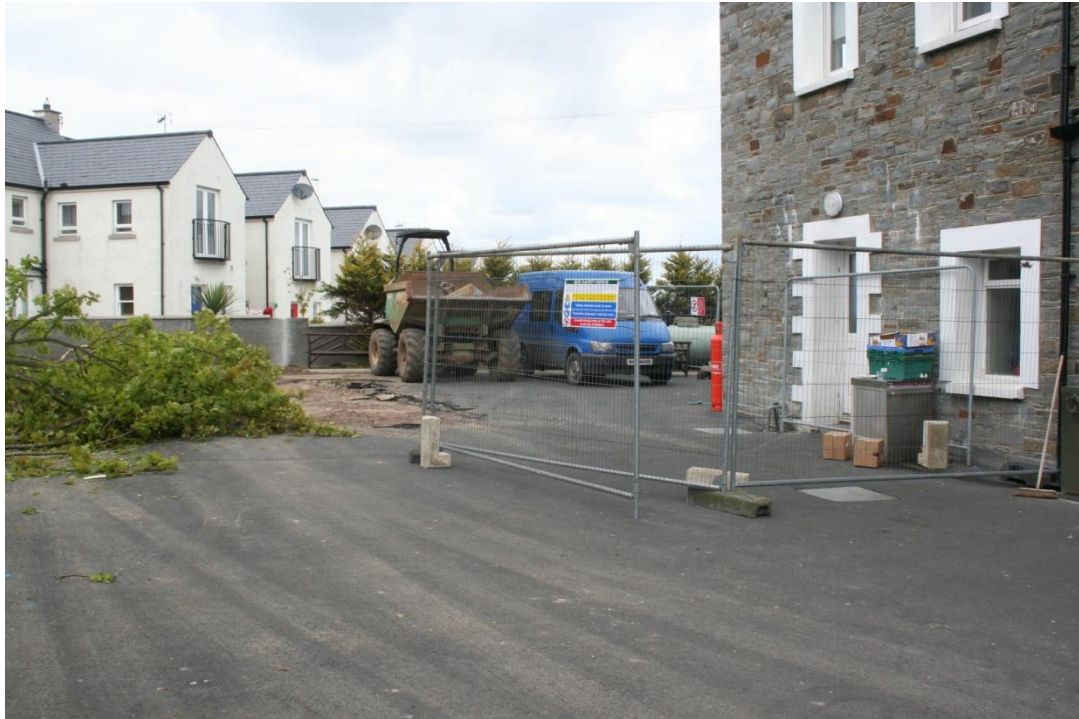
The tarmac was removed in the area between the garden and the nursing home (Plate 9) using a mini digger fitted with a back acting toothed bucket. On removal of the tarmac, a grey blue stoney hard core layer (C102) was revealed.

Plate 9: Tarmac area, between the garden and the nursing home, looking north.

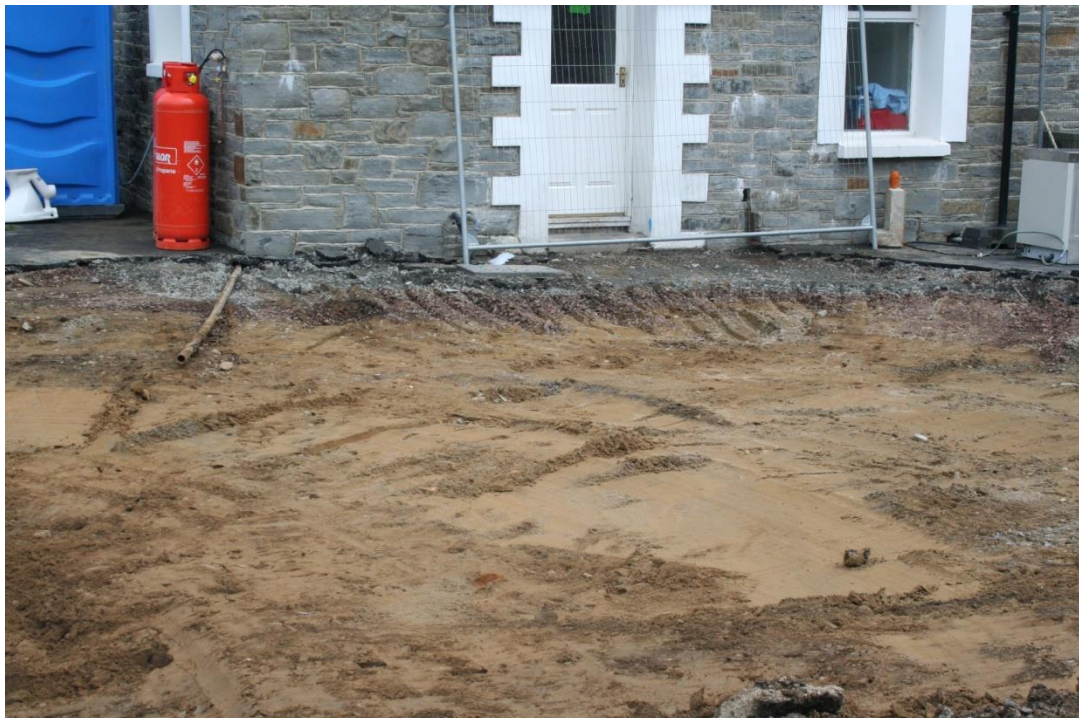
Plate 10: Driveway area on removal of tarmac and hardcore layer (C102), showing natural sand subsoil, looking east.

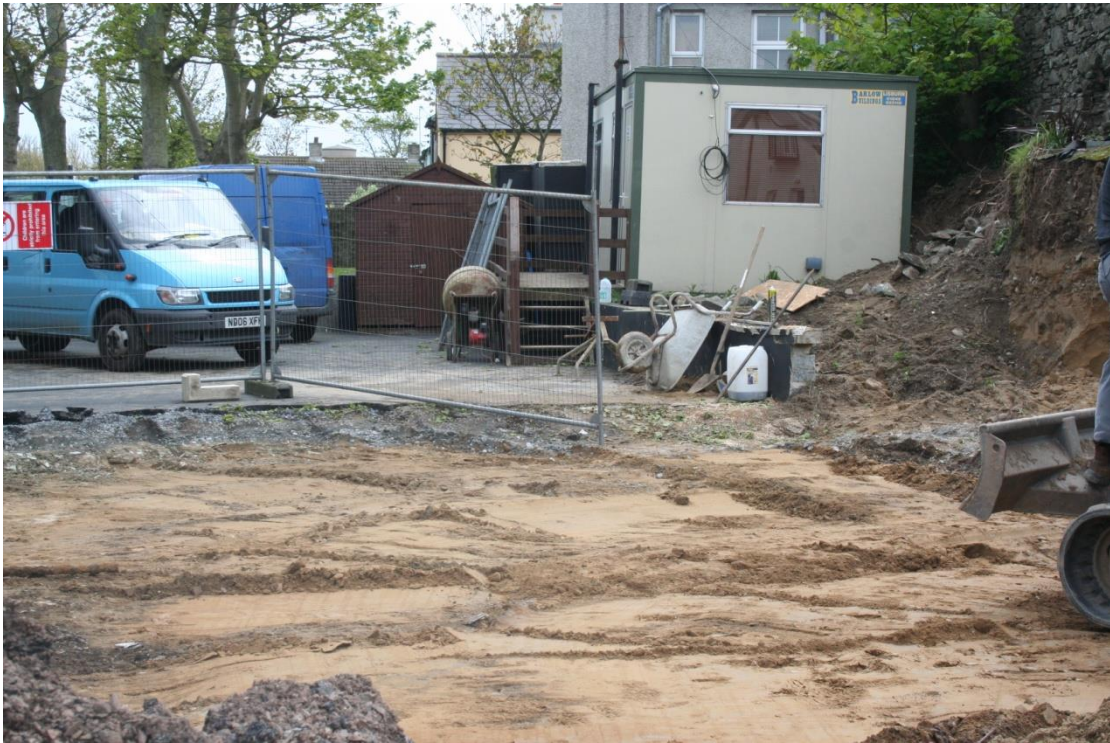
Plate 11: Tarmac driveway area on removal of tarmac and hardcore layer (C102), showing natural sand subsoil, looking south west.
