Evaluation/Monitoring Report No. 259

**SITE 100M EAST OF 16 LEARMORE ROAD
CASTLEGORE
CASTLEDERG
COUNTY TYRONE**

LICENCE NO.: AE/13/36E

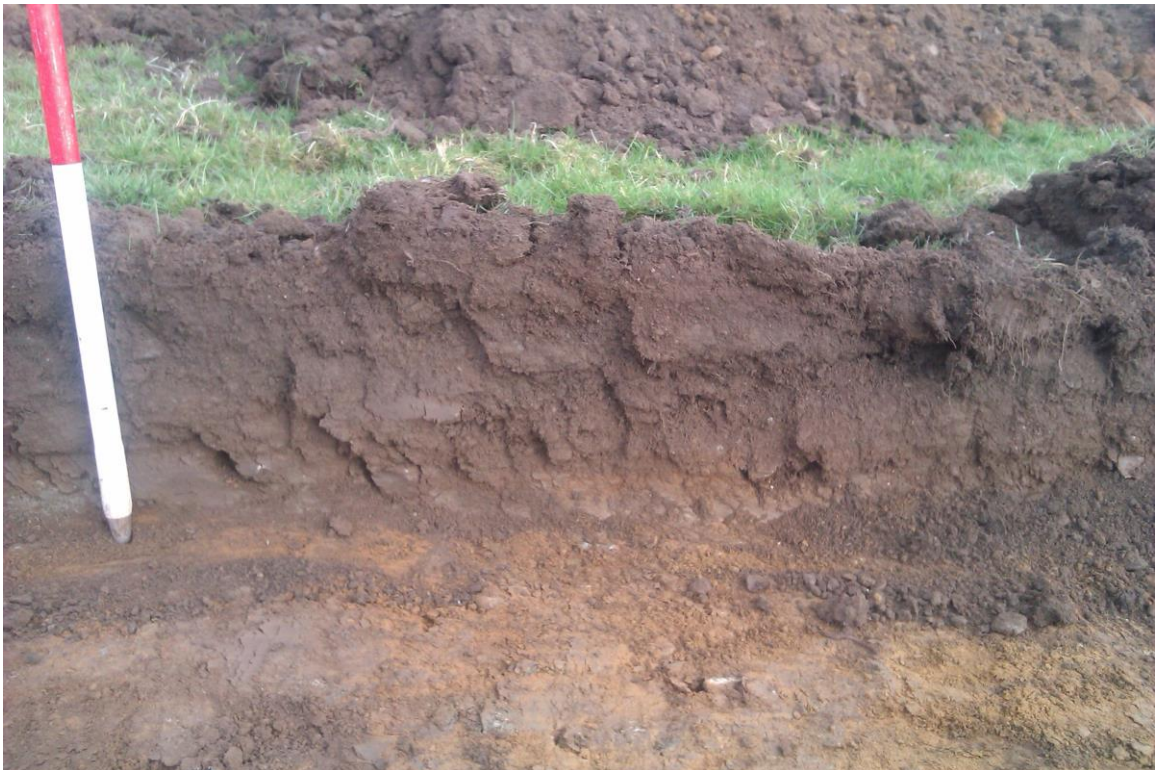
Plate 4: South-facing section of Trench 1, looking north

Trench 1 was located in the area of the footprint of the house and garage. It ran parallel to the southernmost field boundary, 11.0m to the north-east of it. It was some 20m from the field's easternmost boundary. The trench was 2.0m wide and 34.0m long and aligned with its long axis roughly north-west/south-east (Plates 4 and 5). The uppermost layer in Trench 1 was the sod and topsoil layer (C101) which consisted of dark greyish brown clay loam with few inclusions. It was 0.1m thick. Below this was a cultivation layer (C102) comprising greyish brown silty clay loam with few small inclusions 2mm long. It was 0.15-0.20m thick.

Below the cultivation layer, at the south-eastern end of the trench, was a layer of brown sandy clay (C103) which appeared to fill a hollow in this part of the site. It was 0.35m thick. There was a small drain (C104) cut into the sandy clay. The drain

was disturbed during the evaluation and found to contain a plastic pipe in a matrix of sub to well-rounded stones 100mm in diameter (C105). Stratigraphically below the sandy clay was the boulder clay subsoil (C106) which ranged from orange clay to sandy clay to crushed bedrock. The surface was encountered at depths ranging from 0.30-0.65m. There were no finds or features of archaeological significance uncovered during the excavation of Trench 1.

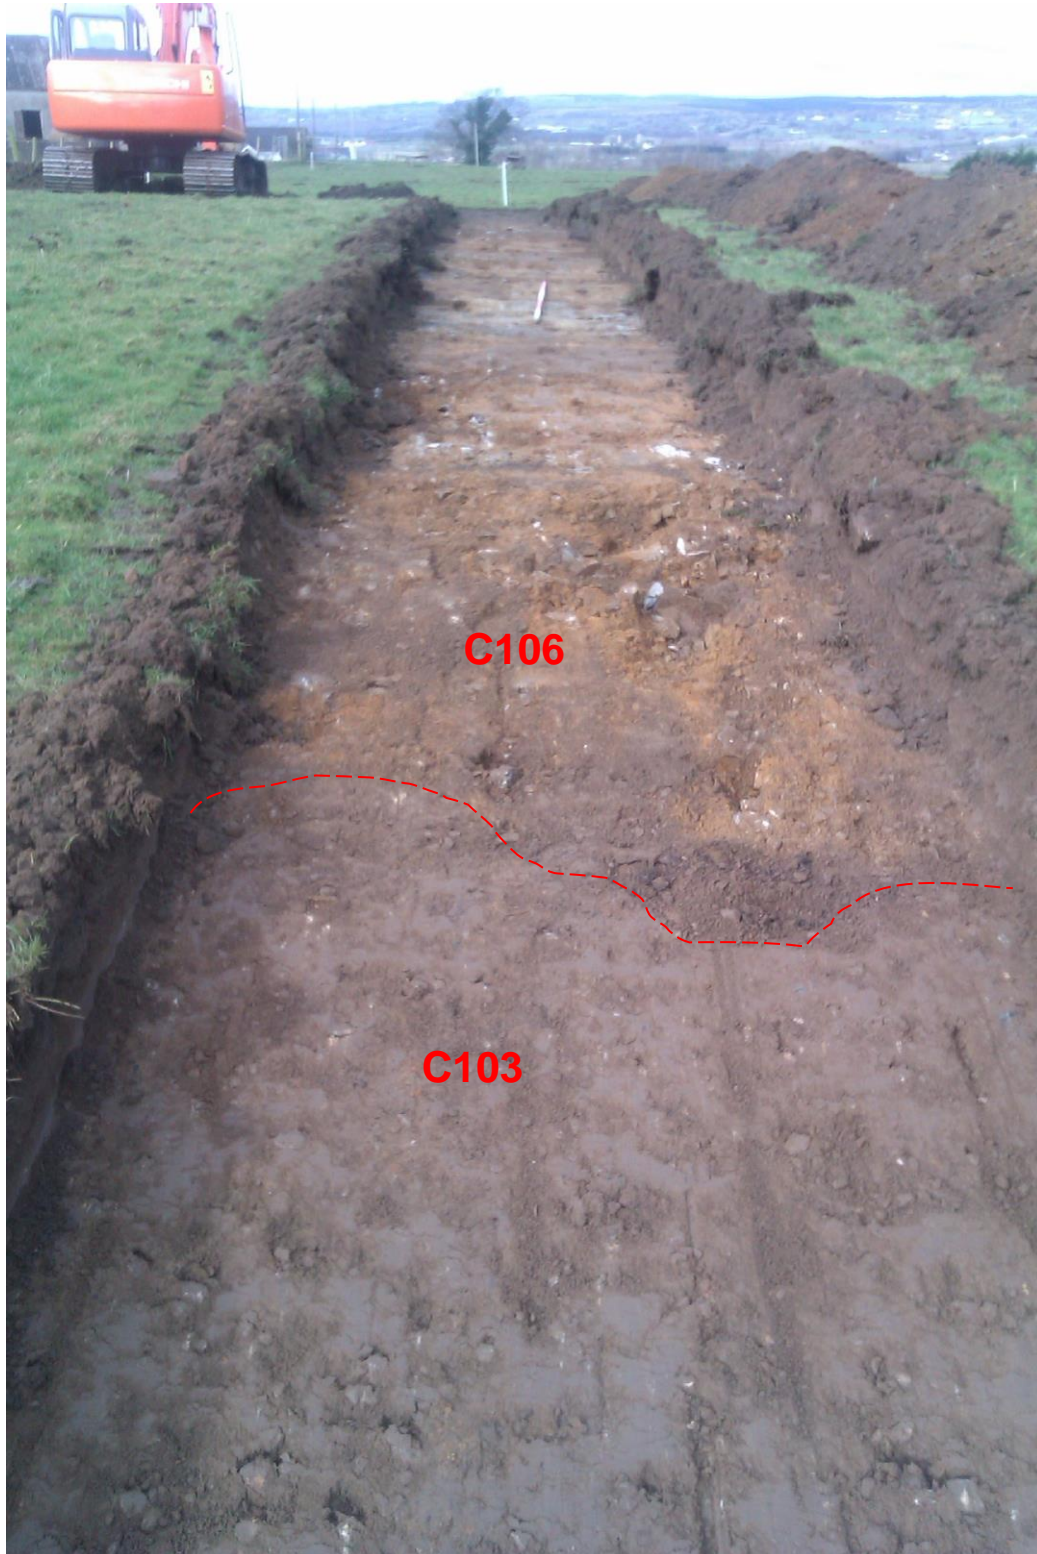
Plate 5: Trench 1 during evaluation showing brown sandy clay at south-eastern end, looking north-west

No finds or features of archaeological interest were found during the evaluation. The sandy clay and drains at the south-eastern end of Trenches 1-3 probably represent either natural infill of a hollow at this end of the site and its subsequent drainage or deliberate infill or leveling up of a hollow. The presence of the drains suggest that this area was waterlogged at some point. It is not thought that the proposed development will impinge on any unknown archaeological deposits and therefore recommended that no further archaeological fieldwork is carried out. A short summary will be prepared for inclusion in the annual '*Excavations*' bulletin.

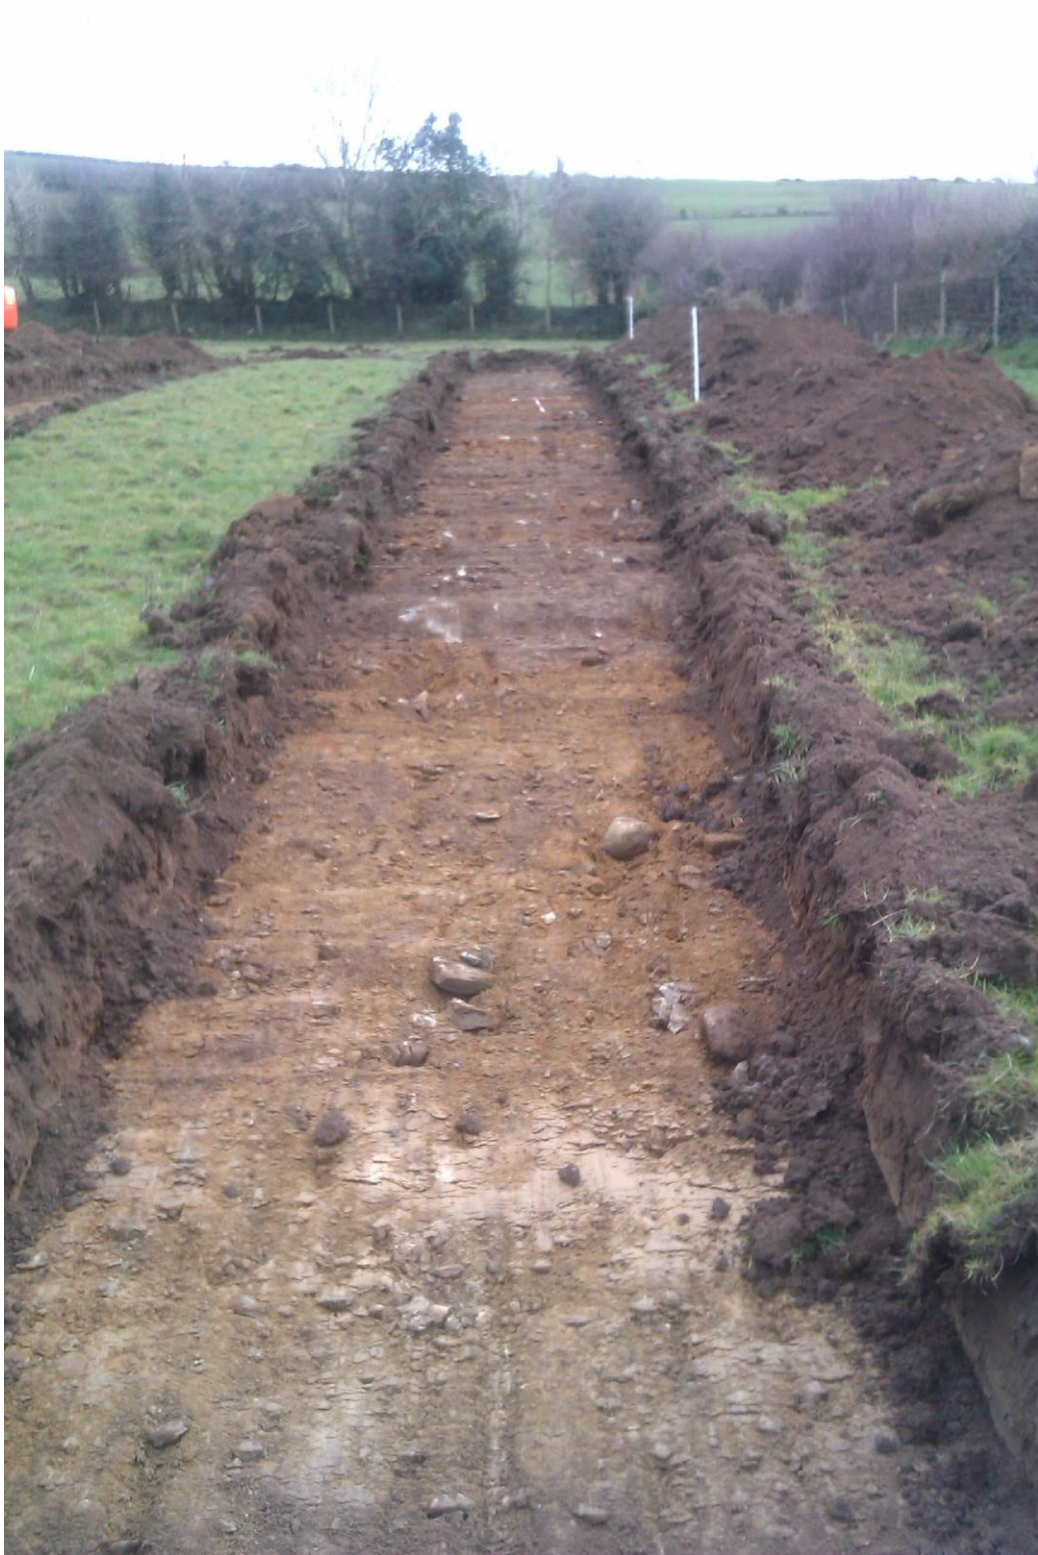
Plate 6: Trench 2 following excavation to subsoil level, looking east

Trench 2 was located 3.0m to the south of Trench 1, 5.0m from the southernmost field boundary and 20.0m from the easternmost field boundary. The trench was aligned roughly north-east/south-west. It was 2.0m wide and 33.5m long (Plates 6 and 8). The uppermost layer in Trench 2 was the sod and topsoil layer (C201) which consisted of dark grayish brown loamy clay with some small inclusions 2mm long. It was 0.1m thick. Below the topsoil was a cultivation layer (C202) consisting of grayish brown loamy clay silt with some small inclusions 2mm long. The layer was 0.2-0.25m thick. Below it was a brown sandy clay deposit (C203) which was present at the south-eastern end of the trench and also visible in Trench 1. The clay appeared to fill a natural hollow at this end of the site as it was not the fill of a cut feature. It was up to 0.35m thick. Cut into the sandy clay was a small field drain (C204: Plate 7). The cut of the drain was 0.4m wide. It was filled with sub- to well-rounded stones (C205) with an average diameter of 100mm. Below the stones a plastic pipe was visible. Stratigraphically below the sandy clay was the subsoil (C206) which consisted of orange sandy clay containing crushed bedrock. It was whiteish yellow in colour in parts, particularly at the south-eastern end of the trench. The surface of the subsoil was present at depths of up to 0.75m at the south-eastern end of the trench. There were no finds or features of archaeological significance in Trench 2.

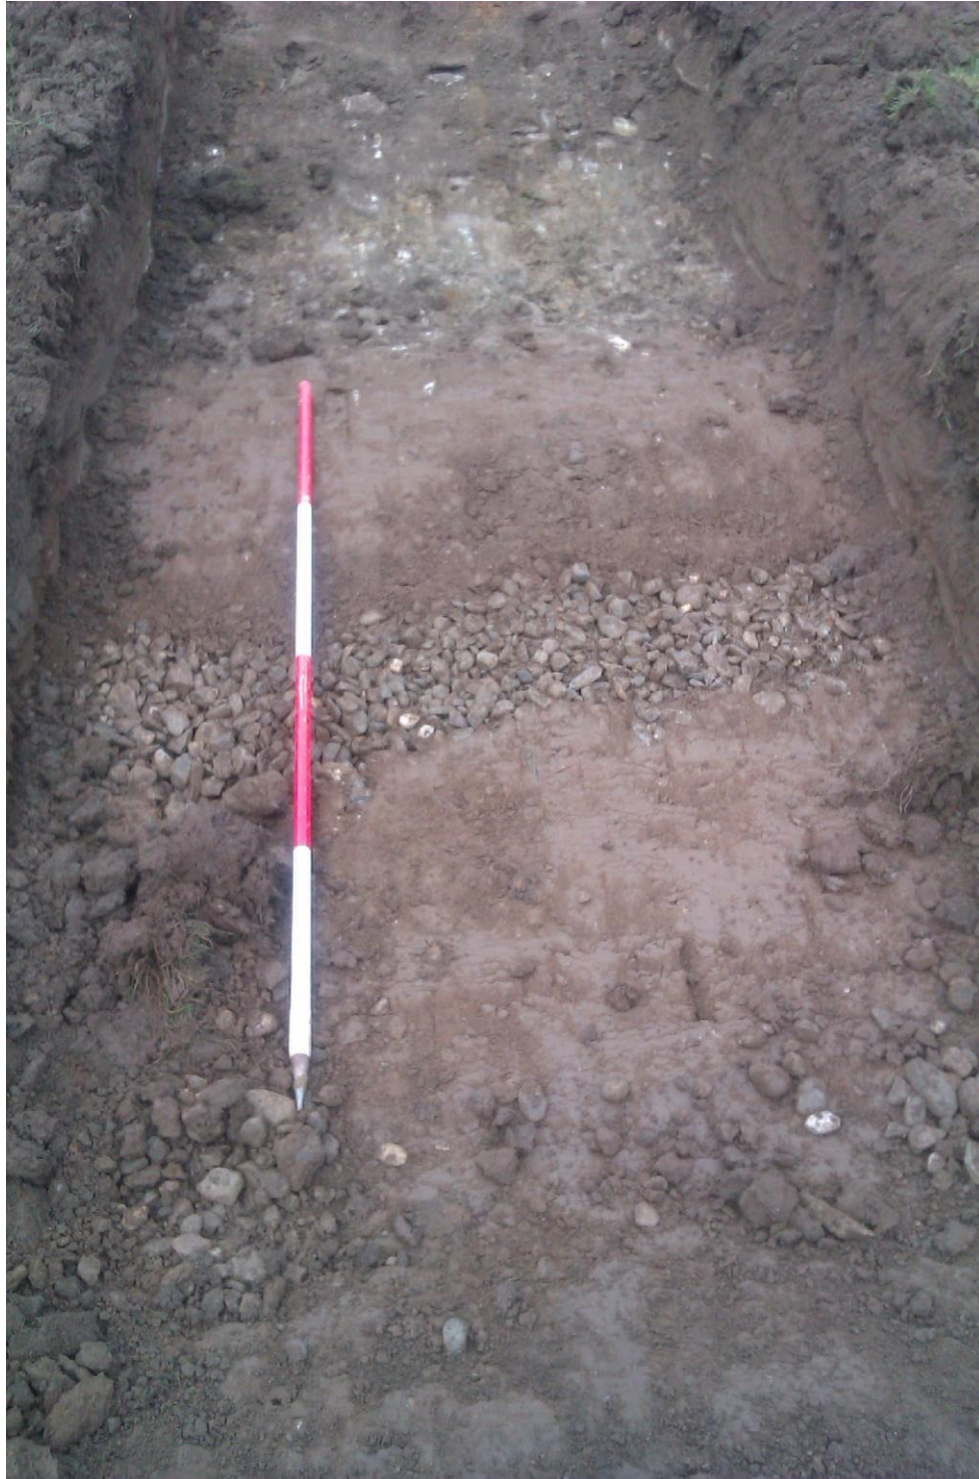
Plate 7: South-eastern end of Trench 2 showing drain C204/205, looking north-west

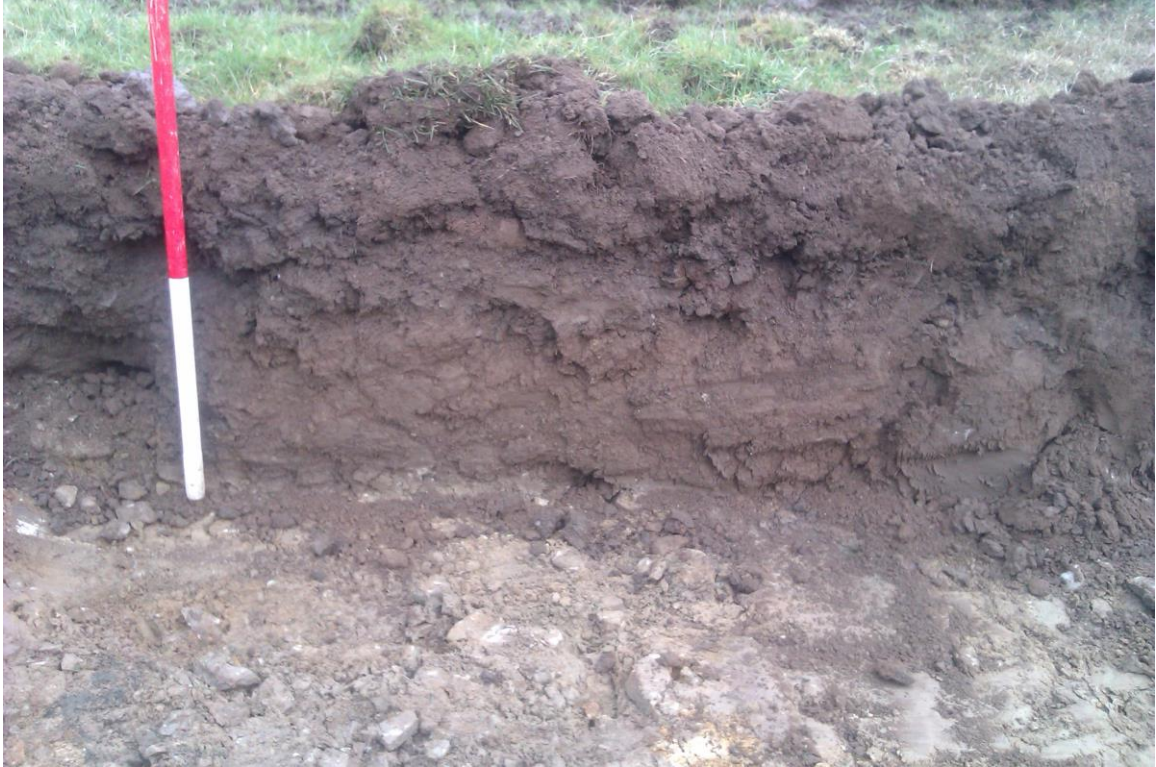
Plate 8: South-facing section of Trench 2, looking north

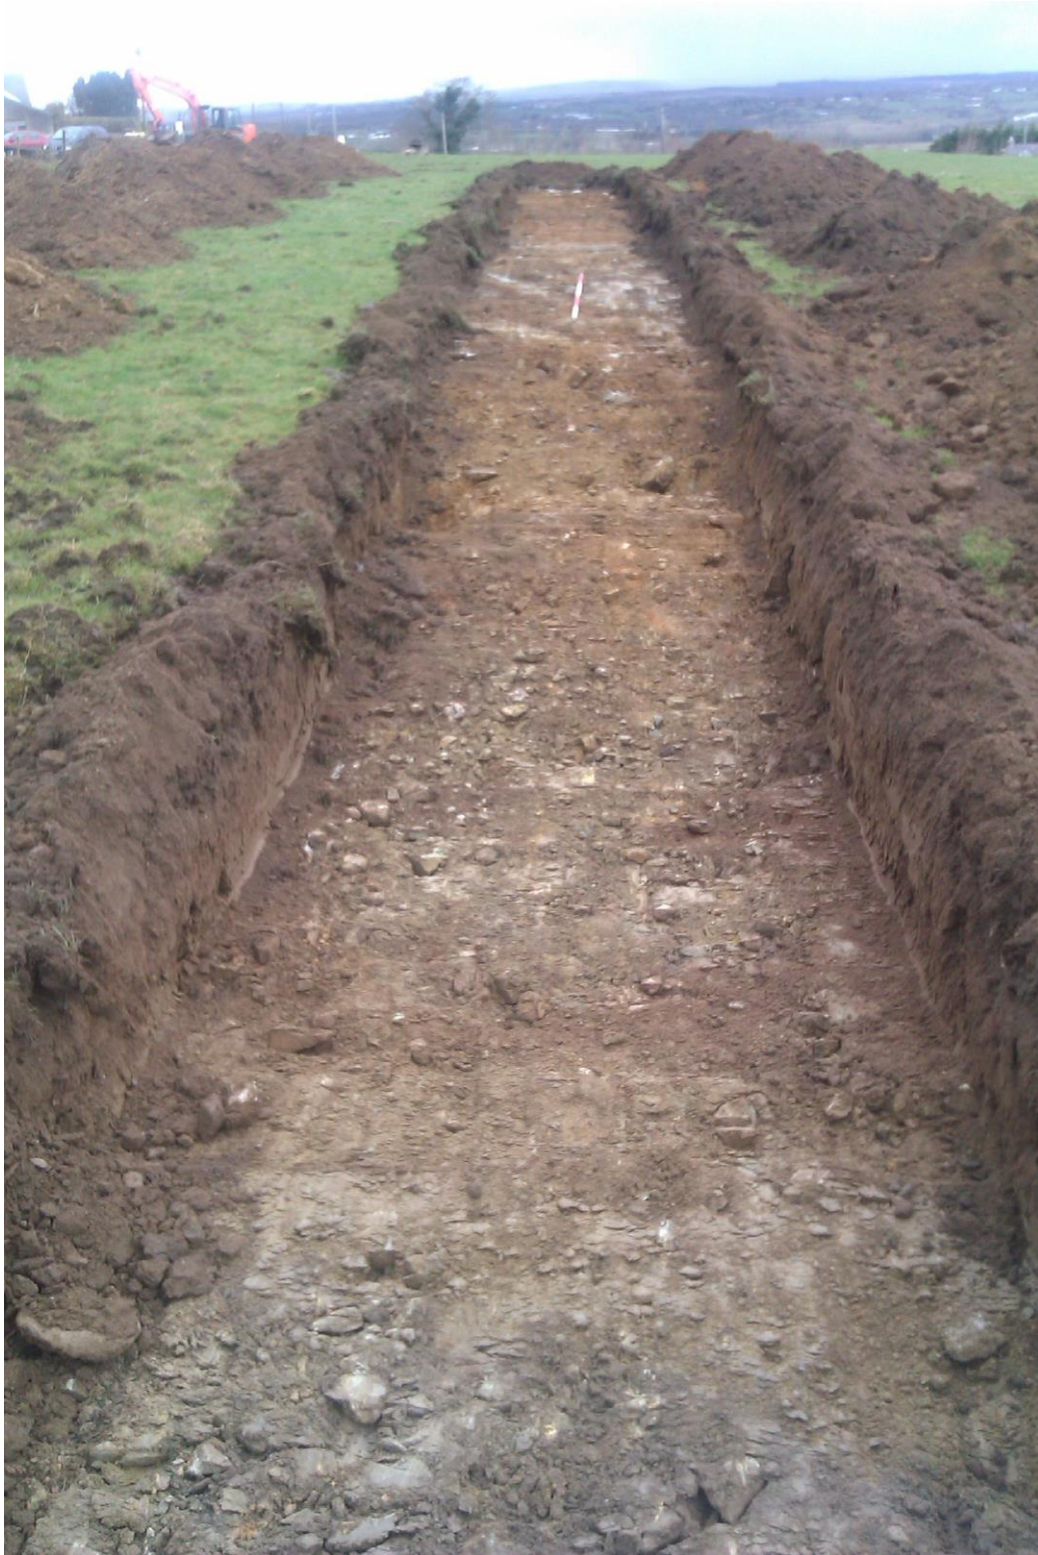
Plate 9: Trench 3 following excavation to subsoil level, looking north-west

Trench 3 was located approximately 5.0m to the north of Trench 1 and ran parallel to it. The trench was 2.0m wide and 31.0m long (Plates 9 and 10). The uppermost layer in Trench 3 was the sod and topsoil layer (C301) which consisted of dark greyish brown loamy clay which was approximately 0.1m thick. Below this was a cultivation layer (C302) comprising mid brown silty clay approximately 0.2m thick. The deposit of brown clay (C303) was present below the cultivation layer at the south-eastern end of the trench and was up to 0.4m thick. There was no sign of the field drain or plastic pipe which was present in Trenches 1 and 2. Below the brown clay was the boulder clay subsoil (C304) which was stony in parts and varied in colour from orange to yellowish grey. The surface of the subsoil was encountered at a depth of 0.7m. There were no finds or features of archaeological significance in Trench 3.

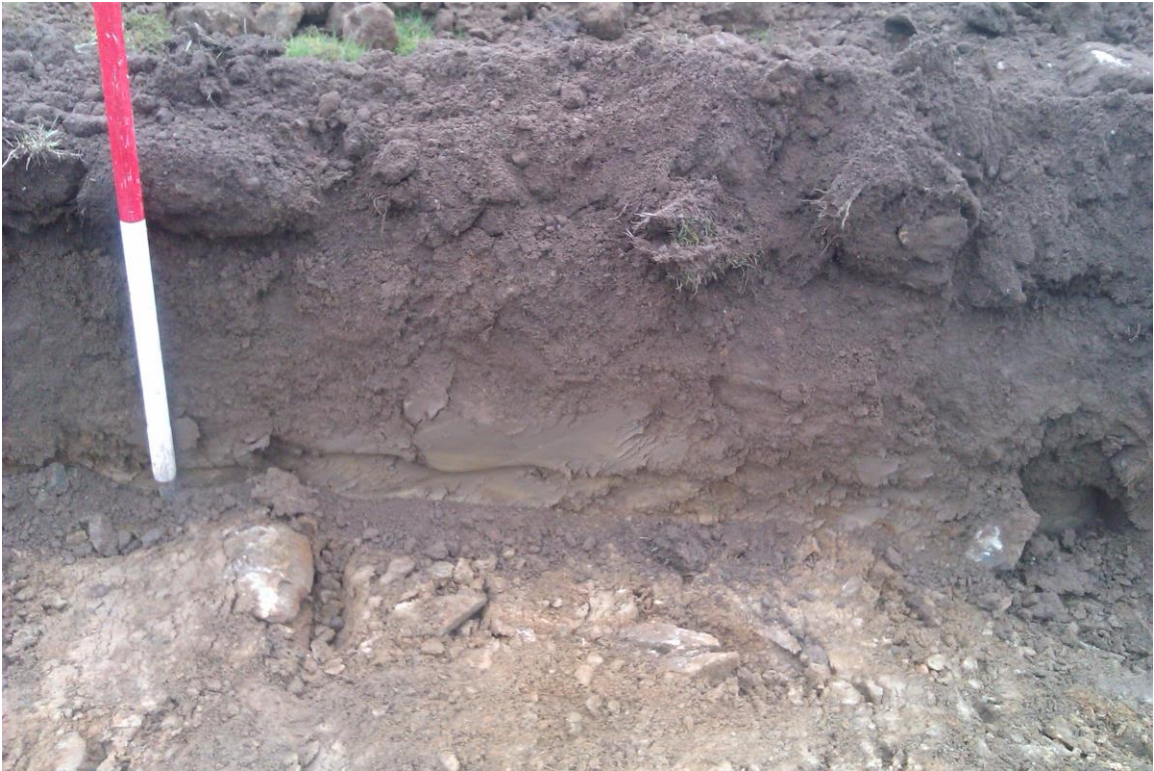
Plate 10: South-facing section of Trench 3, looking north

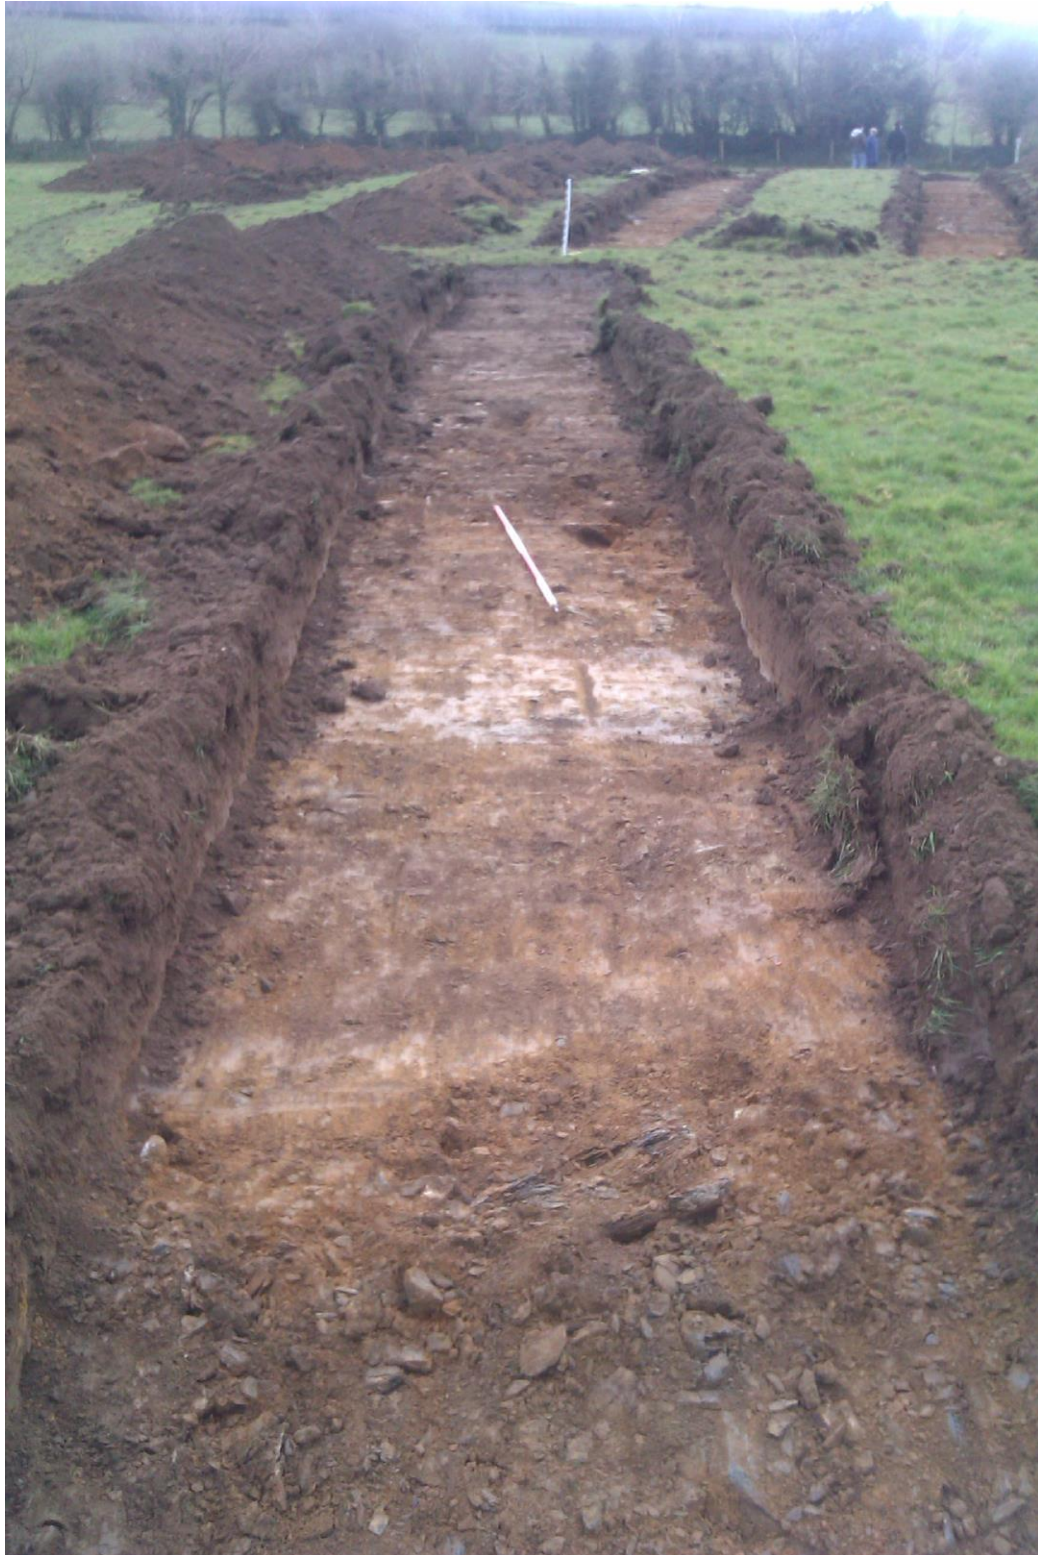
Plate 11: Trench 4 following excavation to subsoil level, looking east

Trench 4 was located 2.0m from the western end of Trench 3 and ran diagonally towards the end of the proposed new laneway (Figure 3). It was aligned west south-west/east north-east. The trench was 2.0m wide and 18.0m long (Plates 11 and 12). The stratigraphically latest layer in Trench 4 was the sod and topsoil layer

(C401) which was made up of dark brown loamy clay silt containing some angular inclusions 20mm long. The layer was 0.24m thick. Below the sod and topsoil layer was a cultivation layer (C402) consisting of mid greyish brown silty loamy clay with angular inclusions 20mm long. The layer was 0.20m thick and contained a sherd of 19th century white-glazed ceramic. Below the cultivation layer was the boulder clay subsoil (C403) which varied in colour from orange to greyish orange. There were no finds or features observed in Trench 4. The surface of the subsoil was encountered at a depth of 0.44m.

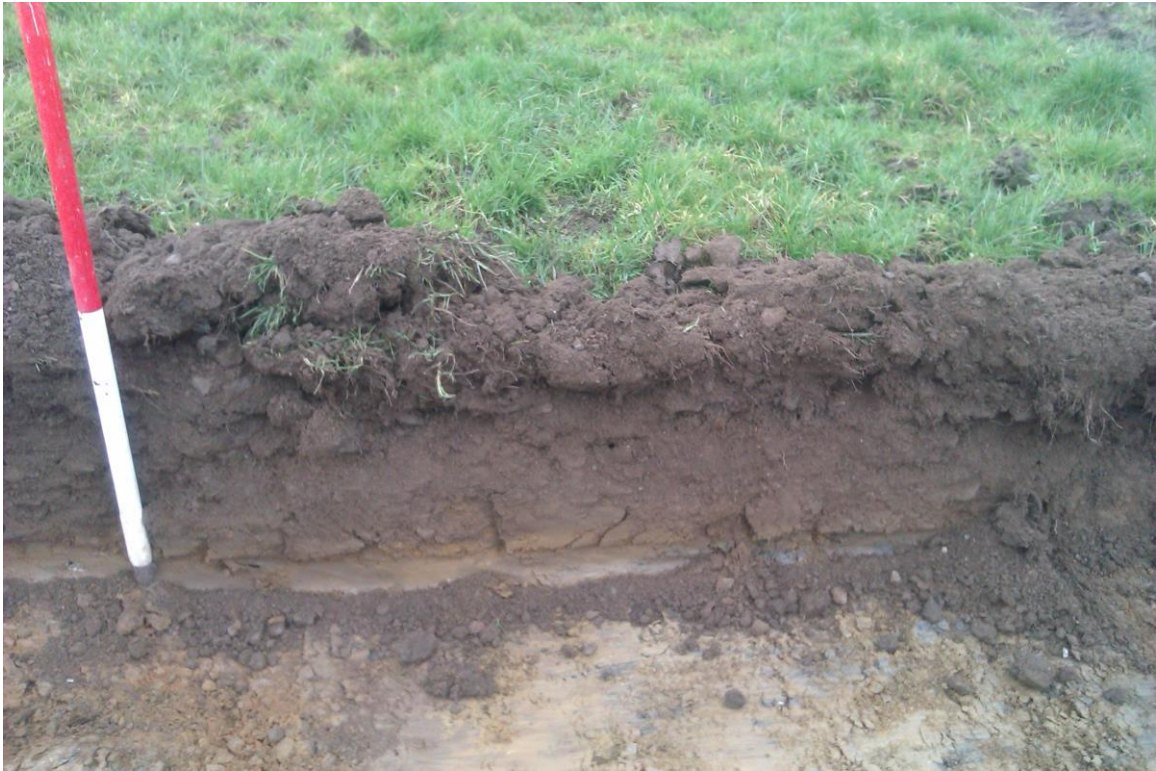
Plate 12: North-facing section of Trench 4, looking south

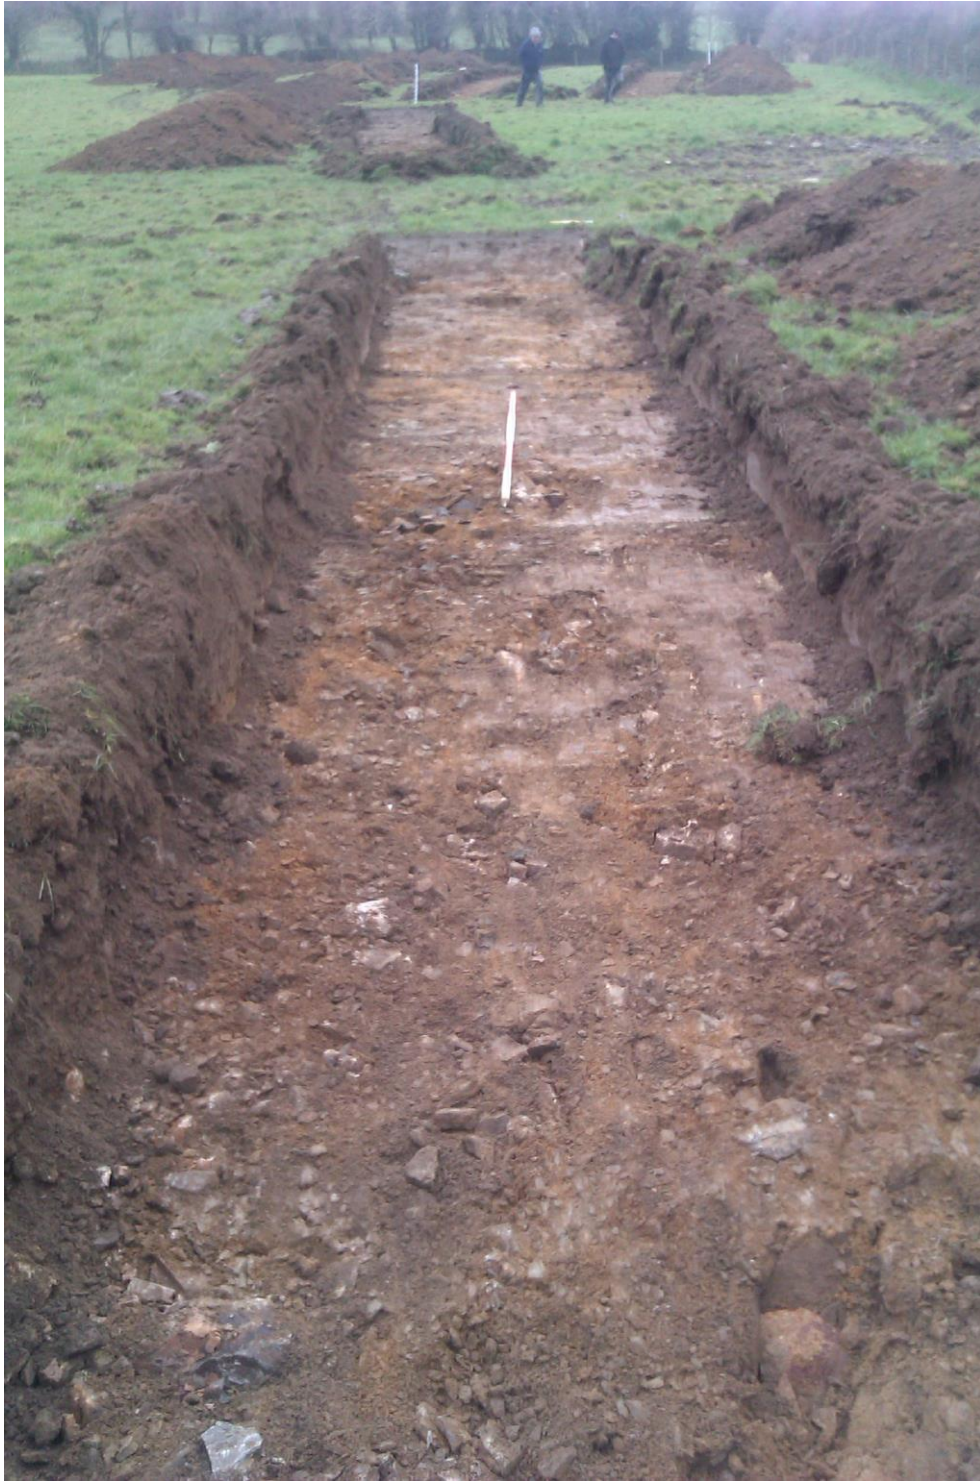
Plate 13: Trench 5 following excavation to subsoil level, looking east

Trench 5 was 6.0m to the south-west of Trench 4 and continued on the same alignment as it and the proposed new laneway. A gap was left between the two trenches to avoid a drain running across the site. Trench 5 was 2.0m wide and 12.0m long (Plates 13 and 14). The uppermost layer in the trench was the sod and topsoil layer (C501) which comprised dark brown silty clay up to 0.2m thick. Below the sod and topsoil layer was a cultivation layer (C502) consisting of greyish brown silty clay with angular inclusions which was also 0.2m thick. The cultivation layer overlay the boulder clay subsoil (C503) which was brownish orange in colour and stony in parts. The surface of the subsoil was encountered at a maximum depth of 0.4m.

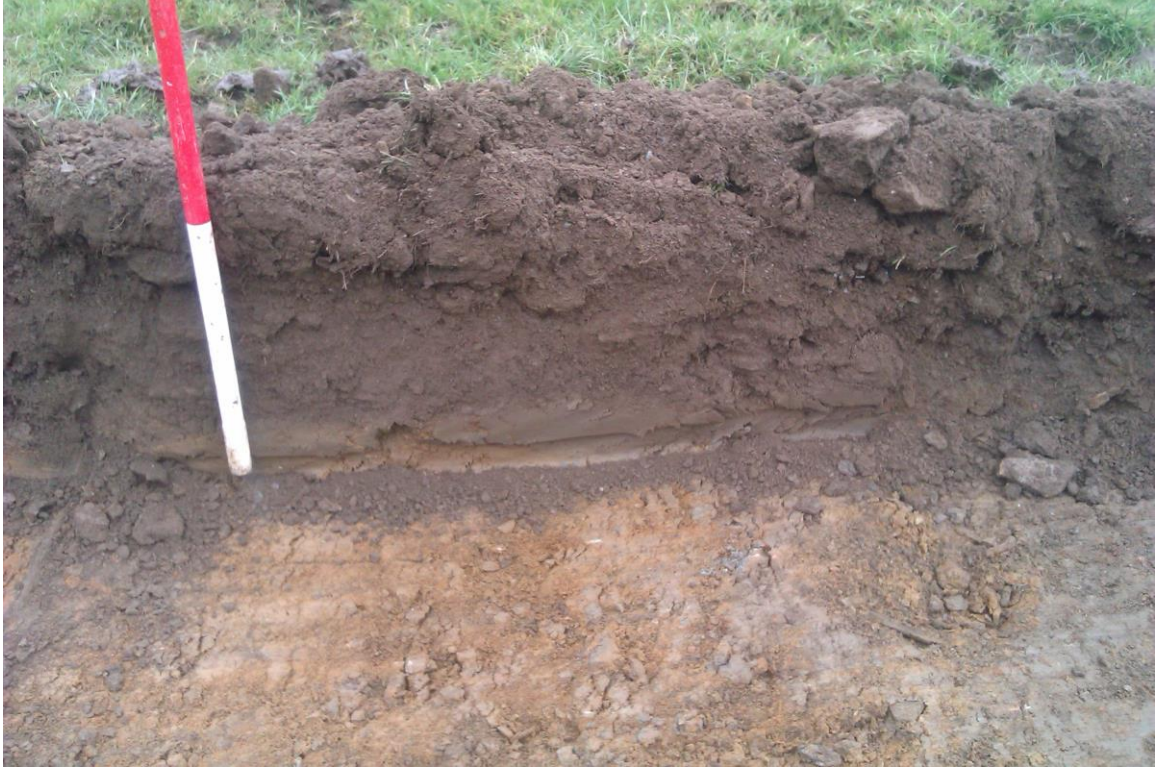
Plate 14: South-facing section of Trench 5, looking north
