Monitoring Report No. 282

**Consolidation of bank slippage
Mount Sandel Fort (LDY 007:020)
Coleraine
County Derry**

AE/14/36E

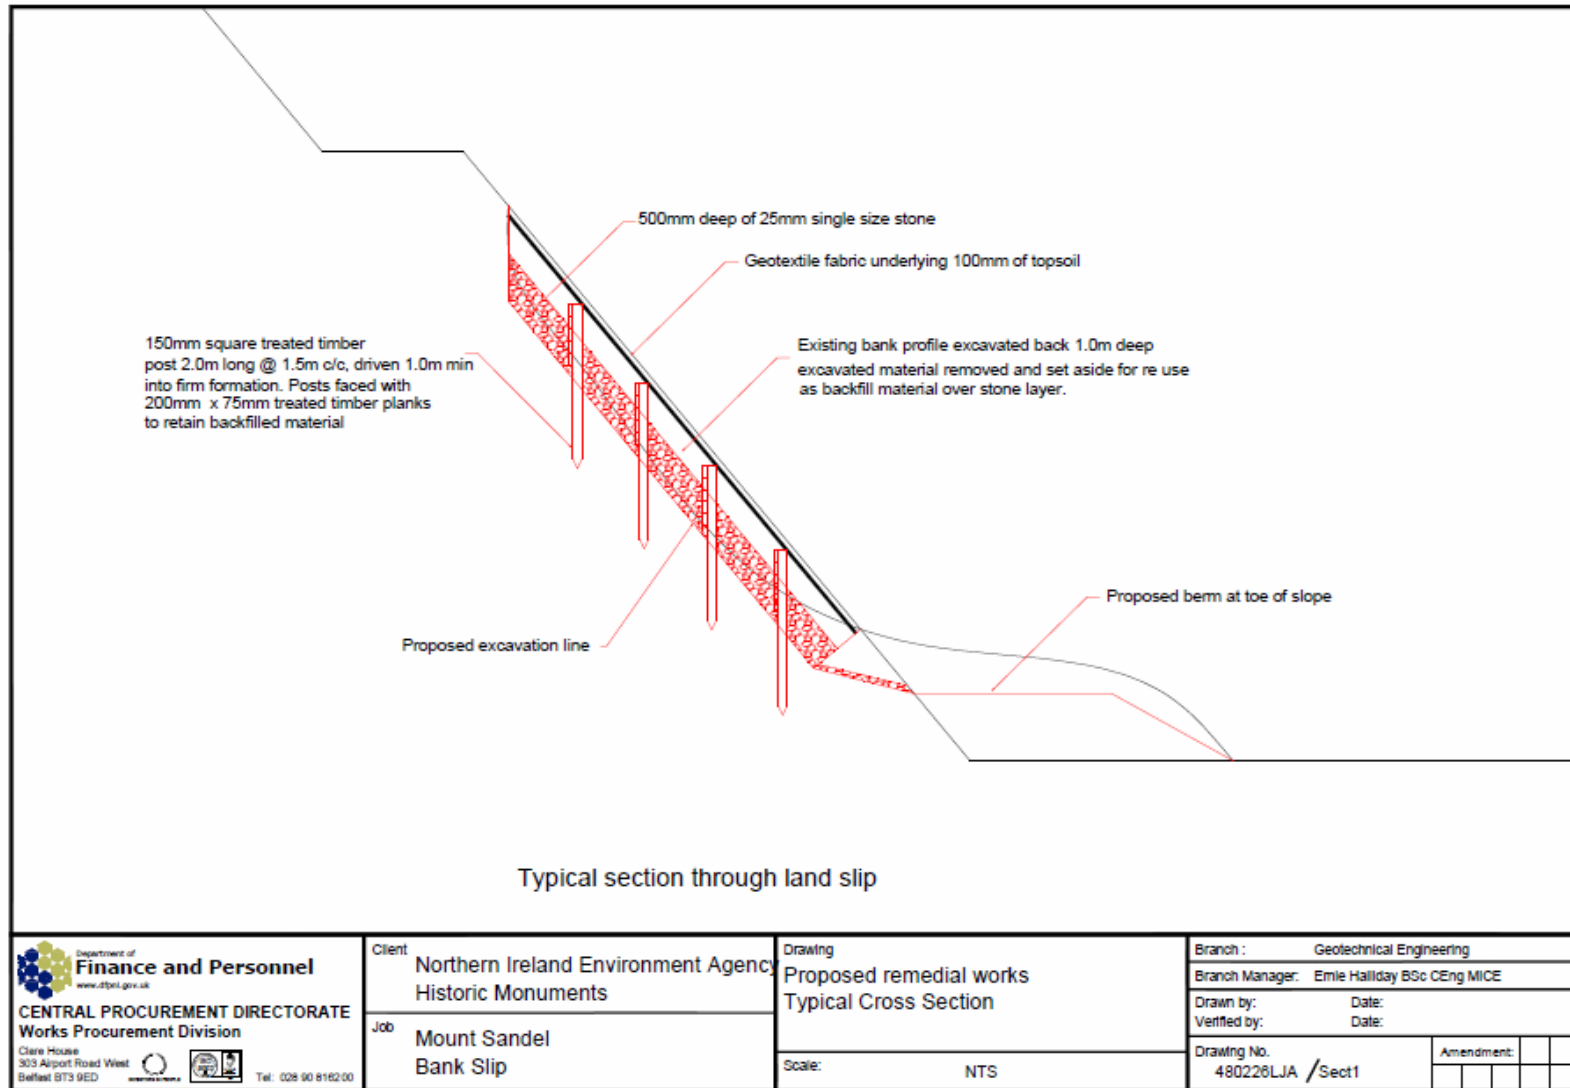
Figure 4: Proposed consolidation works.

Following the slippage it was decided that substantial consolidation work would be necessary to stabilise the monument and prevent further decay. A portion of the bank, varying in width from 10-15m (east/west) had fallen away, exposing the natural reddish-orange natural slope of the original promontory and a thin topsoil layer (maximum thickness of 0.15m) directly lying over. The topsoil consisted of a greyish brown sandy clay with frequent small rounded stones throughout. The mechanical removal of the slipped material was archaeologically supervised and sifted through for any finds (see below). The spoil was set aside on teram for use in the re-instating of the bank. The *in situ* topsoil, present only at the very top of slope, was left untouched.

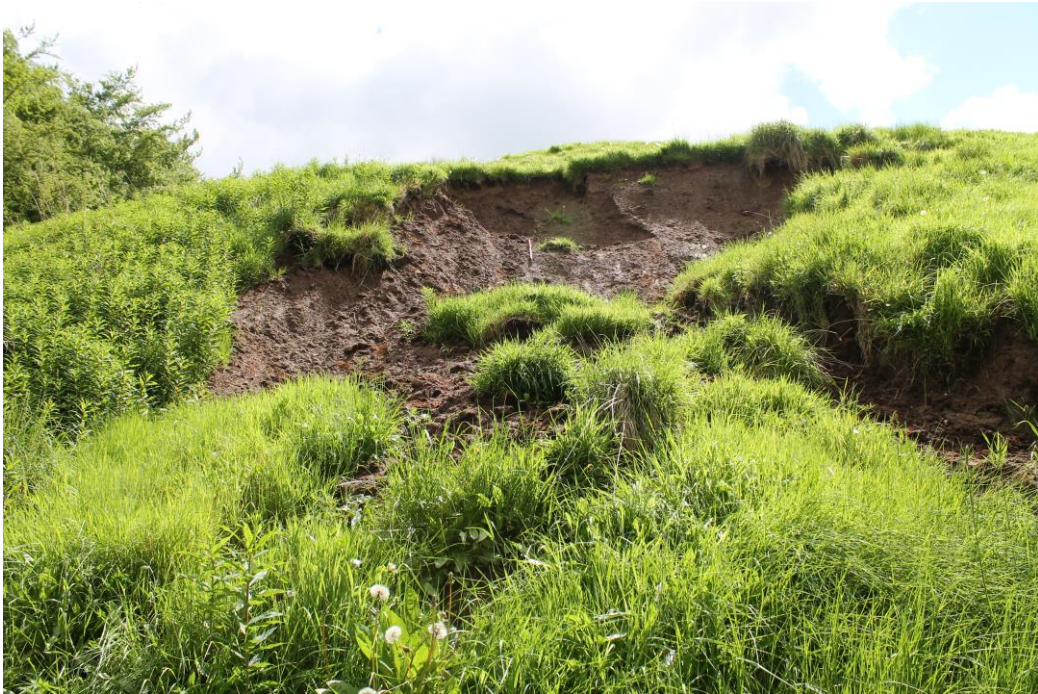
Plate 1: Slippage prior to the consolidation works, looking south-east.

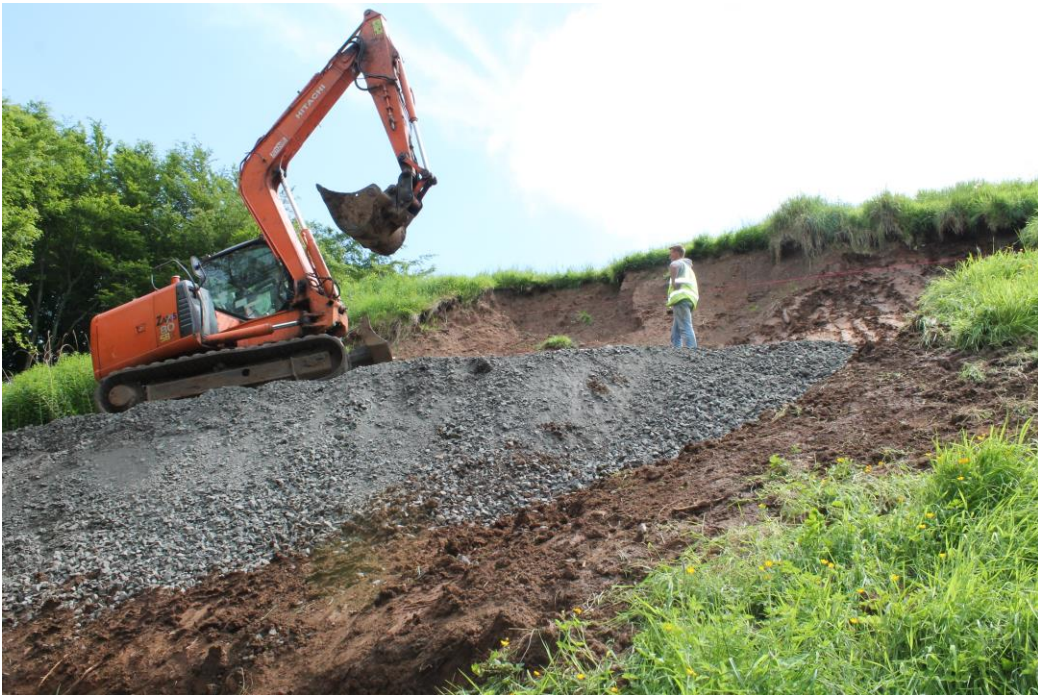
Plate 2: Mechanical removal of the slipped material, looking south-east.

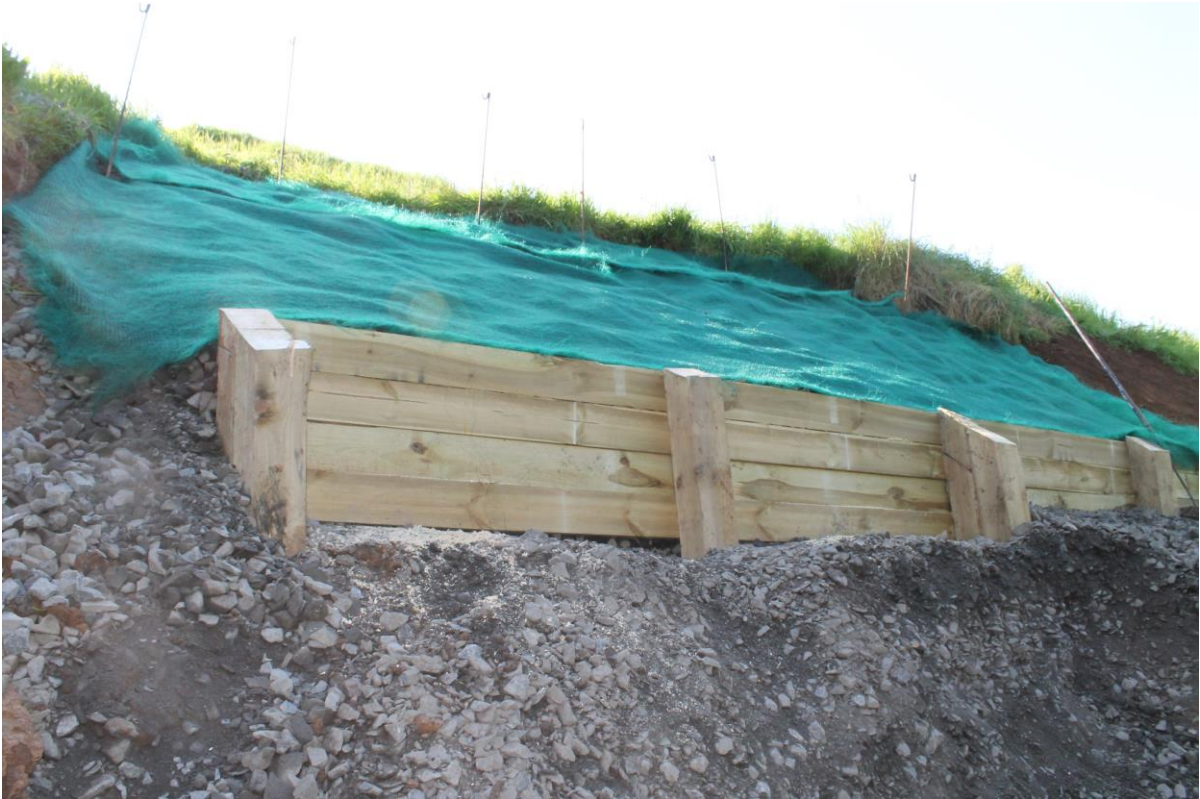
Plate 3: Construction of the 'upper tier' of the retaining fence, looking south.

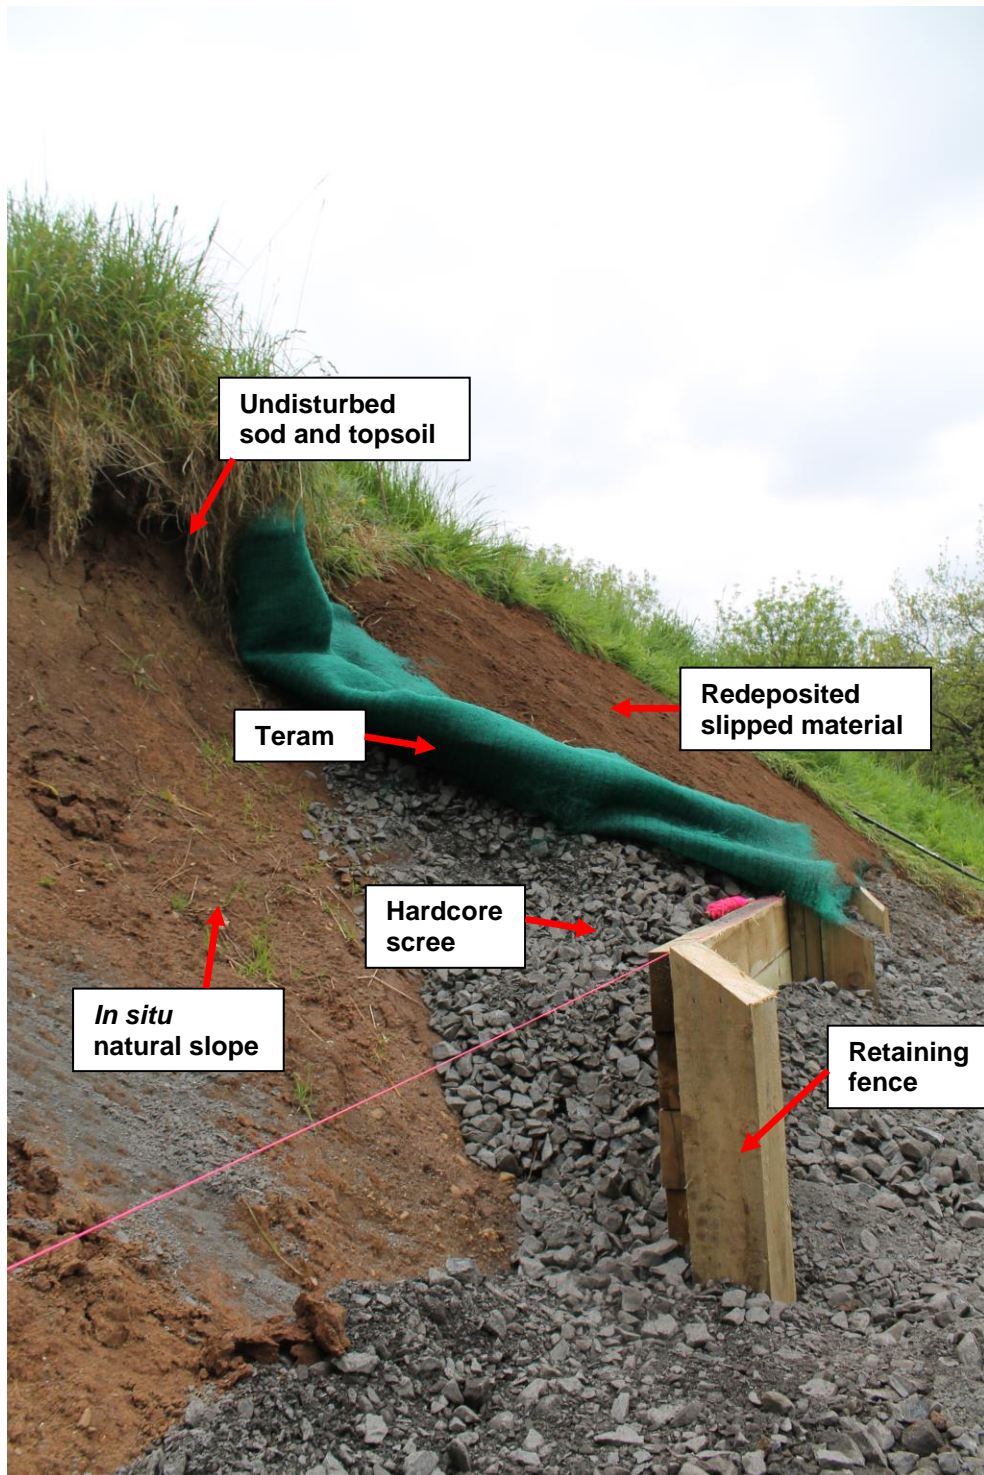
Plate 4: Detail of the consolidation works, looking west.

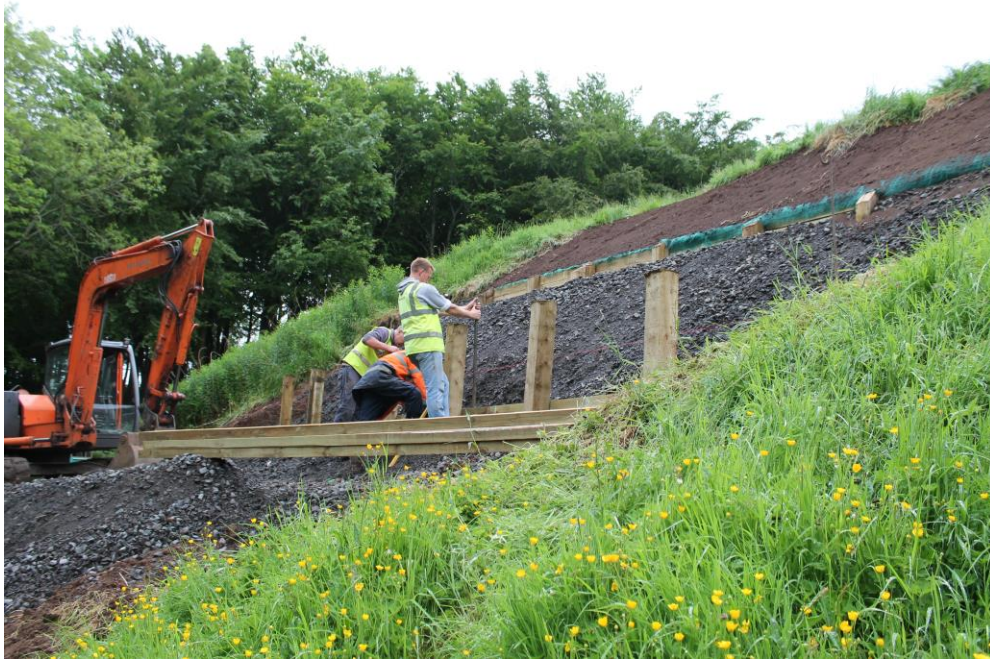
Plate 5: Construction of the second retaining fence, looking south-east.

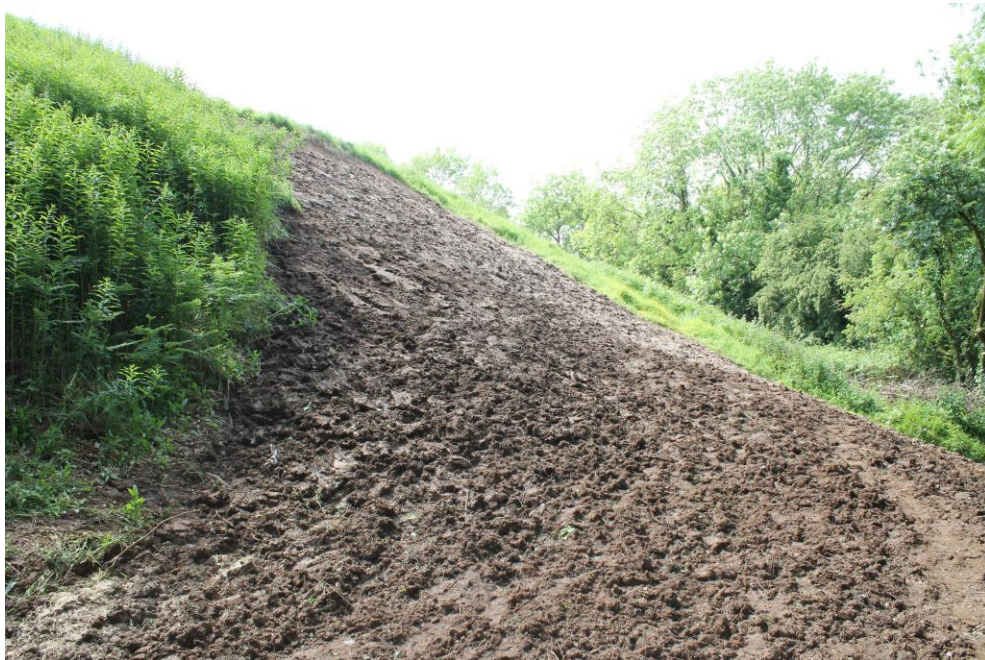
Plate 6: The slipped area following consolidation, looking west. Grass seed was spread on top of the exposed soil to aid in the consolidation of the monument.
