**CAF Data Structure Report No. 108**

**Excavations at Grey Point Fort,**

**Co. Down**

*Ruairí Ó Baoill and Heather Montgomery*  
CAF DSR 108

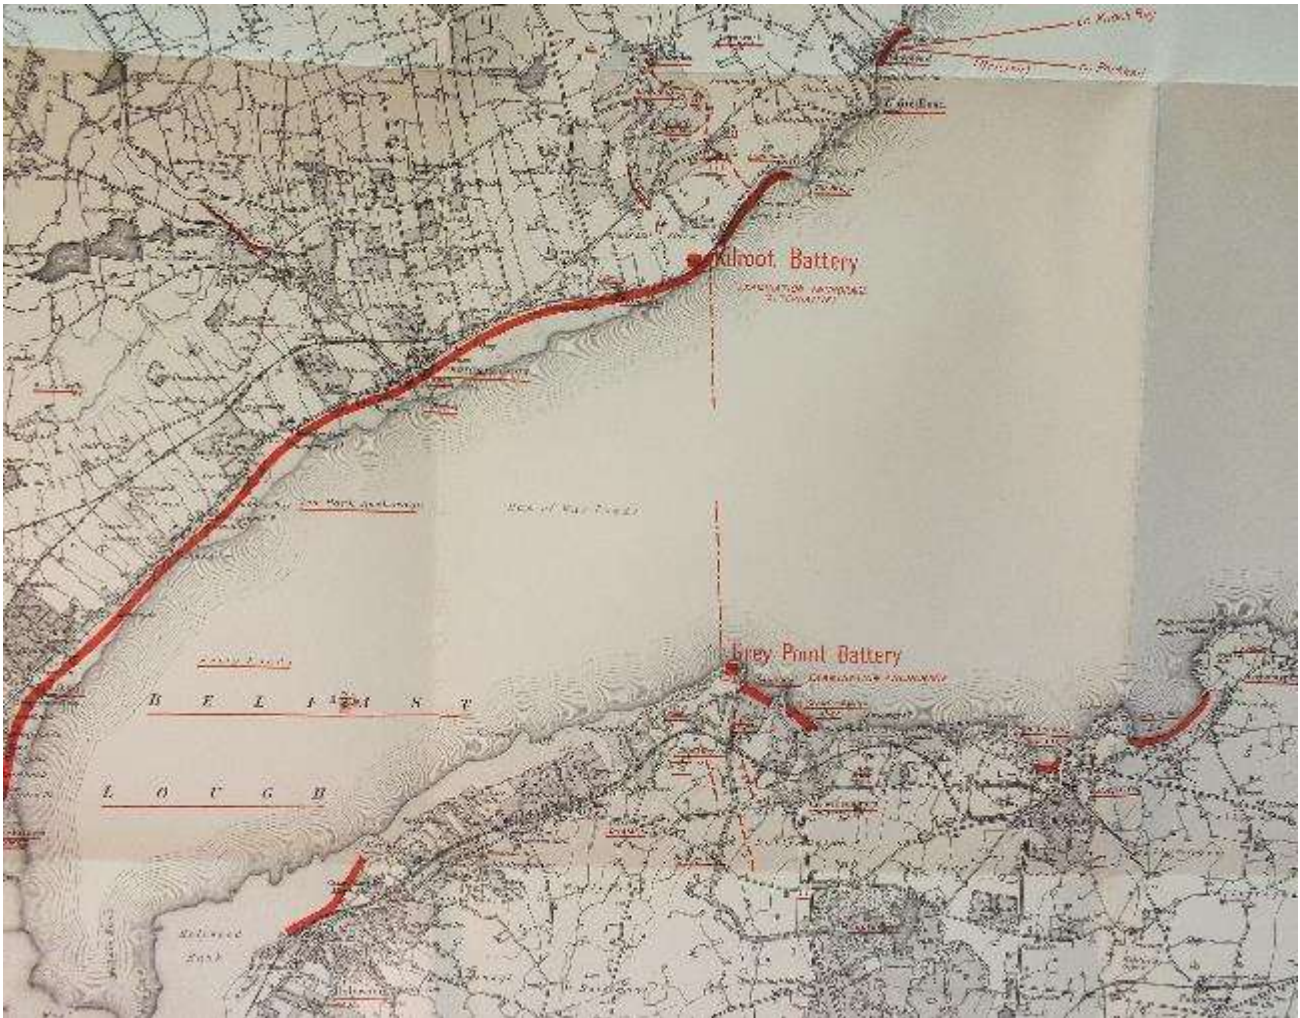
**Plate 3. Detail of a map contained in the W. O. 33/601 document (*Ireland's Defence Scheme: North Irish Ports Part II, Belfast Defences (Revised to July 1912)*) entitled *North Irish Defended Ports Scheme: Map of Belfast Defences*. The heavy red line indicates *Coast practicable for [enemy] landing* and the lighter dashed red line marks map shows the *General Line of Defence* around the two coastal batteries on either side of Belfast Lough. The map enforces picture of the symbiotic relationship between the Grey Point Fort Battery and the Kilroot Battery and their perceived crucial importance in the defence of Belfast Lough in the years immediately prior to the First World War.**

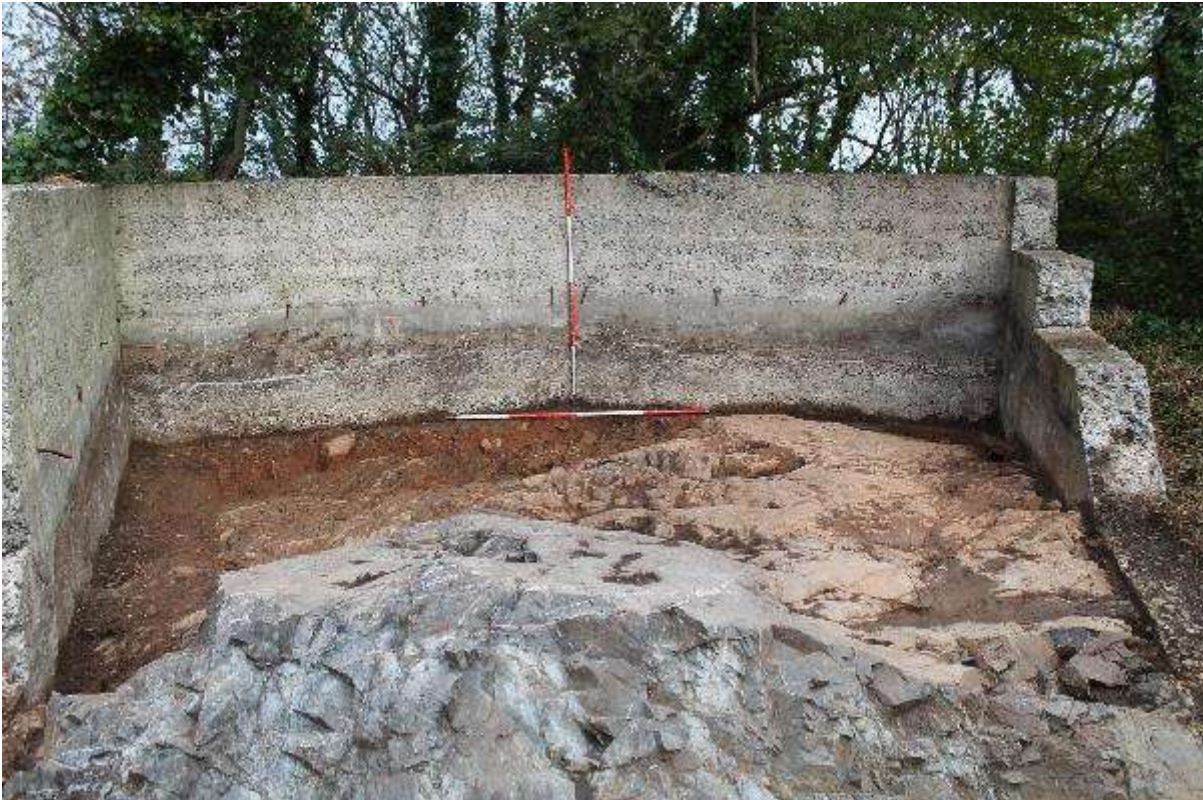
**Plate 7. Trench 1A. The internal area of the Blockhouse excavated to the level of bedrock. From the south.**

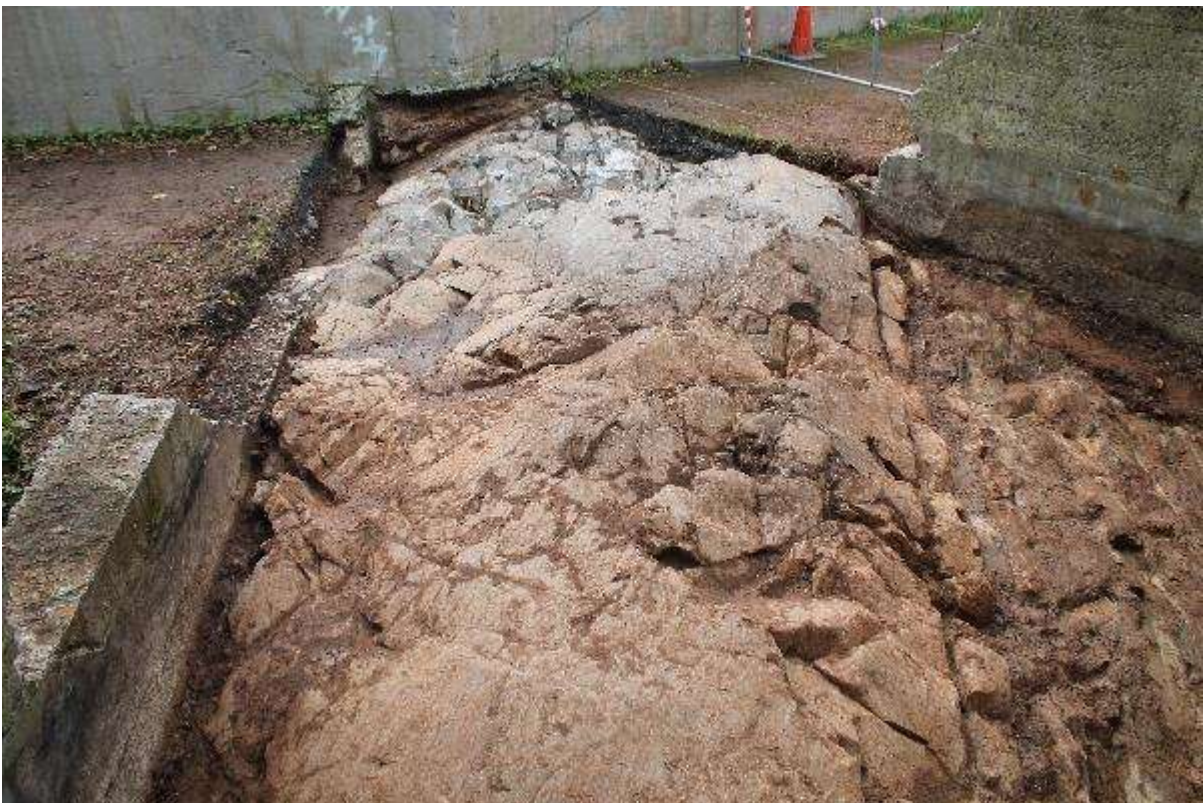
**Plate 8. Trench 1A. The internal area of the Blockhouse excavated to the level of bedrock. From the north. At the top of the photograph the stumps of the eastern and western walls of the blockhouse are visible below the later northern stone perimeter wall of the Fort.**

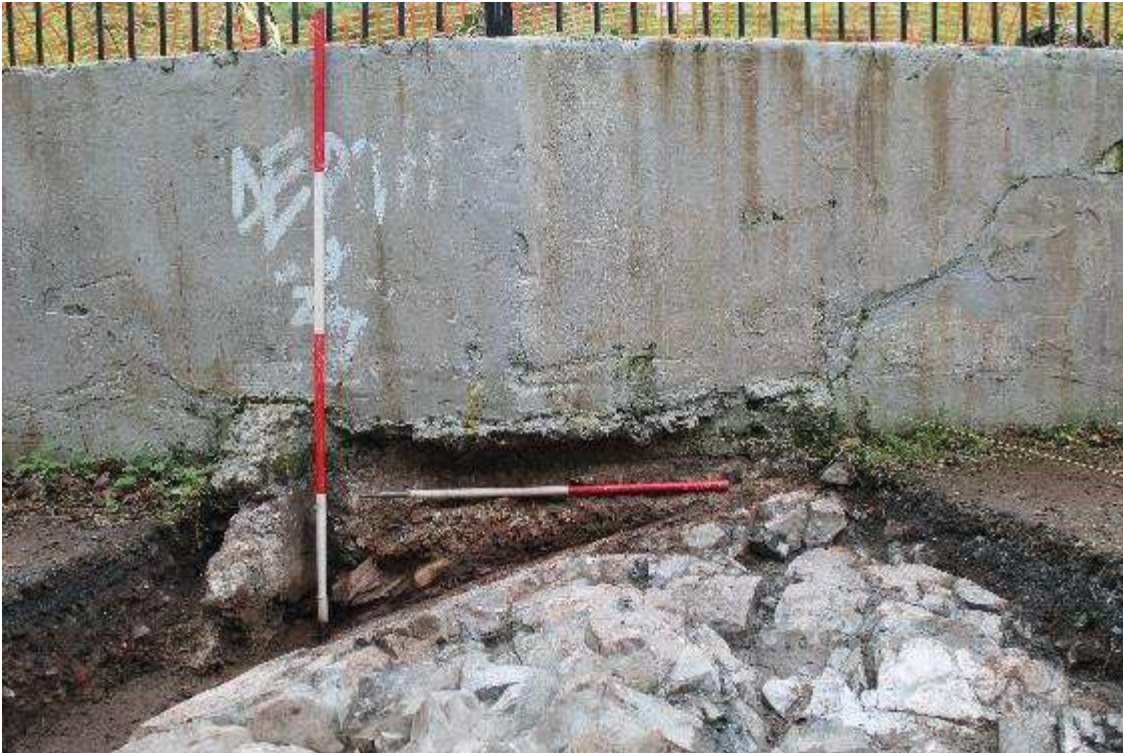
**Plate 9. Trench 1A. The southern end of trench showing the stumps of the western and eastern walls of the Blockhouse and the later northern stone perimeter wall (C.1029) of the Fort built over these. Between the Blockhouse walls layers of poured concrete and a concrete lintel were used to level up the uneven bedrock and provide a firm base for the perimeter wall.**

At the southern end of the Trench 1A an approximately 3m stretch of both the eastern and western wall of the Blockhouse had been removed to facilitate the construction of the extra-mural path. This construction also involved the lowering of the underlying bedrock to the required level of the path and much chipped bedrock was found directly over bedrock proper in the south of the site. The path consisted of a layer of compact grey gravel (Context 2) up to 0.30m deep and was laid directly over the old topsoil layer (Context 6) in the area of the path. Above this was the modern topsoil layer (Context 1) that was a dark brown silty loam with occasional small to medium angular stones and frequent roots.

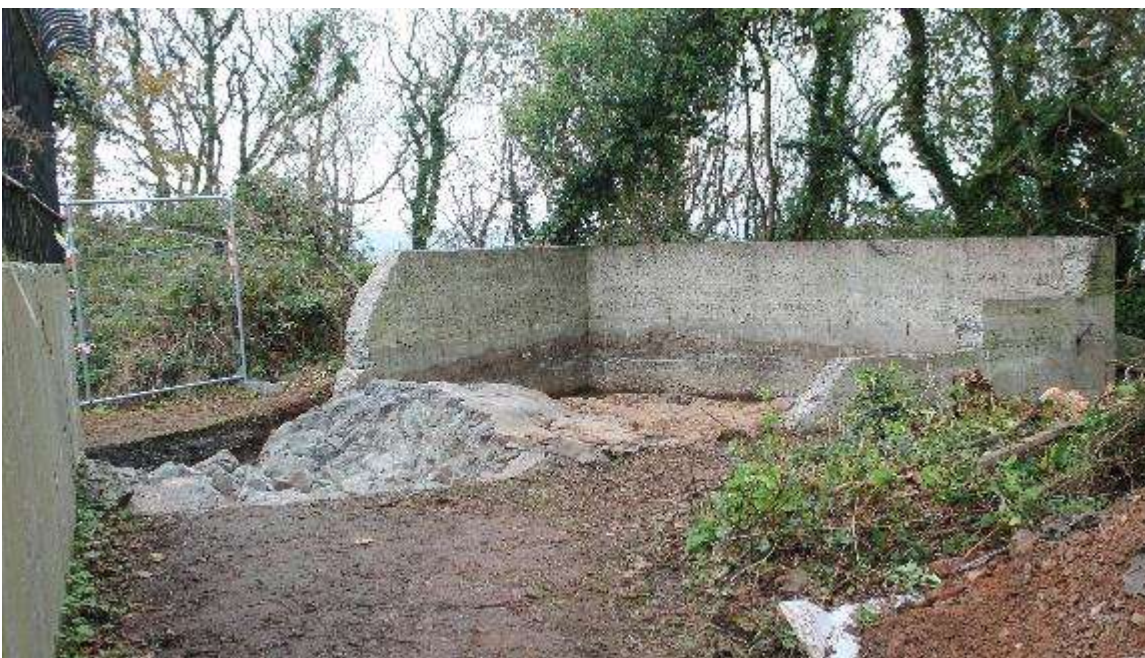
**Plate 10. Trench 1A. The fully excavated Blockhouse from the south-west. At the far left of the shot the later northern stone perimeter wall of the Fort is visible. Also visible are the modern gravel path and the section of bedrock and the sections of the western and eastern walls of the Blockhouse which had been removed to facilitate the creation of the path.**

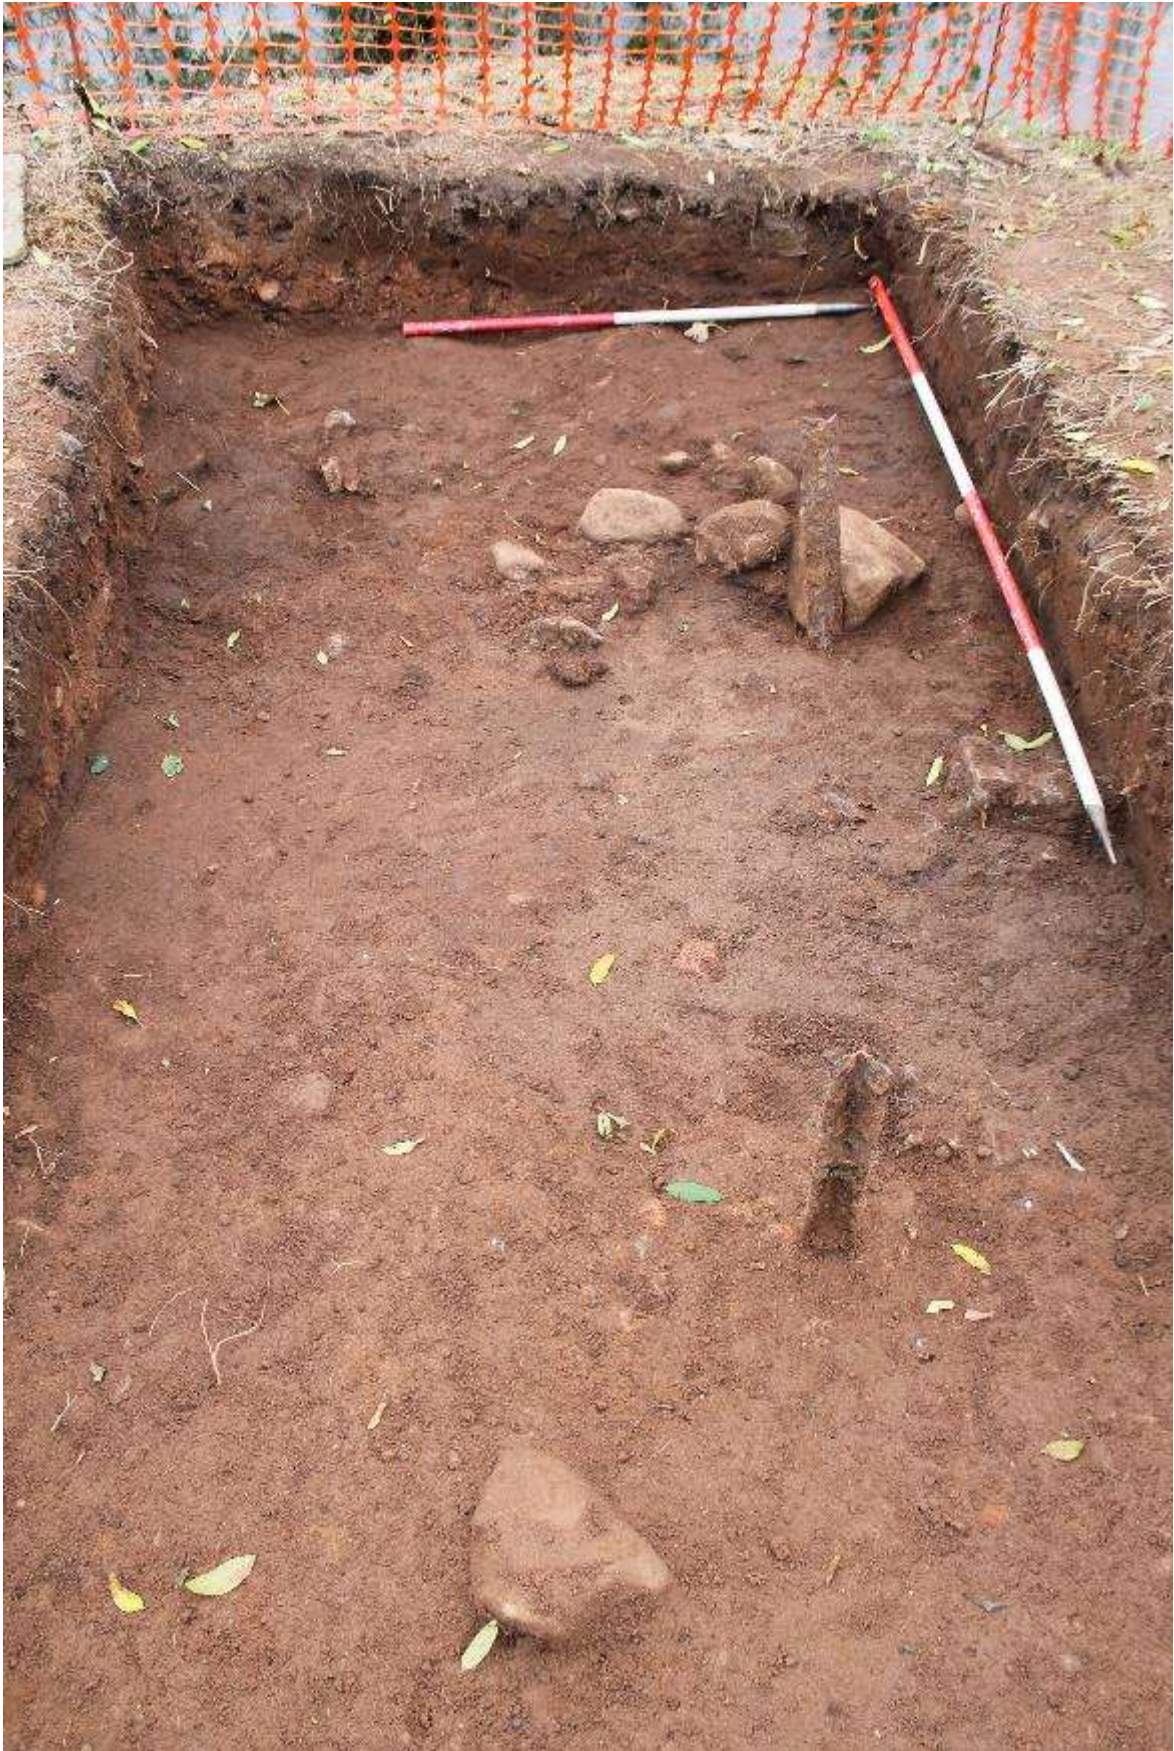
**Plate 11. Trench 1B, main trench. Iron fence pickets C.1013A and C.1013B, to right of shot, during excavation. From the South.**

The two trench pickets were 1.34m apart. They were both roughly 0.70m long, L-shaped in section with both sides measuring 0.045m. The trench pickets were exposed in topsoil (Context 1001) just centimetres below the grass that now constitutes modern ground level on the terrace below the Fort guns. It is probable that the tops of the fence pickets were cropped (sawn) after the barbed wire defensive fence around the Fort, of which they were a part, was dismantled and replaced by the stone perimeter wall. Topsoil (Context 1005) below the grass and above the stabilising layer (Context 1011) was a mid-brown loam out of which were recovered struck flint, fragments of barbed wire, corroded iron objects and butchered animal bone.

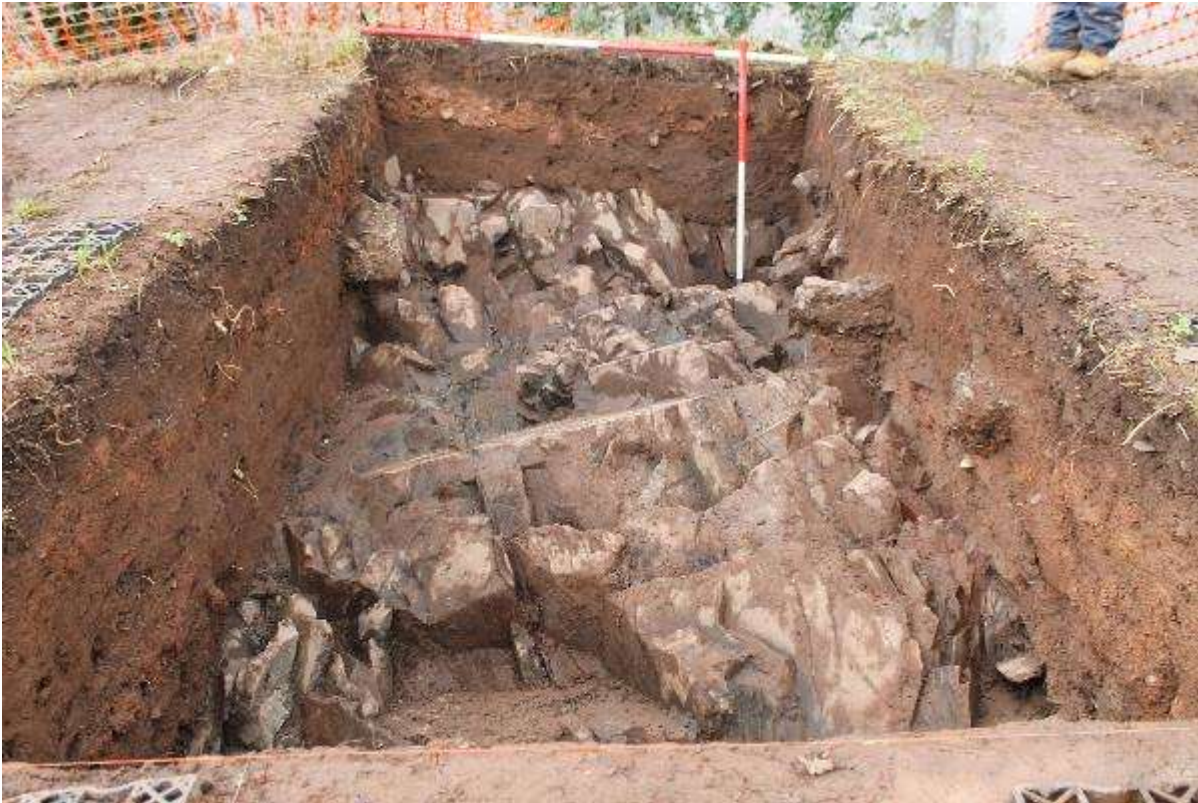
**Plate 12. Trench 1B, main trench fully excavated to the level of bedrock. From the South.**

**Plate 12.** Trench 1B, main trench fully excavated to the level of bedrock. From the South.

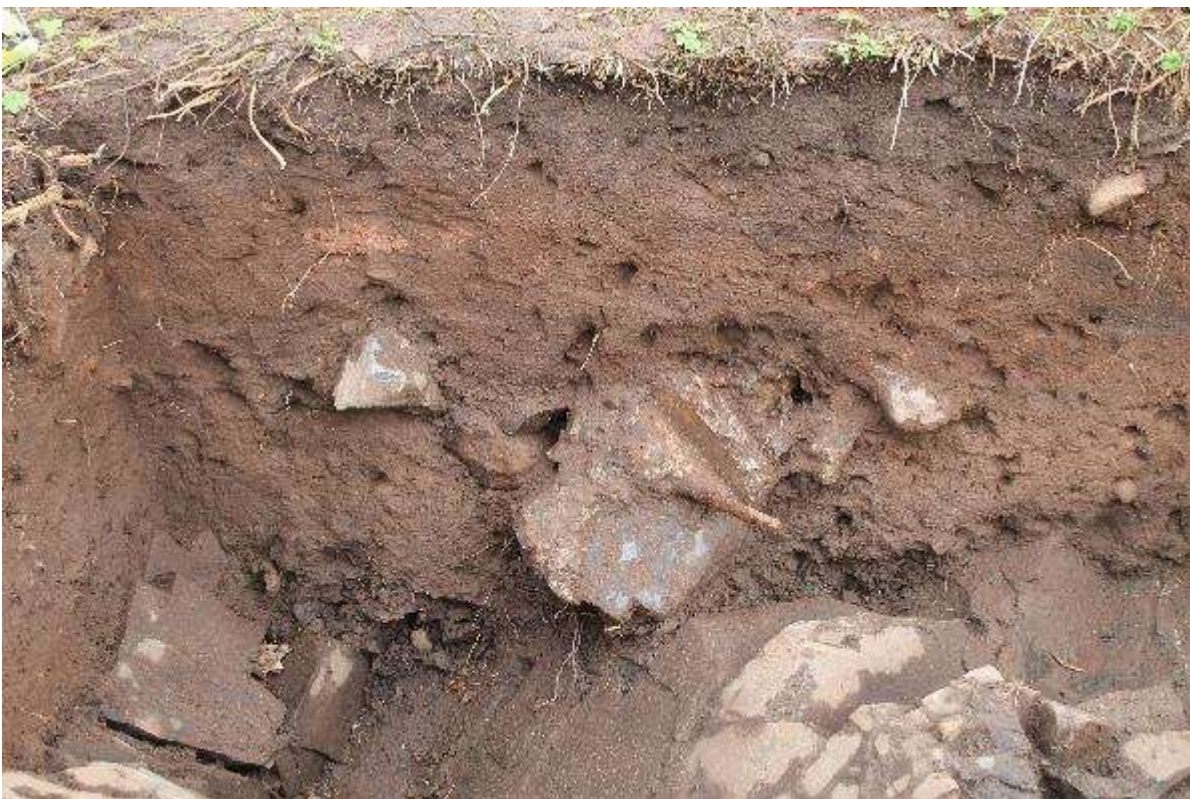
**Plate 13. Trench 1B, main trench. North-east corner. Detail of fragment of concrete in C. 1017 with an impression and portion of iron fitting that matches the dimensions of the excavated fence pickets and which may have been a base of such a defensive structure.**

Above these two layers were, at the northern end of the trench, a layer of redeposited orange subsoil clay along with fragments of concrete, lumps of burnt clay and sub-rounded stones (Context 1021). This localised layer was up to 0.18m thick appears to have been another dumped layer. Above this, and encountered across the whole trench was a more substantial layer of dumped material (Context 1017) that was up to 0.40m deep. The deposit was mottled and a loose mixture of clay, sand, silt and loam. It contained large fragments of reinforced concrete blocks, angular stones, red brick, coal, glass and slag. The deposit seems to be a concerted effort to raise the ground level in this part of the Fort, possibly to create a level surface as part of the works associated with the creation of the pre-WW1 coastal battery. It was into this level that two iron trench pickets (Contexts 1013A & 1013B), discussed below, had been driven. In fact one of the fragments of concrete had an impression in it that perfectly fitted the dimensions of the fence pickets and may be the base of such a defensive structure.

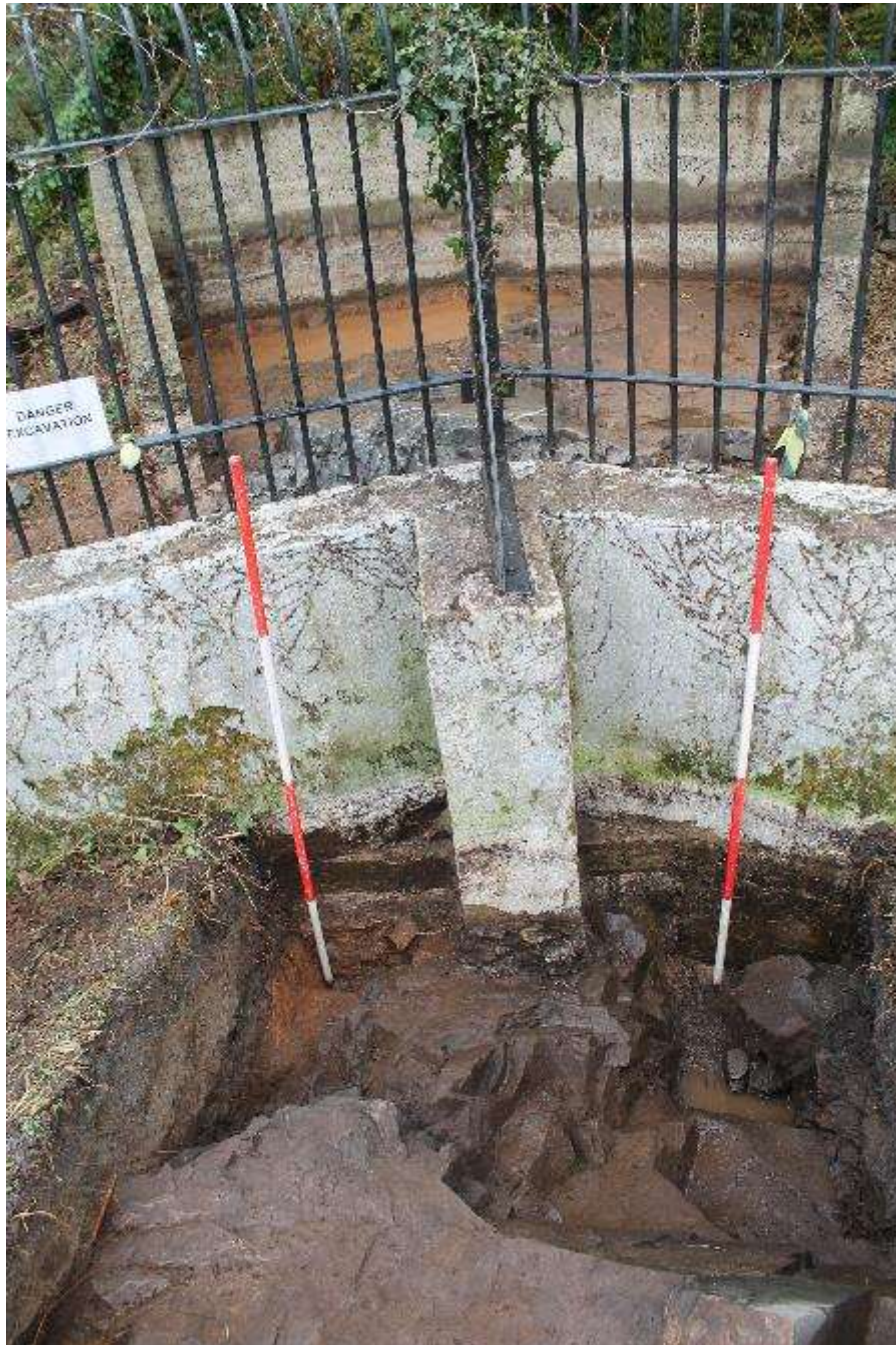
**Plate 14. Trench 1B, Northern Extension. South-facing section, showing the later stone perimeter wall of the Fort founded on the concrete lintel and layers of poured concrete and the drop in bedrock where this has been removed. In the background of the shot is Trench 1A/ the concrete Blockhouse over which the stone perimeter wall had been built.**

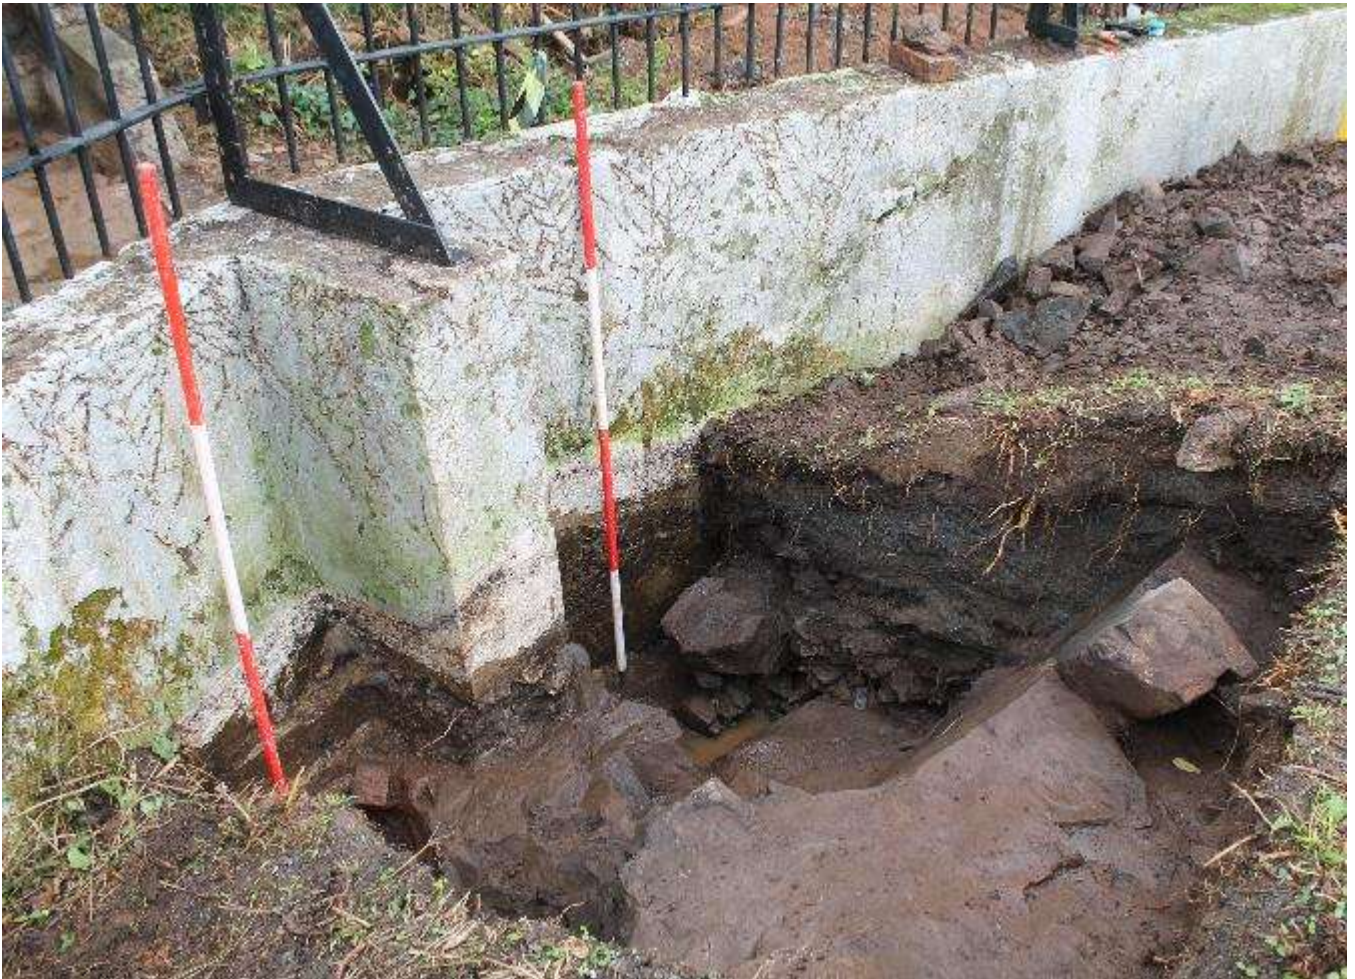
**Plate 15. Trench 1B, Northern Extension. West-facing section showing the later stone perimeter wall of the Fort founded on the concrete lintel and layers of poured concrete. The drop in bedrock where this has been removed is very visible as are the later dumped layers of gravel and sand.**

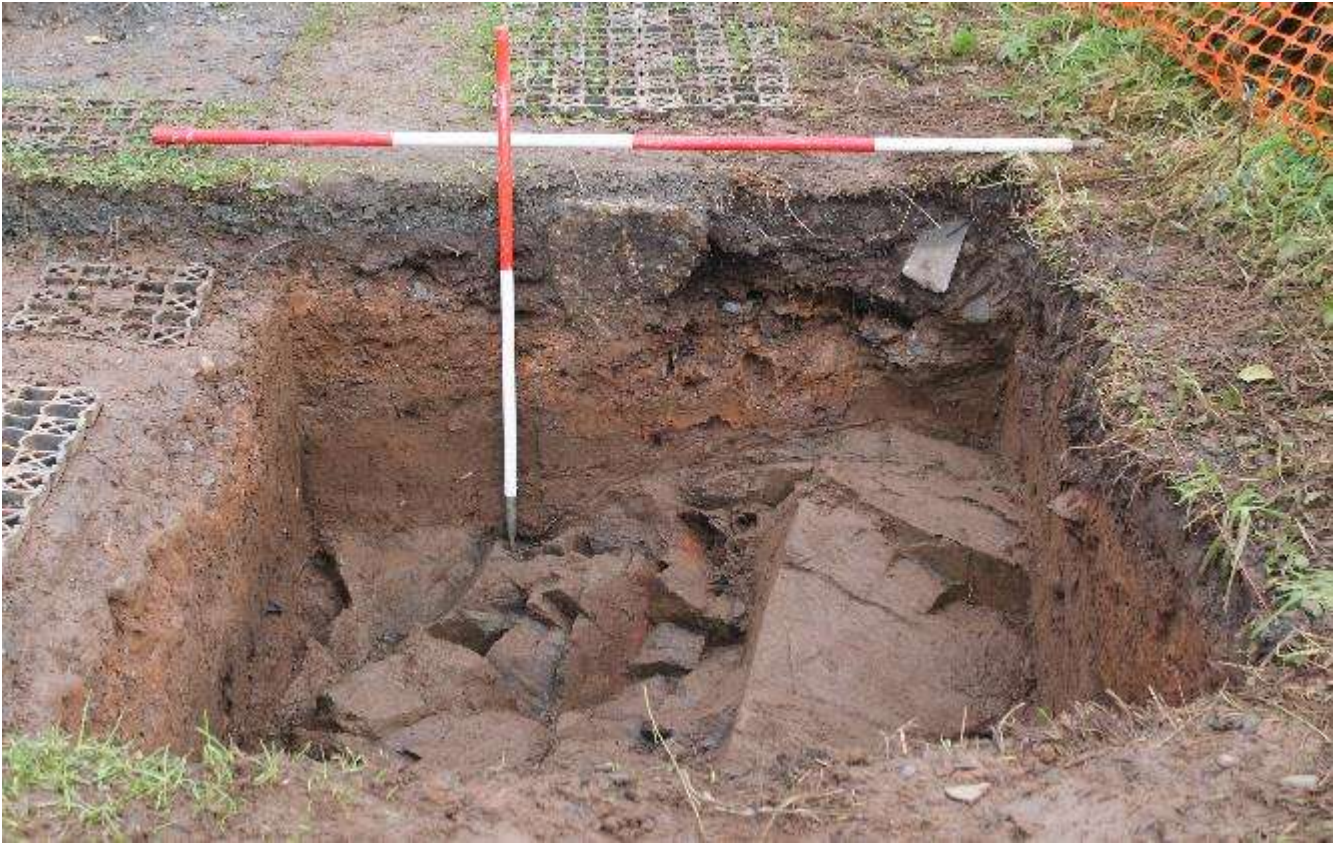
**Plate 16. Trench 1B, Southern Extension. West-facing section.**

**Plate 16.** Trench 1B, Southern Extension. West-facing section.

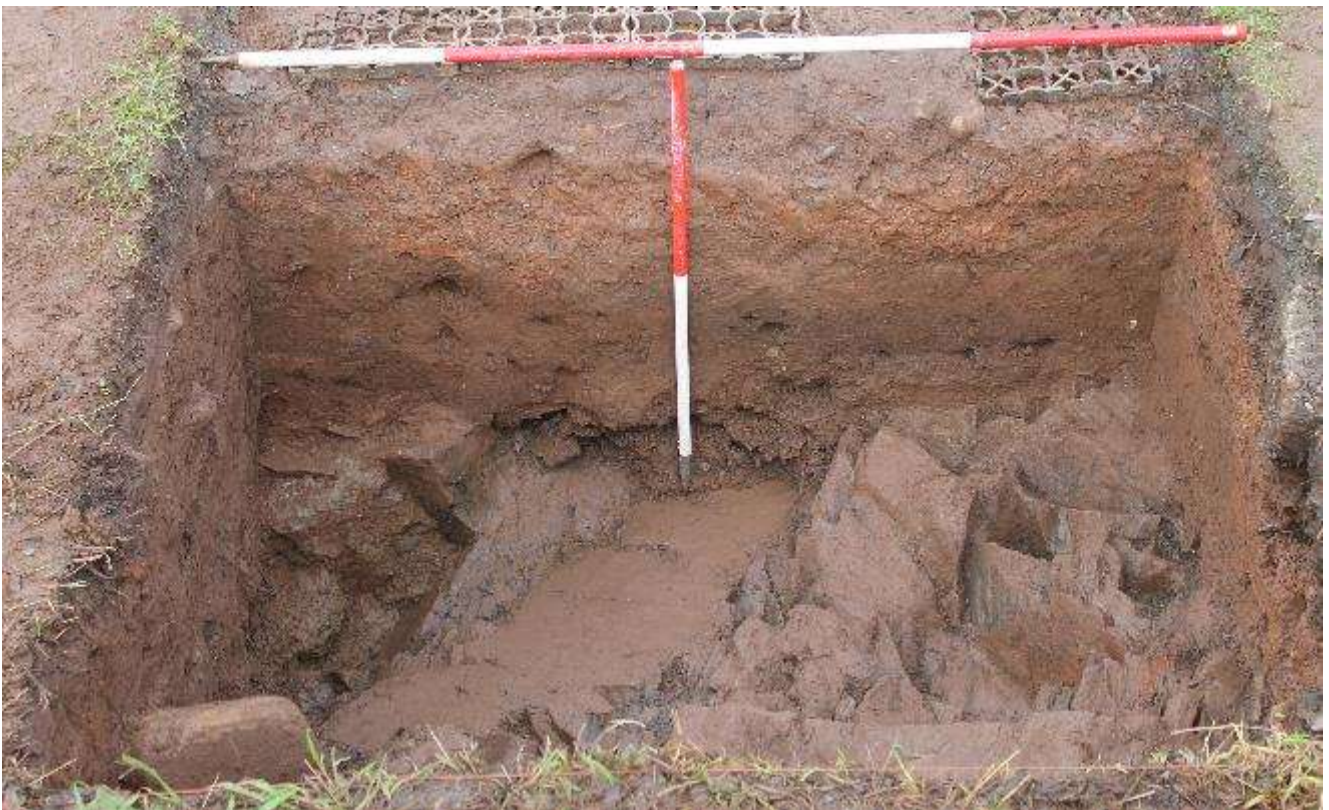
**Plate 17. Trench 1B, Southern Extension. South-facing section.**

**Plate 17.** Trench 1B, Southern Extension. South-facing section.

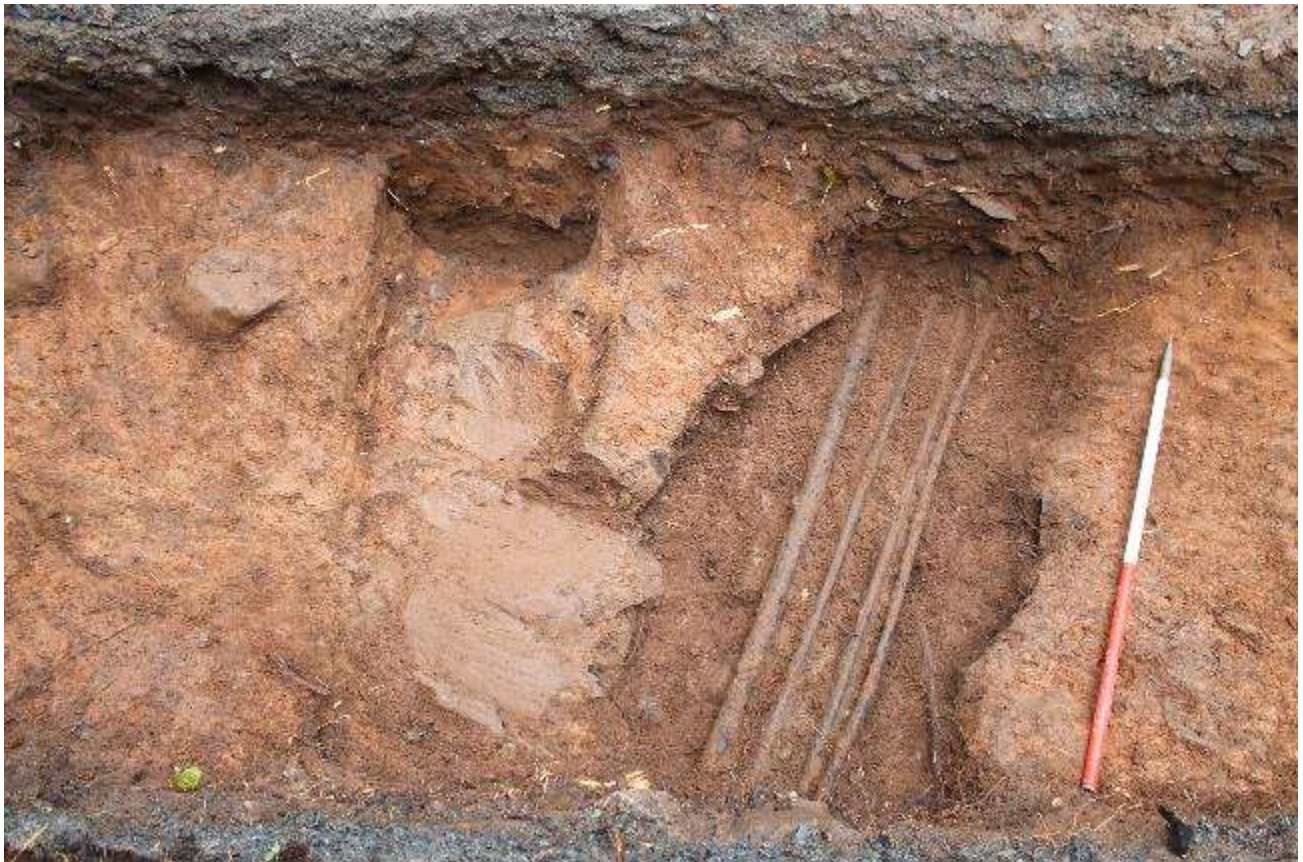
Plate 18. Trench 2 from the East. Detail of the two service trenches (C. 216 and C. 213) and the service cables (C. 211).

Both of the cut features were electricity service trenches and the cables in the most northerly one were a section emanating from Grey Point Fort to the most westerly of the three coastal searchlight emplacements (Defence Heritage Record No. 316) positioned close to the fortification. It may be that the more southerly of the two cuts (Context 216) may have been a first, failed, attempt to facilitate the cables in a service trench and the adjacent cut (Context 213) was a second, successful, one.

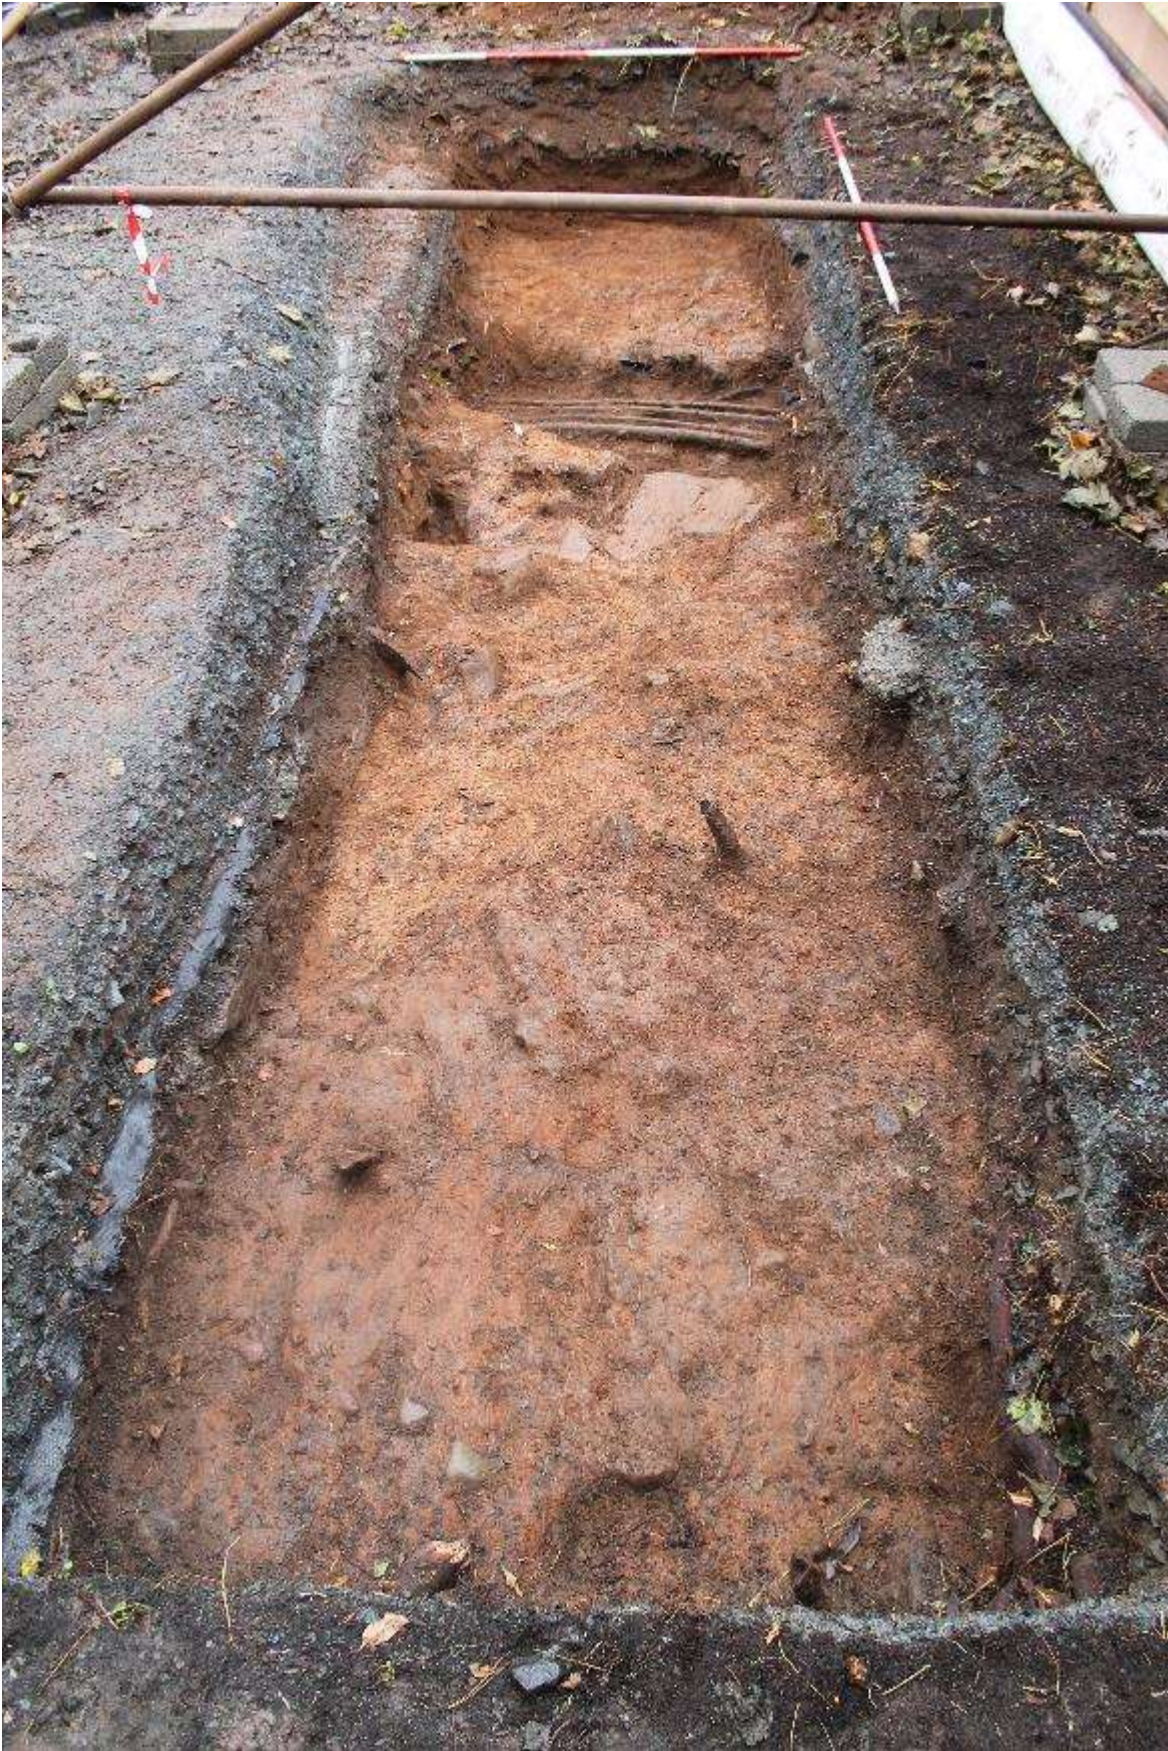
**Plate 19. Trench 2 from the North. Trench excavated to subsoil level with the stumps of four iron fence pickets in the foreground and the later service trench with the service cables in the background.**

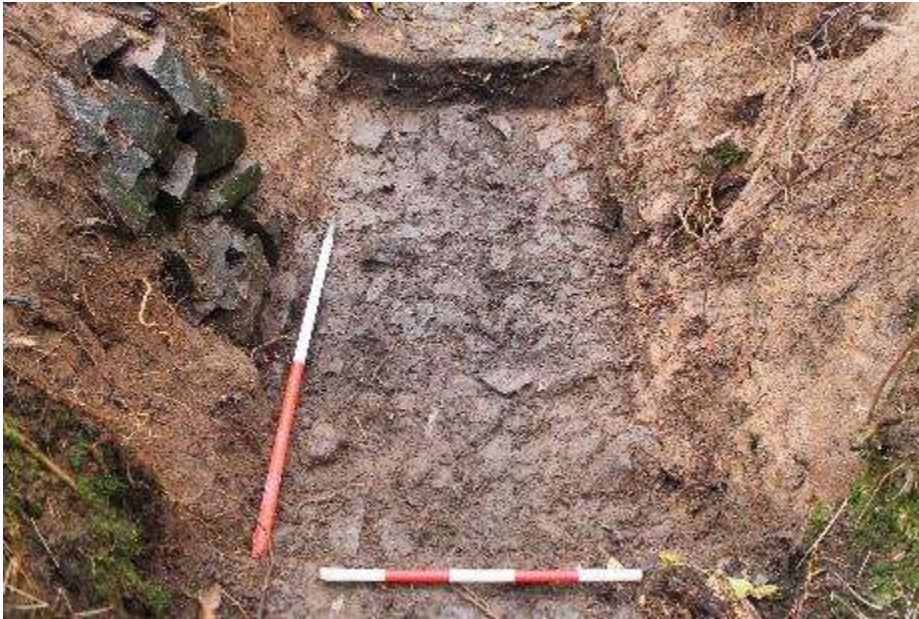
**Plate 20. Trench 3. Stone surface (C.306/ 307) in the base of the trench and the drain (C.303/ C.312) built into the eastern bank. From North.**

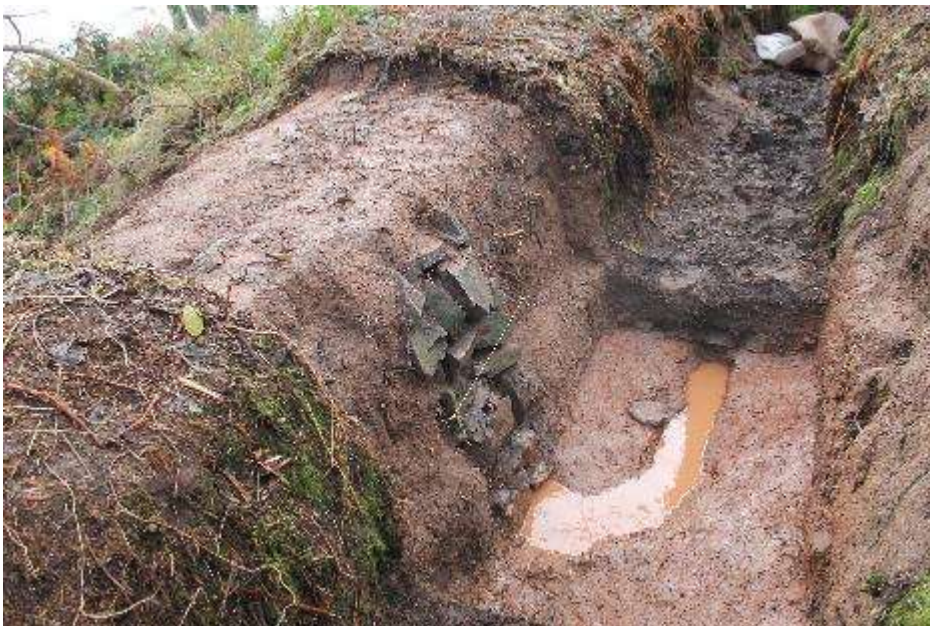
**Plate 21. Trench 3. The subsoil-cut drain (C.309) in the base of the earthen shoreline defensive trench and the larger drain (C.303) built into the eastern bank of the defence. From North.**

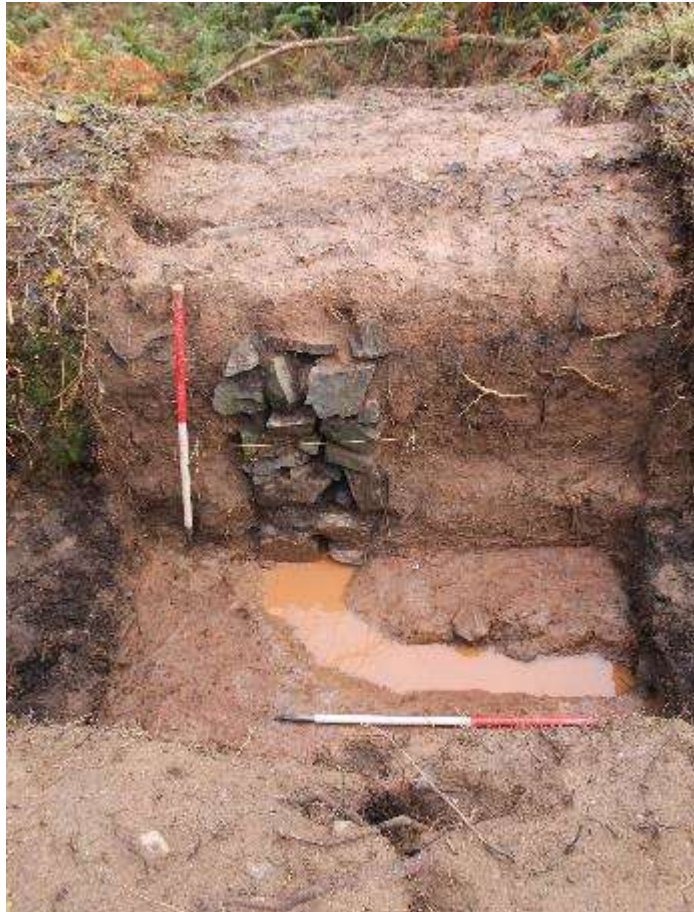
**Plate 22. Trench 3. As Plate 21 but from the West.**

**Plate 22.** Trench 3. As Plate 21 but from the West.

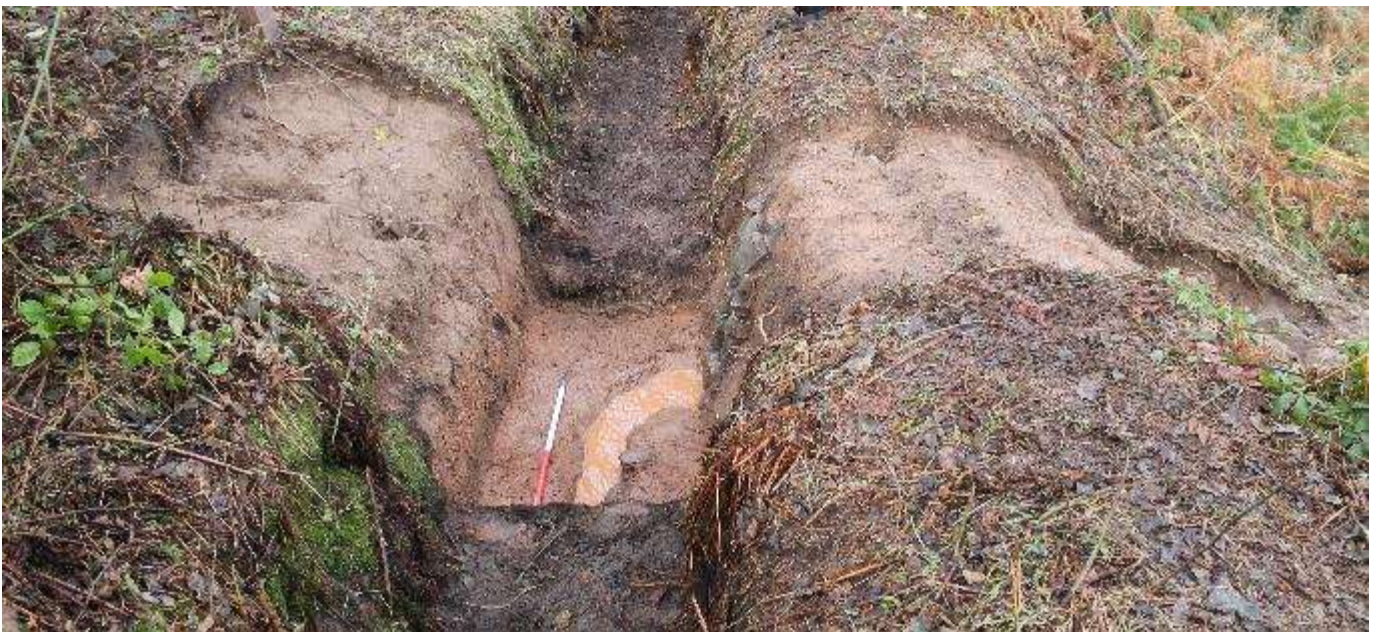
**Plate 23. Trench 3, post-excavation, with subsoil-cut drain (C.309) in the base of the earthen shoreline defensive trench and larger drain (C.303). Visible at the extreme right of shot are the stones (C.312) of the drain emerging from the outer face of the bank where water in the base of the trench was diverted downslope and out of the trench.**

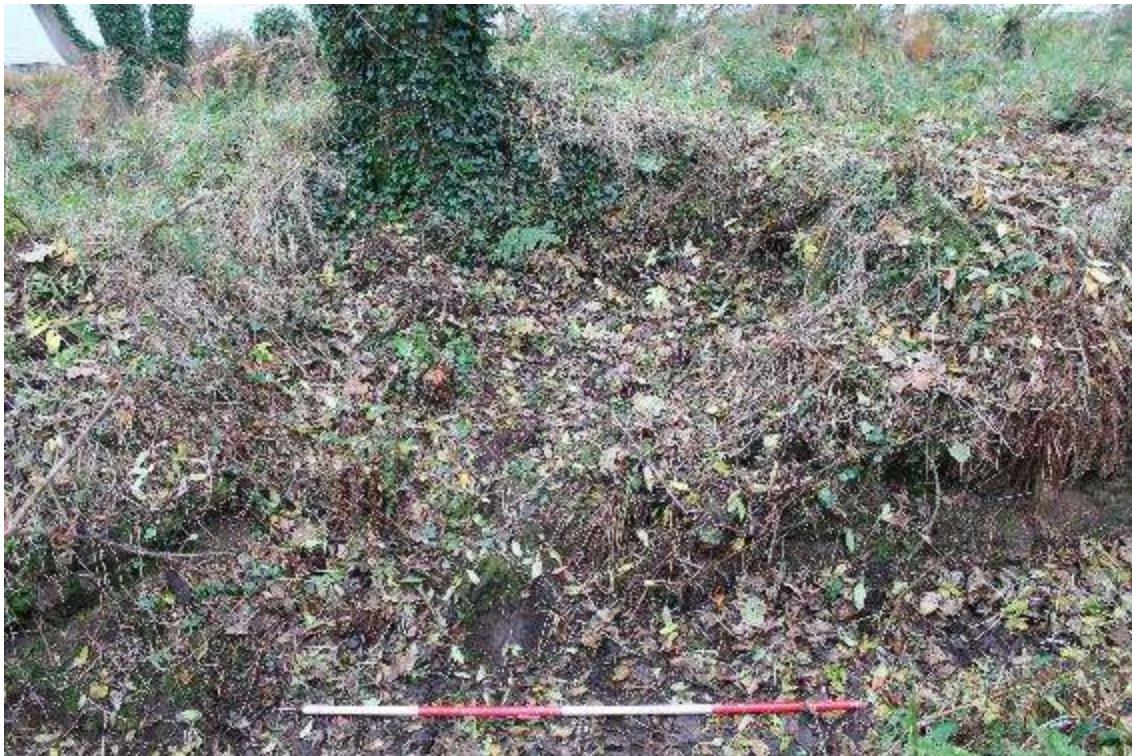
**Plate 24. Trench 4. The dugout pre-excavation, October 2014. From West.**

**Plate 24.** Trench 4. The dugout pre-excavation, October 2014. From West.

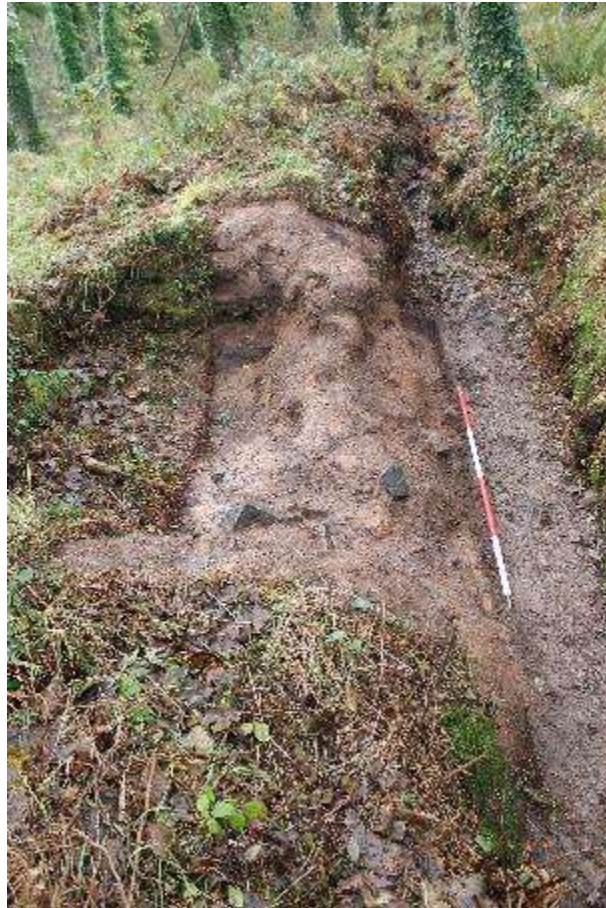
**Plate 25. Trench 4. The dugout mid-excavation. Note also the base and western bank of the adjacent earthen shoreline defensive trench. From North.**

**Plate 25.** Trench 4. The dugout mid-excavation. Note also the base and western bank of the adjacent earthen shoreline defensive trench. From North.
