**CAF Data Structure Report No. 108**

**Excavations at Grey Point Fort,**

**Co. Down**

*Ruairí Ó Baoill and Heather Montgomery*  
CAF DSR 108

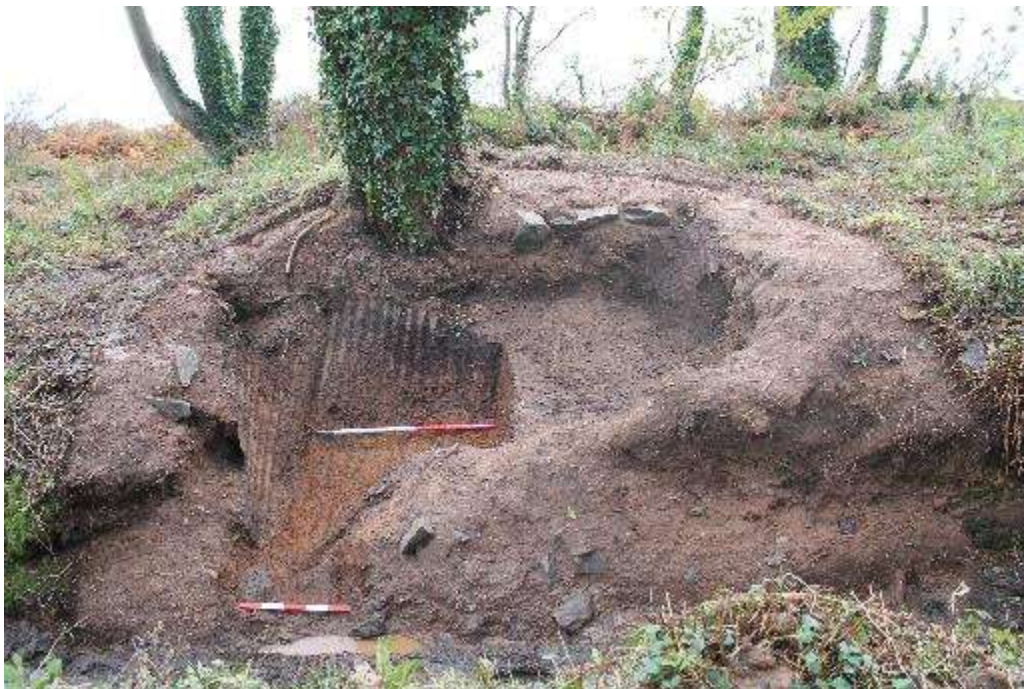
**Plate 26. Trench 4. The wiggly tin uncovered in the northern half of the dugout. Note also the stone revetment in the northern, eastern and south-western banks of the dugout. From West.**

Orange-brown keuper marl clay subsoil was located close to the remains of the entrance. In the northern half of the dugout the inner faces of the northern and eastern walls were found to be revetted with sheets of wiggly tin (Context 403) which had slumped on to the base of the dugout due to the degradation of the earthen walls, and in the case of the eastern wall tree root action, behind them. These sheets were left *in situ* within the dugout because of the limited scope of the 2014 excavation. No mettled stone surface, similar to that uncovered in the base of Trench 3, was observed during the excavation as the base of the dugout was not bottomed during the 2014 investigation. Future excavation might clarify this aspect of the dugout.

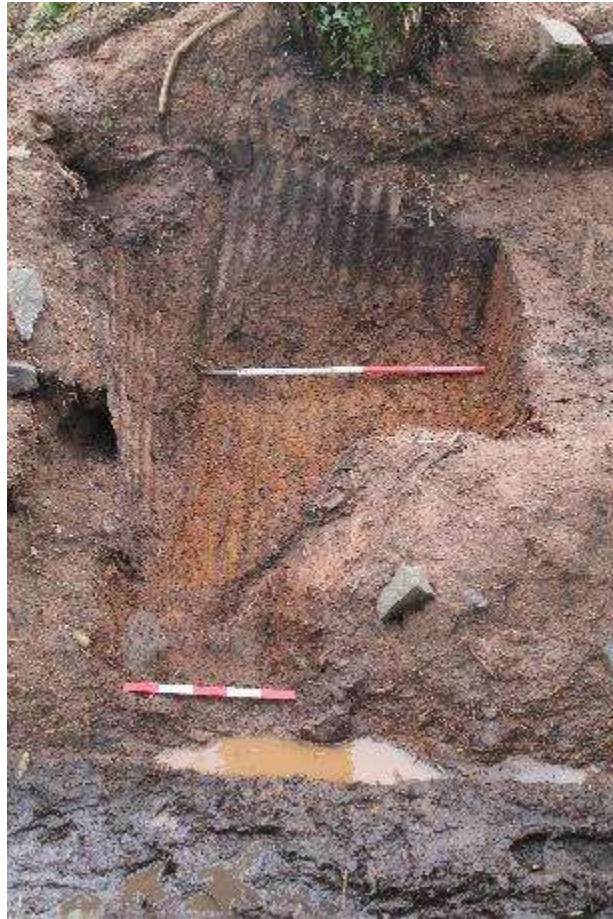
**Plate 27. Trench 4. Detail of the wiggly tin in the northern half of the dugout. The tin in the middle of the shot (below the larger ranging rod) probably represents collapsed roofing. That to the left of the shot, along the inner face of the northern is probably revetting of the walls of the structure. From West.**

There were three main horizons encountered within the dugout above the wiggly tin in the northern portion investigated. Directly above the slumped wiggly tin was a thick layer of orange-brown clay loam (Context 404), between 0.40-0.50m thick, which probably represents slump from the dugout walls. This was below a thin and patchy layer of fragmented and corroded wiggly tin (Context 402), possibly representing either a portion of collapsed roof or else later slump of the wiggly tin that revetted the sides of the dugout. The latest horizon was a deposit of humic-rich silt (Context 401) that constituted topsoil and which had accumulated within the dugout after it had gone out of use. It was a maximum of 0.05m thick and contained many roots. Wiggly tin uncovered against the inside face of the southern wall of the dugout when modern vegetation was removed also suggests that the tin revetting was used against all of the four dugout walls.

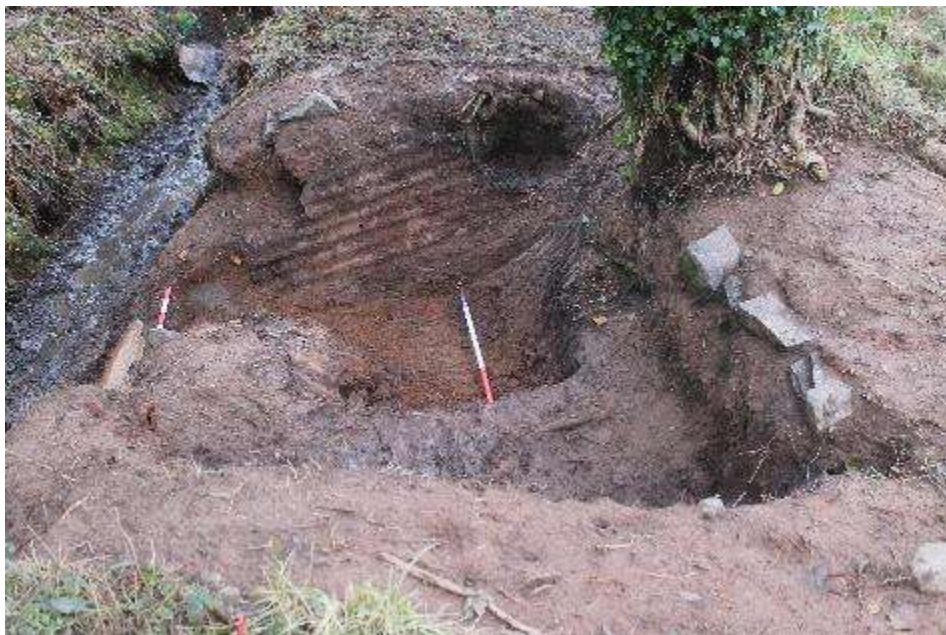
**Plate 28. Trench 4. As Plate 27, but from South. Note post-abandonment badger set in the north-east corner of the dugout and the tree growing on the eastern wall.**

**Plate 28.** Trench 4. As Plate 27, but from South. Note post-abandonment badger set in the north-east corner of the dugout and the tree growing on the eastern wall.

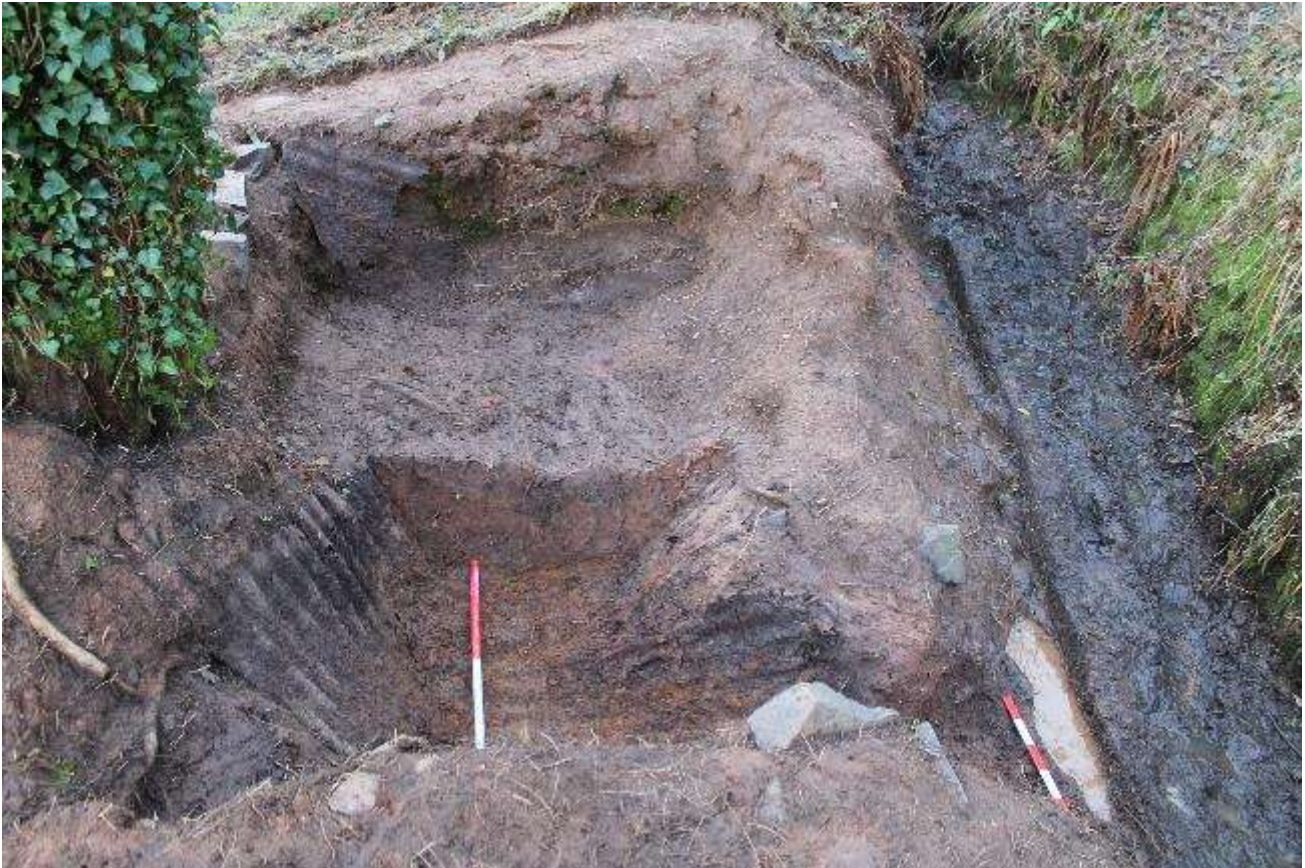
**Plate 29. Trench 4. The dugout when excavation ceased in November 2014. The exposed wiggly tin is in the foreground covered by the thick layer of slump (C.404) from the dugout banks which has accumulated post-abandonment. From North.**
