ULSTER ARCHAEOLOGICAL SOCIETY

Survey Report: No. 11

**House Site 1, Black Mountain, Belfast
UAS/08/01**

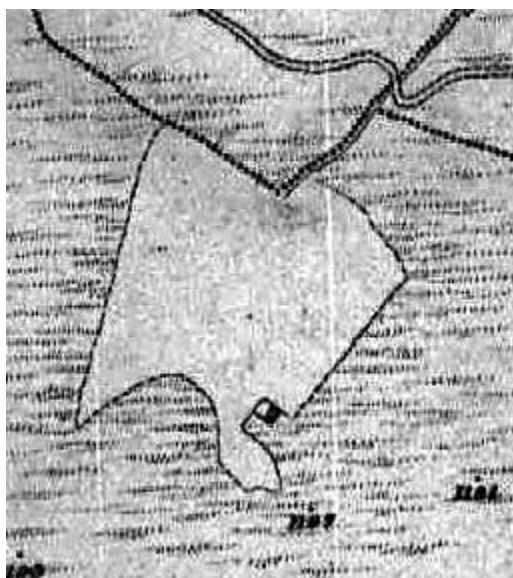
Fig 3. 1st Survey OS-6-1-60-1(1831-32)

The first Ordnance Survey of Ireland carried out in 1831-32 (figure 3) shows what was found to be a small single room cottage measuring some 5m wide x 6m long. The small building in question is shown shaded thereby indicating that it was in a habitable state at the time of the survey. The 2nd Edition OS map of 1857 (figure 4) indicates that there was two structures, one appearing to be a larger building in place of the original small cottage and another in line with a trackway leading to an enclosed yard or garden. The first of these two was shown completely shaded and therefore habitable whilst the second indicated that part of this unit was not habitable since it was not shown shaded. The UAS April 2008 survey findings (see "Survey" in section 3 below) found that a building measuring approximately 9m long x 5m wide was built in line with the original small cottage with a separation of just over 2m between them. However, due to the scale of 6" to 1 mile, these two buildings were shown as one in the 1857 OS map.

The first Ordnance Survey of 1831-32 (figure 3) shows a single building which is believed to be House 'a' in the survey plan drawing (figure 7). From the survey measurements the size of the house would suggest that it was a single room *cottier* type house much the same as the built example of a *cottier* house in the Ulster Folk and Transport Museum, Cultra (UFTM) - Rural Area exhibit 43 (figure 14). Indeed exhibit 44 (figure 15) in the same Rural Area of the museum is similar in size to Settlement House 1 'b' in the plan drawing, but not necessarily of the same layout or construction.

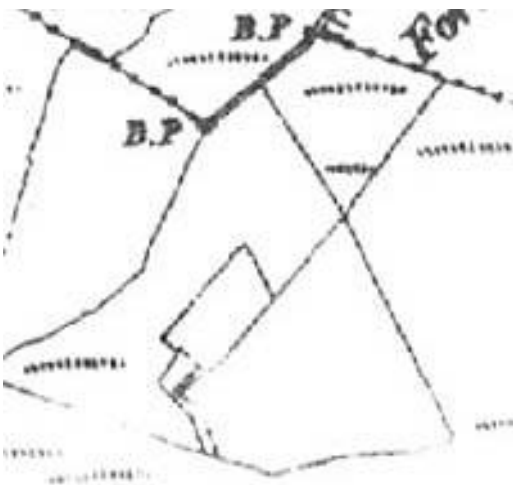
Fig 5. 3rd Edition OS-6-1-60-3 (1901)

The 3rd Edition of the OS map of 1901 shows the building in line with the trackway had been removed and the original small cottage was shown un-shaded meaning that it was not habitable at that time. By 1921 there was no habitable buildings in the settlement enclosure.

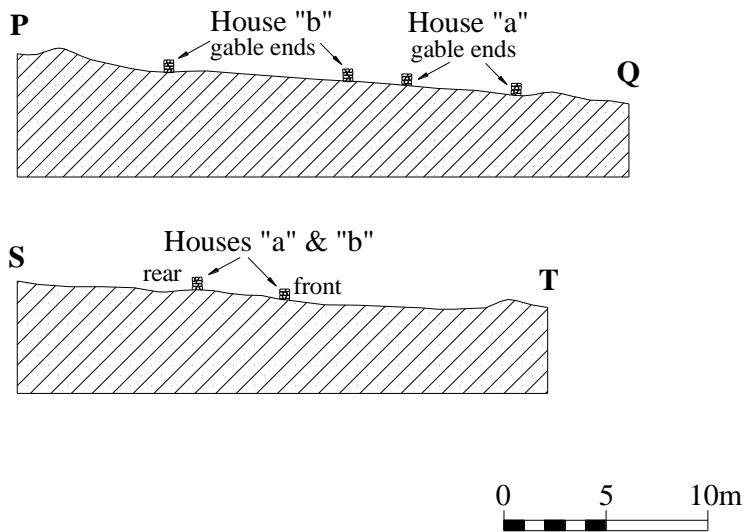
Figure 8. Profiles - House Site 1, Black Mountain

Plan and profile drawings were completed from data obtained from a field survey. Measurements were obtained by using the society's *Leica Sprinter 100* electronic measuring device. Sketch plans at 1:200 scale were completed on site by recording these measurements on drafting film secured to a plane table and backing up the data on a field notebook for subsequent reference. Field plans were later transferred to a computer-based format for printing (figures 7 & 8).

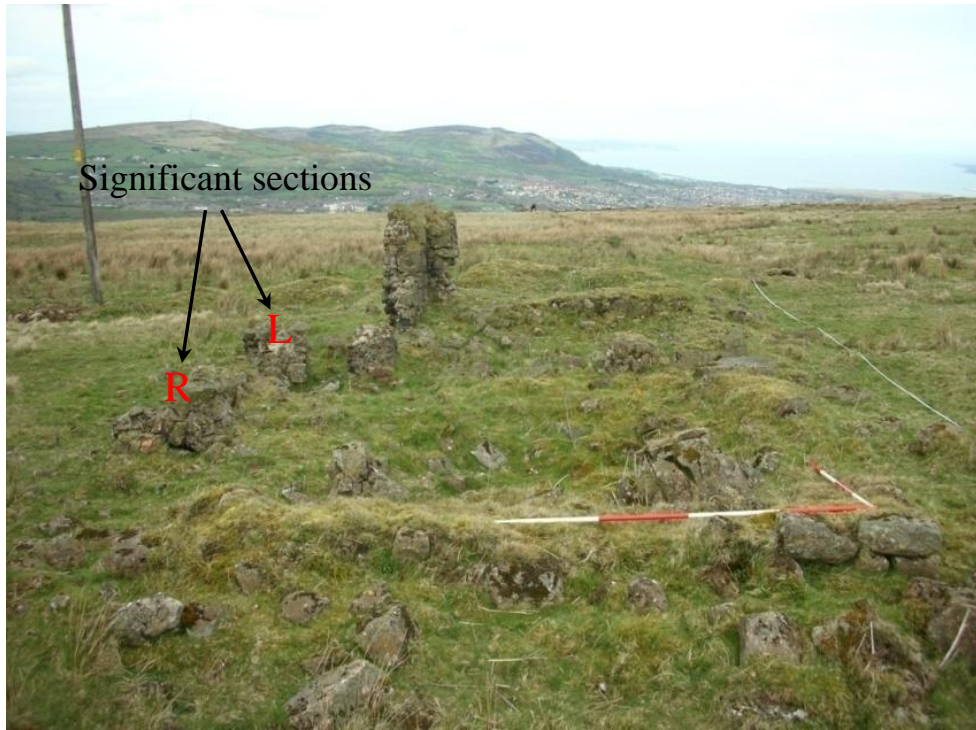
Figure 11. Remains of House 'b'

The size and lie of the two significant sections close to the front of House “b” (figures 7, 11 and 12) would suggest that they probably came from each side of the house doorway. Both of these fallen pieces had straight edges with both having a considerable number of fired imperial red brick embedded within the building stone and mortar. Fired red brick can also be seen embedded in the upstanding remains of the wall of house “b” mentioned above. It was noted also that the main upstanding corner section of house “b” showed signs of a window splay in the front section of the wall.

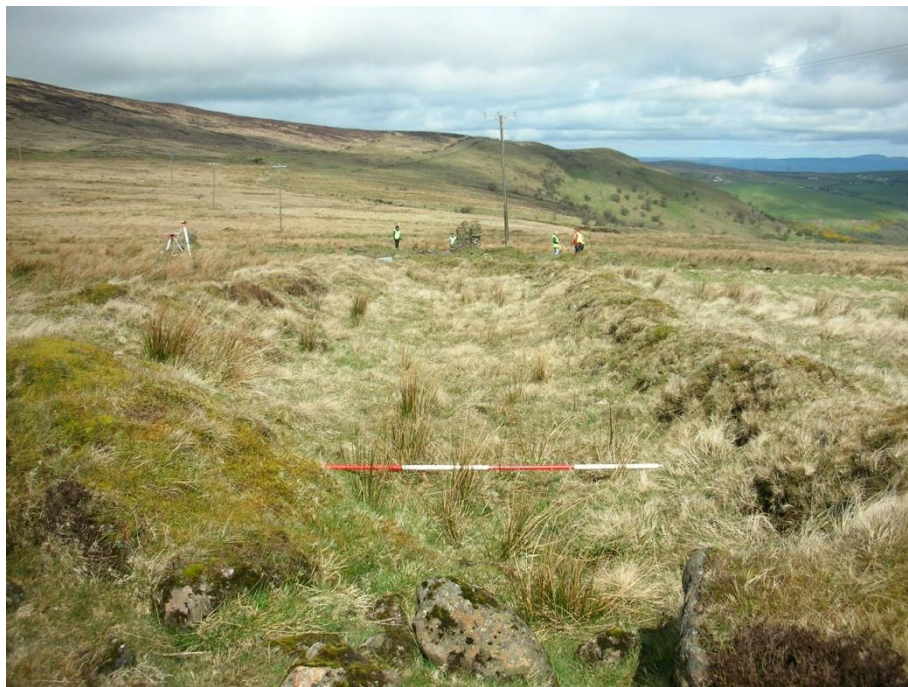
Figure 13. Trackway leading to House Site 1, Black Mountain

The approach to the Settlement site was by means of a trackway (figure 13). The trackway was found to be, on average, approximately 3.5m wide with a raised earth and stone bank on either side roughly 1.2m wide at the base and varying in height from 400 to 800 mm high. A small layer of stonework level with the ground and protruding from beneath the west track bank, opposite the west gable end of house “b”, appears to be a remnant of the base of the 3rd building shown only in the 1857 Survey. Considering the two raised banks associated with the trackway, they appear to have been constructed differently suggesting that they were constructed at different times. From figures 4 and 5 it can be seen that the west track bank was altered between 1857 and 1901 whereby it takes up a position in the 1901 OS map which cuts through where the 3rd building would have stood in the 1857 OS map. This would most likely account for the difference in construction of these banks.
