Survey Report

Reference: **Survey Report No. 64**

**Survey of Temple Water
Castle Ward
County Down**

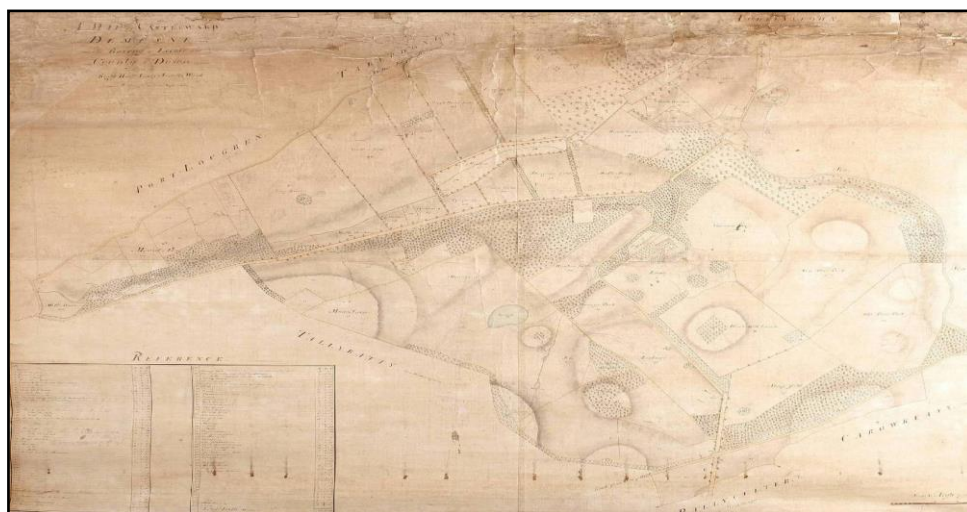
Figure 03: Demesne survey map 1813 *National Trust*

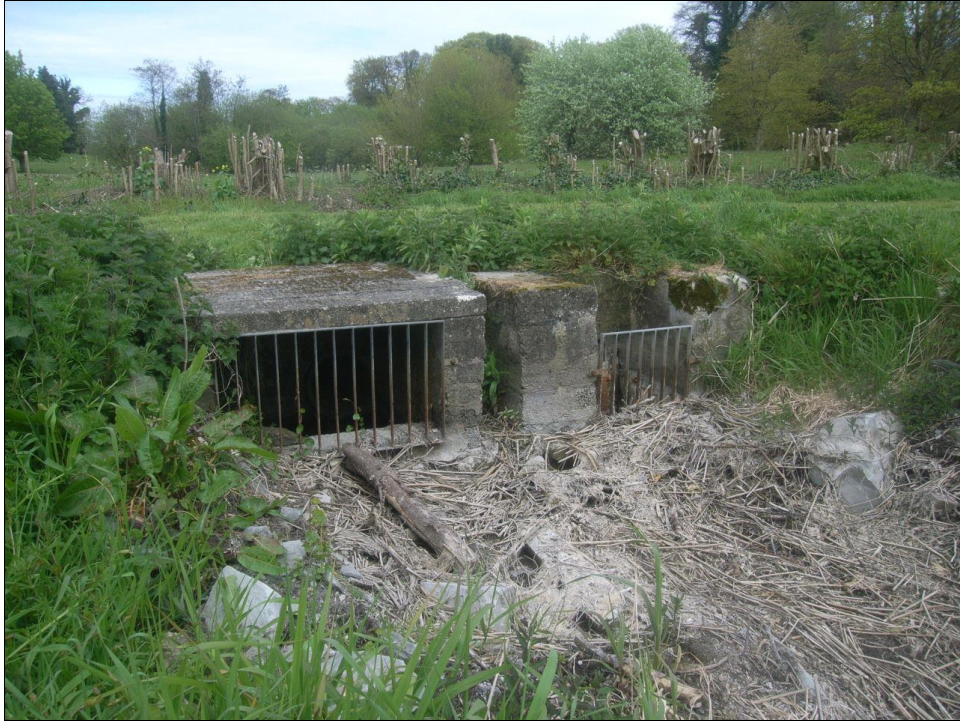
Figure 10: View of eastern drainage sluice, looking east

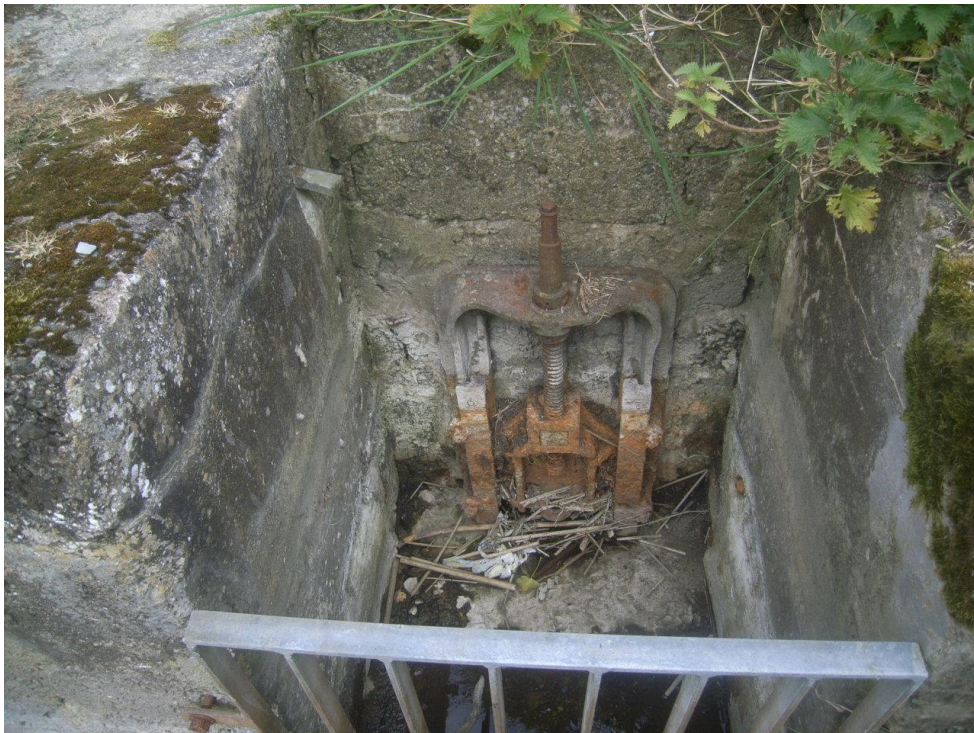
Figure 11: View of eastern sluice gate, looking east

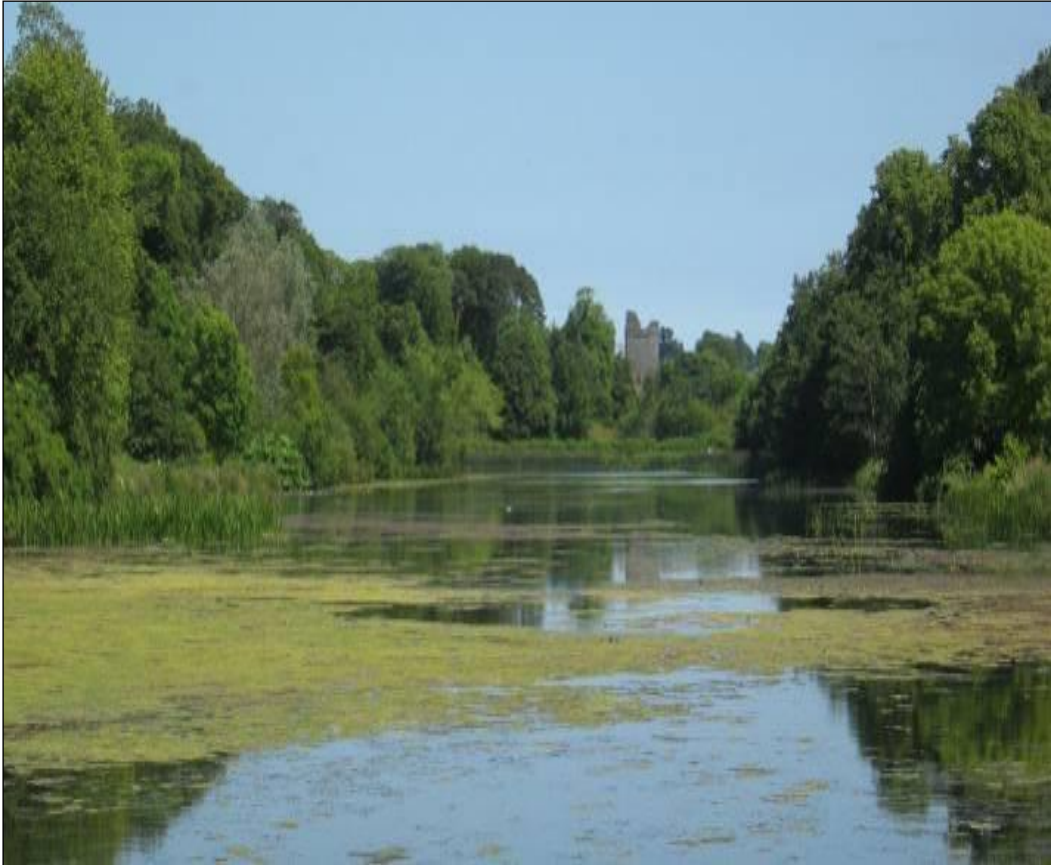
Figure 14: View of Audley's Castle, looking east. The original crisp outline of the lake is obscured by vegetation. *National Trust*

In 2017, The National Trust embarked on an ambitious conservation project at Castle Ward to refurbish the Temple and historic paths and vista points. The man-made landscape of the Temple Water area, designed by the Ward family, is one of the most important late seventeenth and early eighteenth century gardens to survive in Ireland. It is anticipated the project will take three years and will include the repair of the Temple and improvements to the parkland to open up views of both Audley's Castle and Strangford Lough. Temple Water will be a central to the restoration project. Historic paths will also be reinstated along Lime Tree Walk and the Yew Tree Terraces. Improvements will also be made to access around the lake by reinstalling former pathways and steps, repairing drains, creating pockets of natural biodiversity, removing some inappropriate trees, pruning others and planting new trees in locations based on early demesne maps.

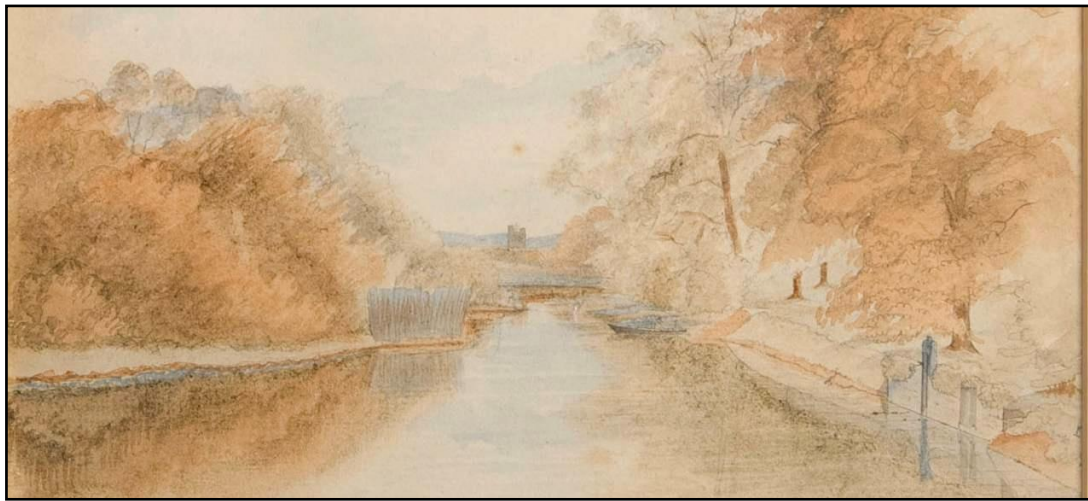
Figure 16: View north-east along lake towards Audley's Castle, Mary Ward c.1850s-60s, shows less sharp outline than originally intended, perhaps intentionally evoking a more Picturesque feel. *National Trust*

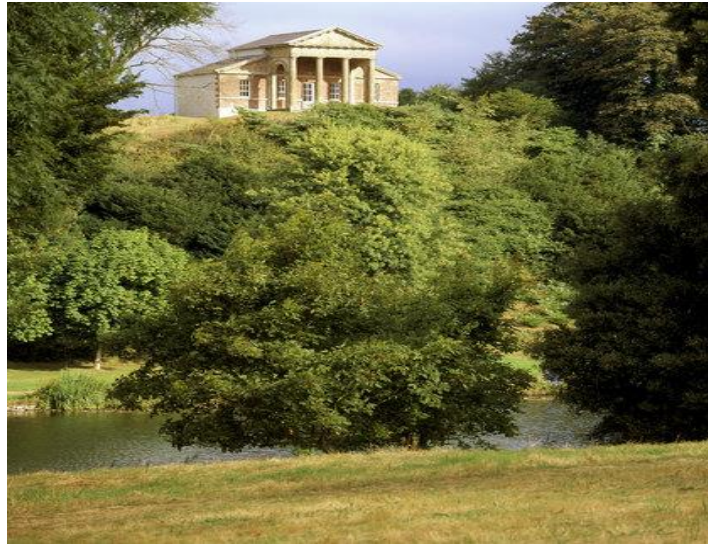
The Temple is a folly in the form of a Greek Temple. The central bay is fronted by a classical pedimented portico with a set of Tuscan columns and carved frieze. It is constructed mainly of brick and of Bath stone, which is a Jurassic limestone formed some 140 to 220 million years ago. The Temple is believed to date from around 1755.

Figure 18: View of the Temple. *National Trust*
